## WERO Dam Removal and Habitat Restoration:

*Initial Wetland Delineation Trip Report and Planning Status Summary 9/22/2017*

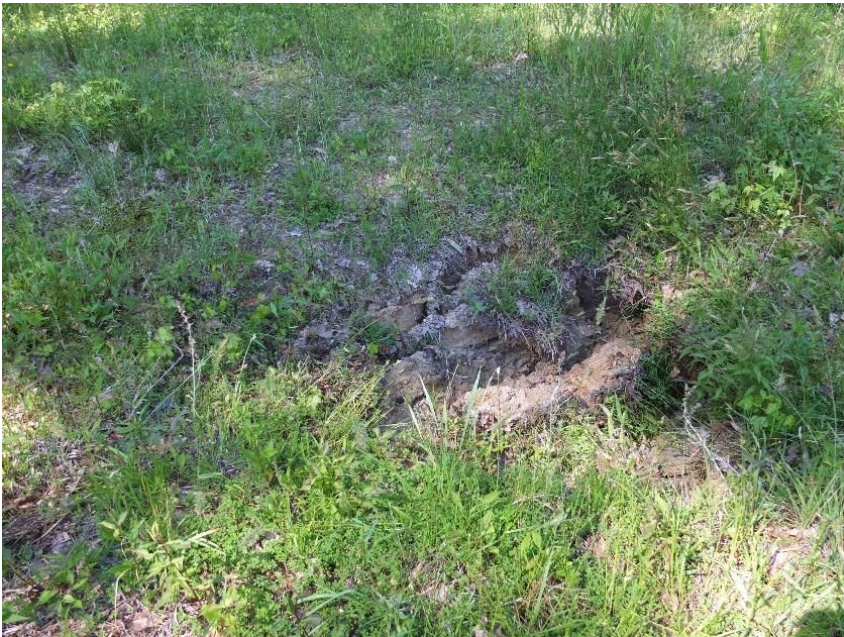
A 20 foot deep sinkhole has opened on the top of the dam, right over the drain pipe (see Figures 4 to the left and 5 and 6 on the next pages) and is now 1/3 the width of the dam. According to Pete Penoyer, Hydrologist, NPS Water Resource Division, the sinkhole in the dam could be due to the beaver activity, if the dam became saturated. Mr. Ripley (former landowner) stated this has happened before and he would just fill the void. COLO Maintenance filled the void.

*Figure 4: Sinkhole during Rapid Assessment Team visit in April 2017.*

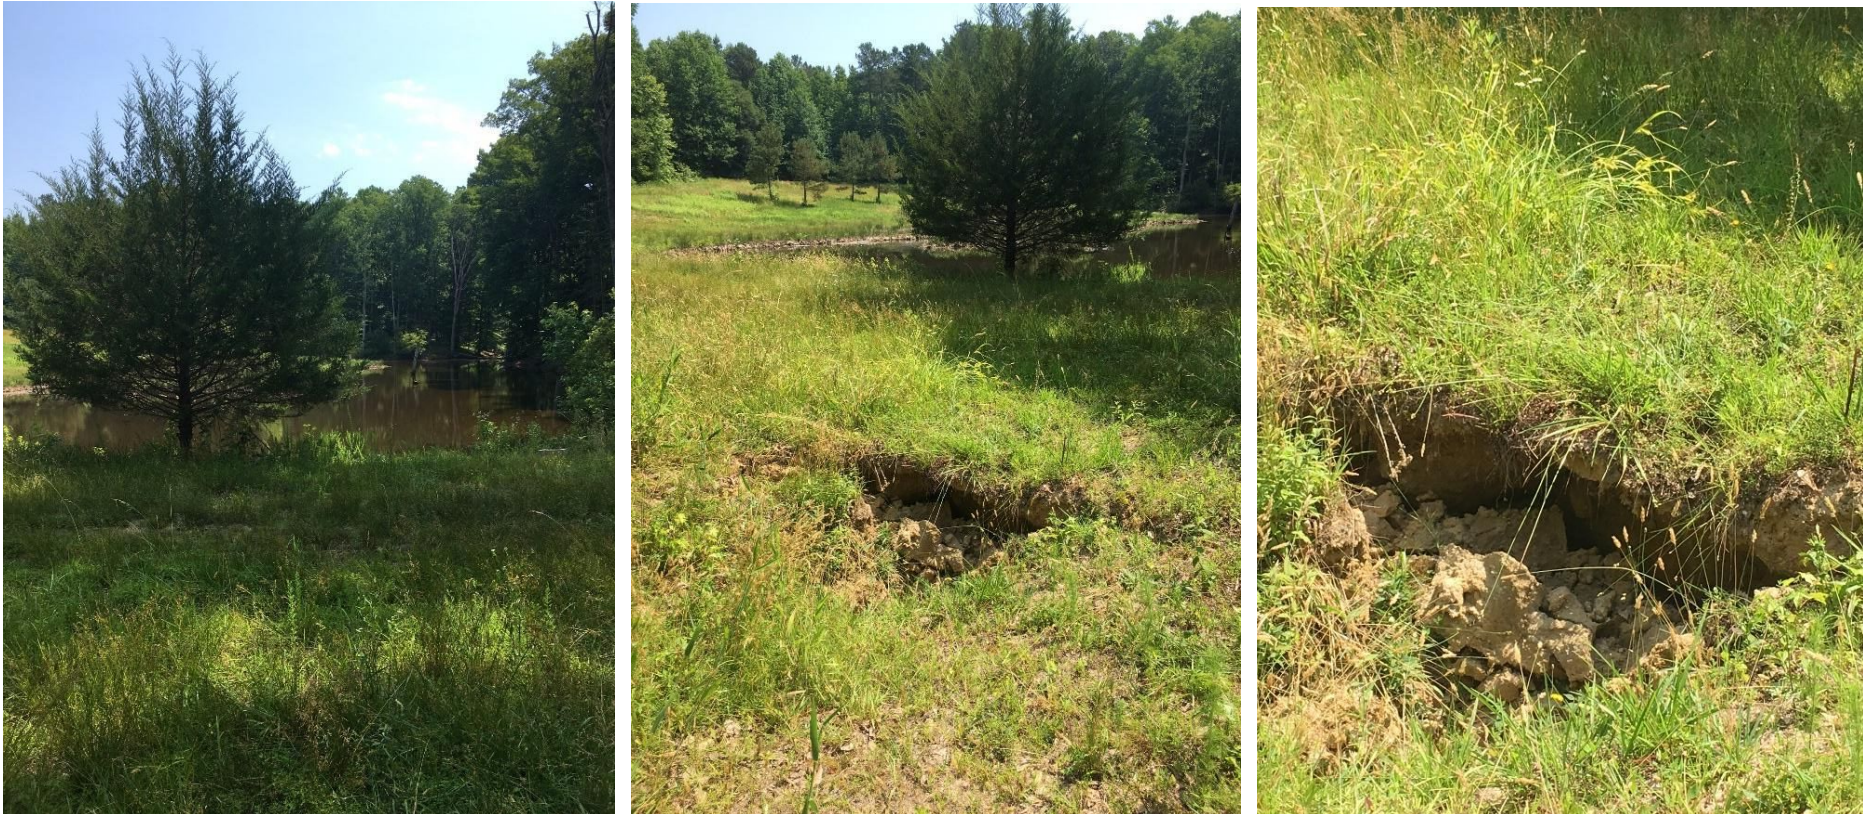
*Figure 5: Site photos from COLO maintenance (On Mon, Jul 3, 2017 at 7:30 AM, William McQuillen <william\_mcquillen@nps.gov>, COLO Yorktown Maintenance). Since these photos COLO maintenance dumped two loads of dirt in the hole. The dump material sank and a 20 foot depression formed around the hole.*

The hole in the top of the dam is increasing in size over time. In 5 months it has expanded from less than a foot in width to 6 or 7 feet. During the site visit on September 22<sup>nd</sup> the filled area was 1/3 the width of the dam (Figure 6). At this rate, with no additional material added (WERO is currently unfunded, COLO maintenance worked overtime at WERO in FY17 under WERO funding) the top of the dam will be completely breached within the year.

Based on the size of the dam (Table 1, next page) and the potential volume of water behind it, Mark E. Baker, Dam & Levee Safety Program Manager, WASO Transportation, 303-969-2921, determined the dam is non-jurisdictional and not eligible for NPS Dam & Levee Safety Program funding (personal communication, 11 July 2017).

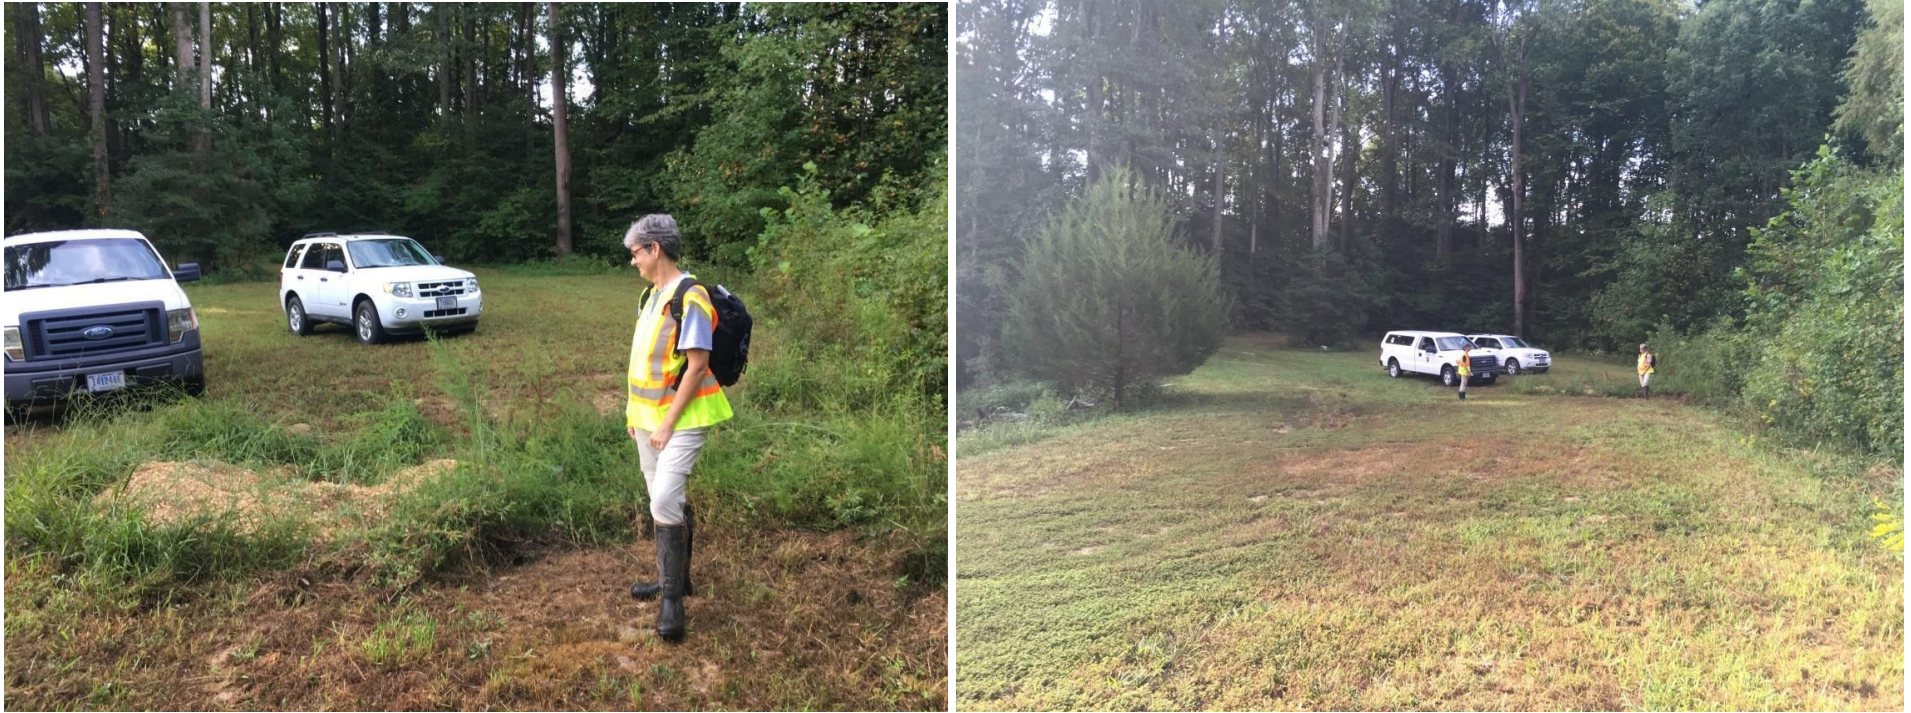
Figure 6: Filled Sinkhole on 9/22/2017. The sinkhole is hypothesized to be directly above the bend in the drain pipe. The drain pipe extends straight into the dam from the pond off image to the left and then must bend sharply at some point in the dam for the end to be sited at the stream elevation 16-19 feet below the crest of the dam off image to the right. It is believed that the seam at the pipe bend is leaking, leading to dam failure from that point towards the stream (behind Dorothy Geyer in the picture).

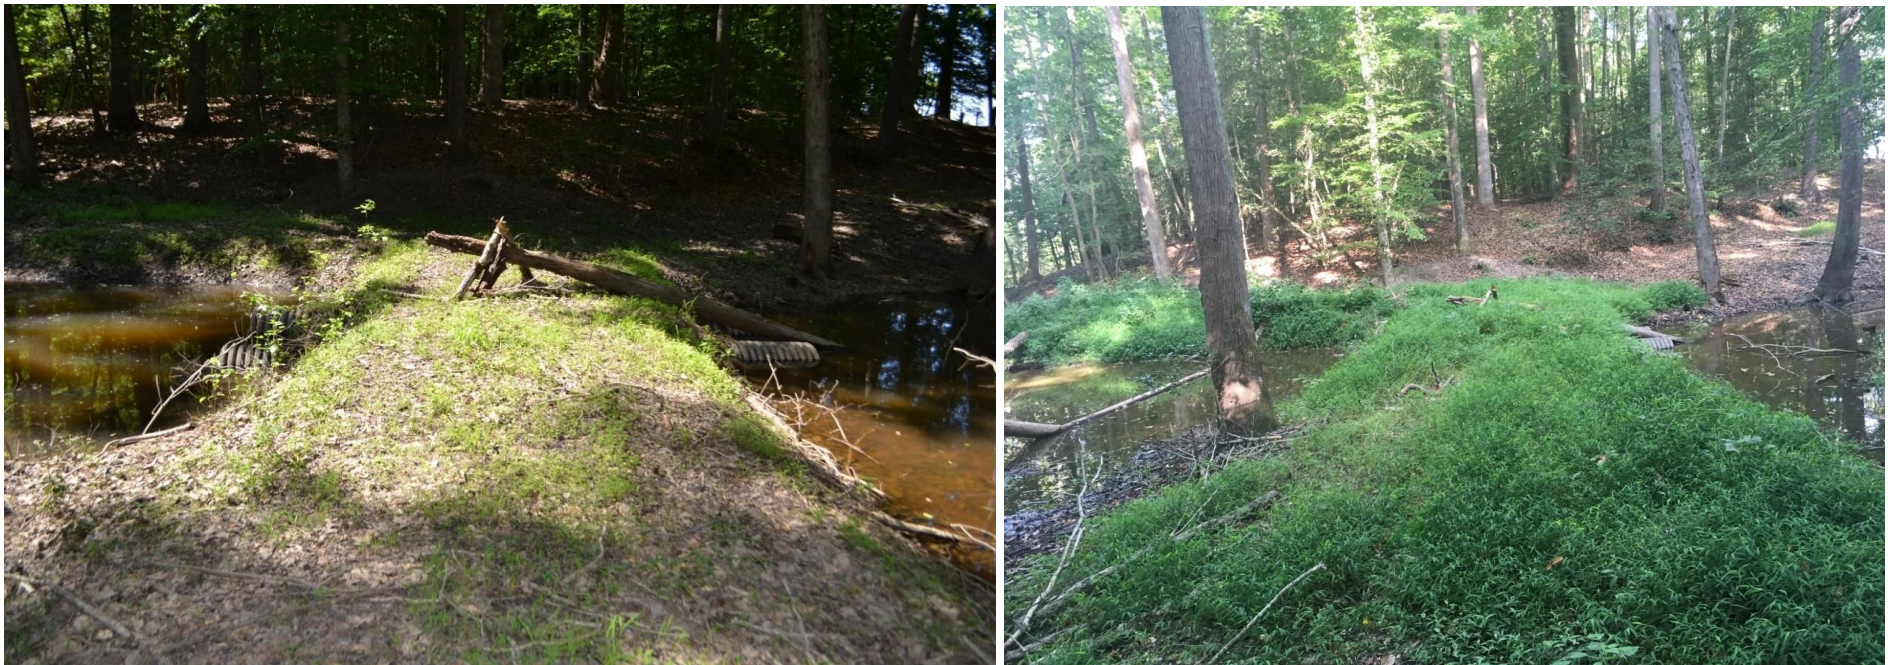
A second dam, which has served as vehicle access and Tim Layton proposed as part of the trail system, occurs in the woods upstream of the first dam (Figure 7).

Figure 7: Second dam in the woods, photographed by Timothy Layton, Rapid Assessment Team, April 2017 on the left and Marian Norris 9/22/2017 on the right. Dam dimensions are 24 feet wide by 2.3 feet tall and the sediment level is halfway up the pipes. In September the vegetation is functionally emergent wetland.

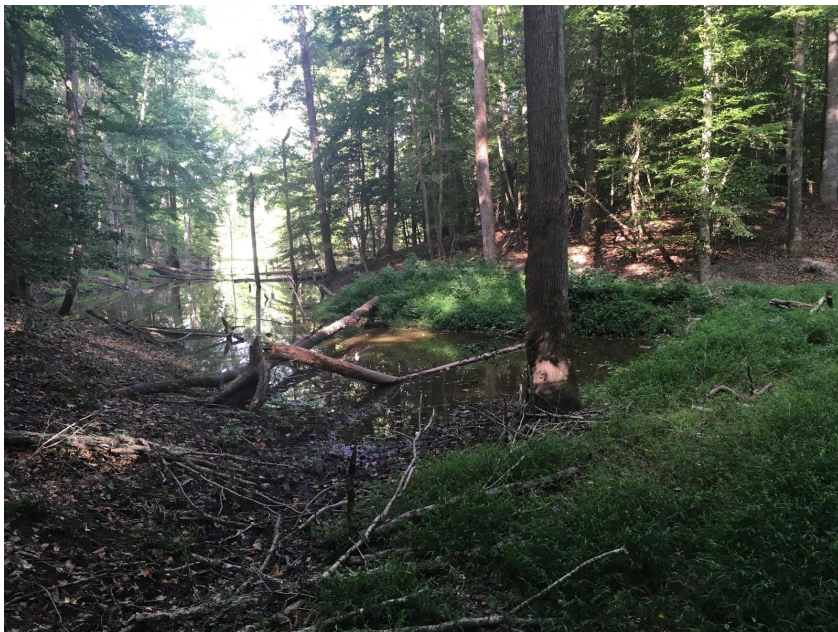
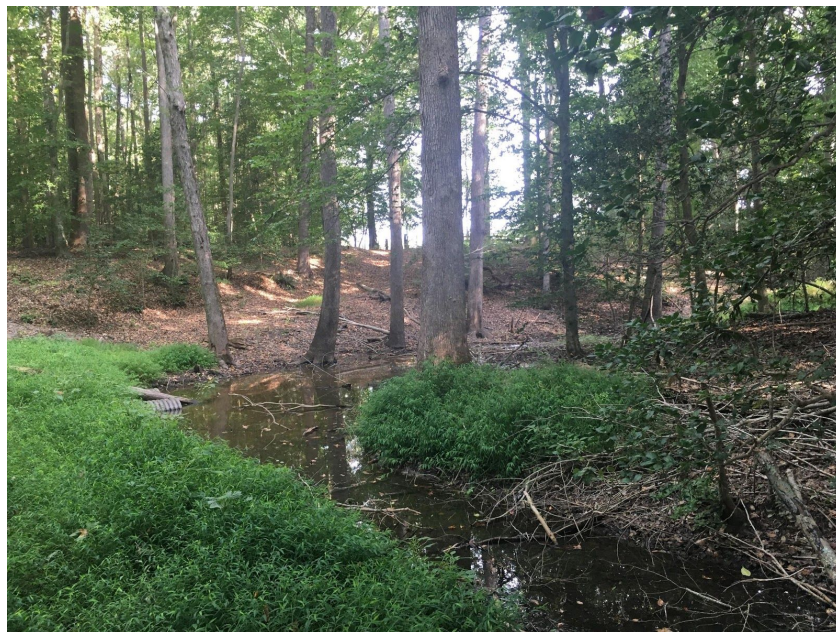
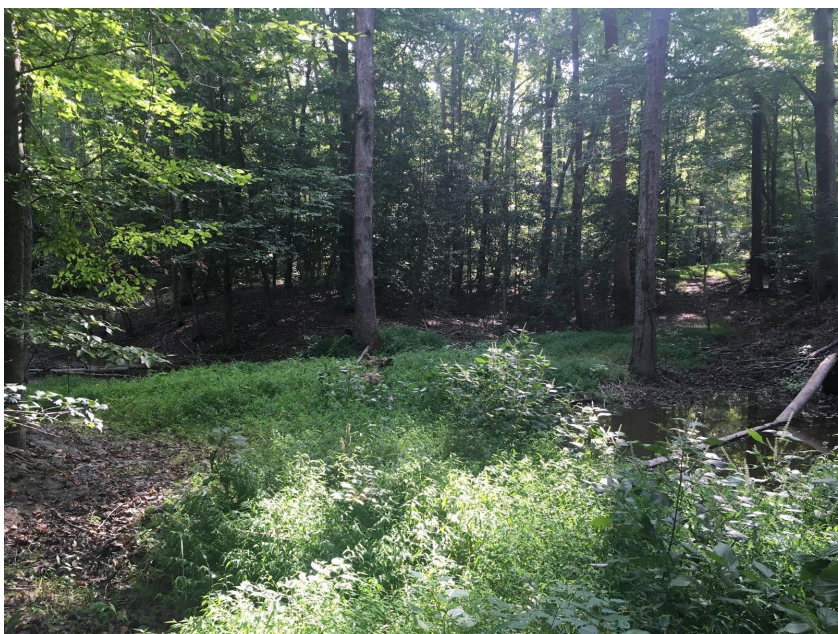
*Figure 8: Extent of second dam and ponding on either side*

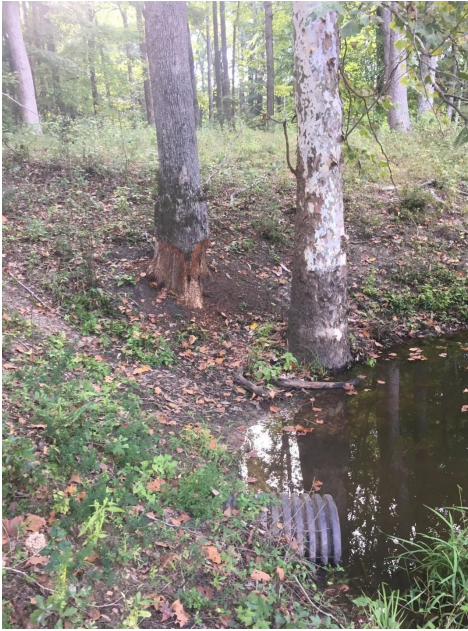
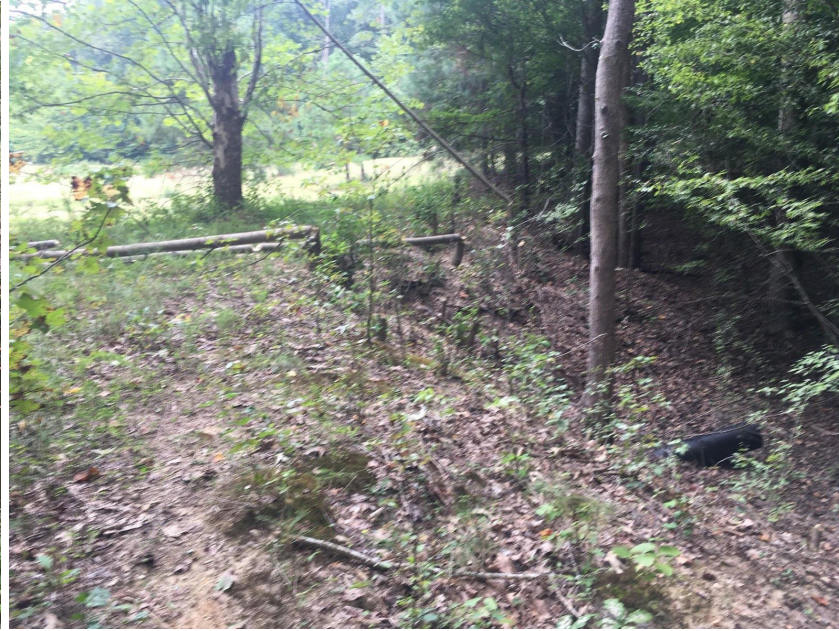
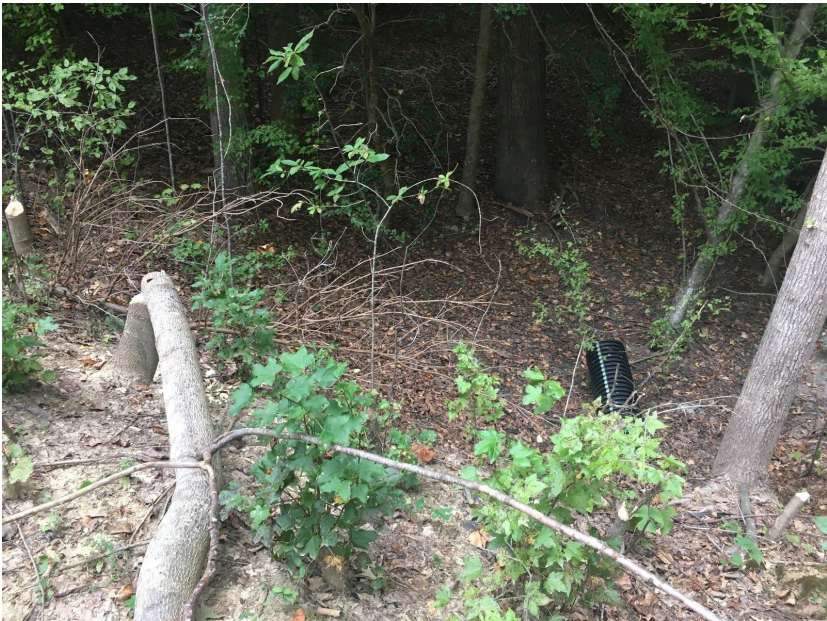
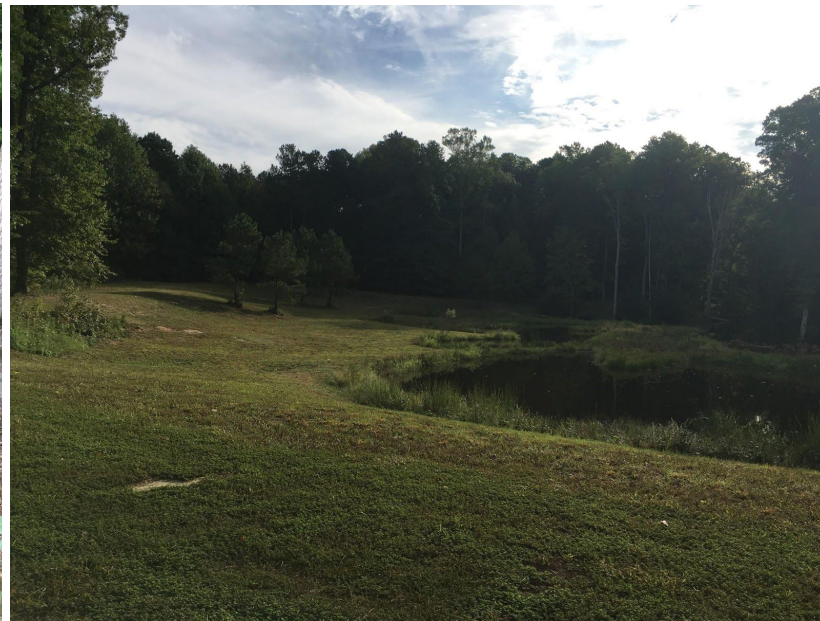
Figure 9: There is a 3rd outfall in the woods, which implies that the ground above and behind it is another dam, somewhere in the tree line at the back of the bottom right picture.

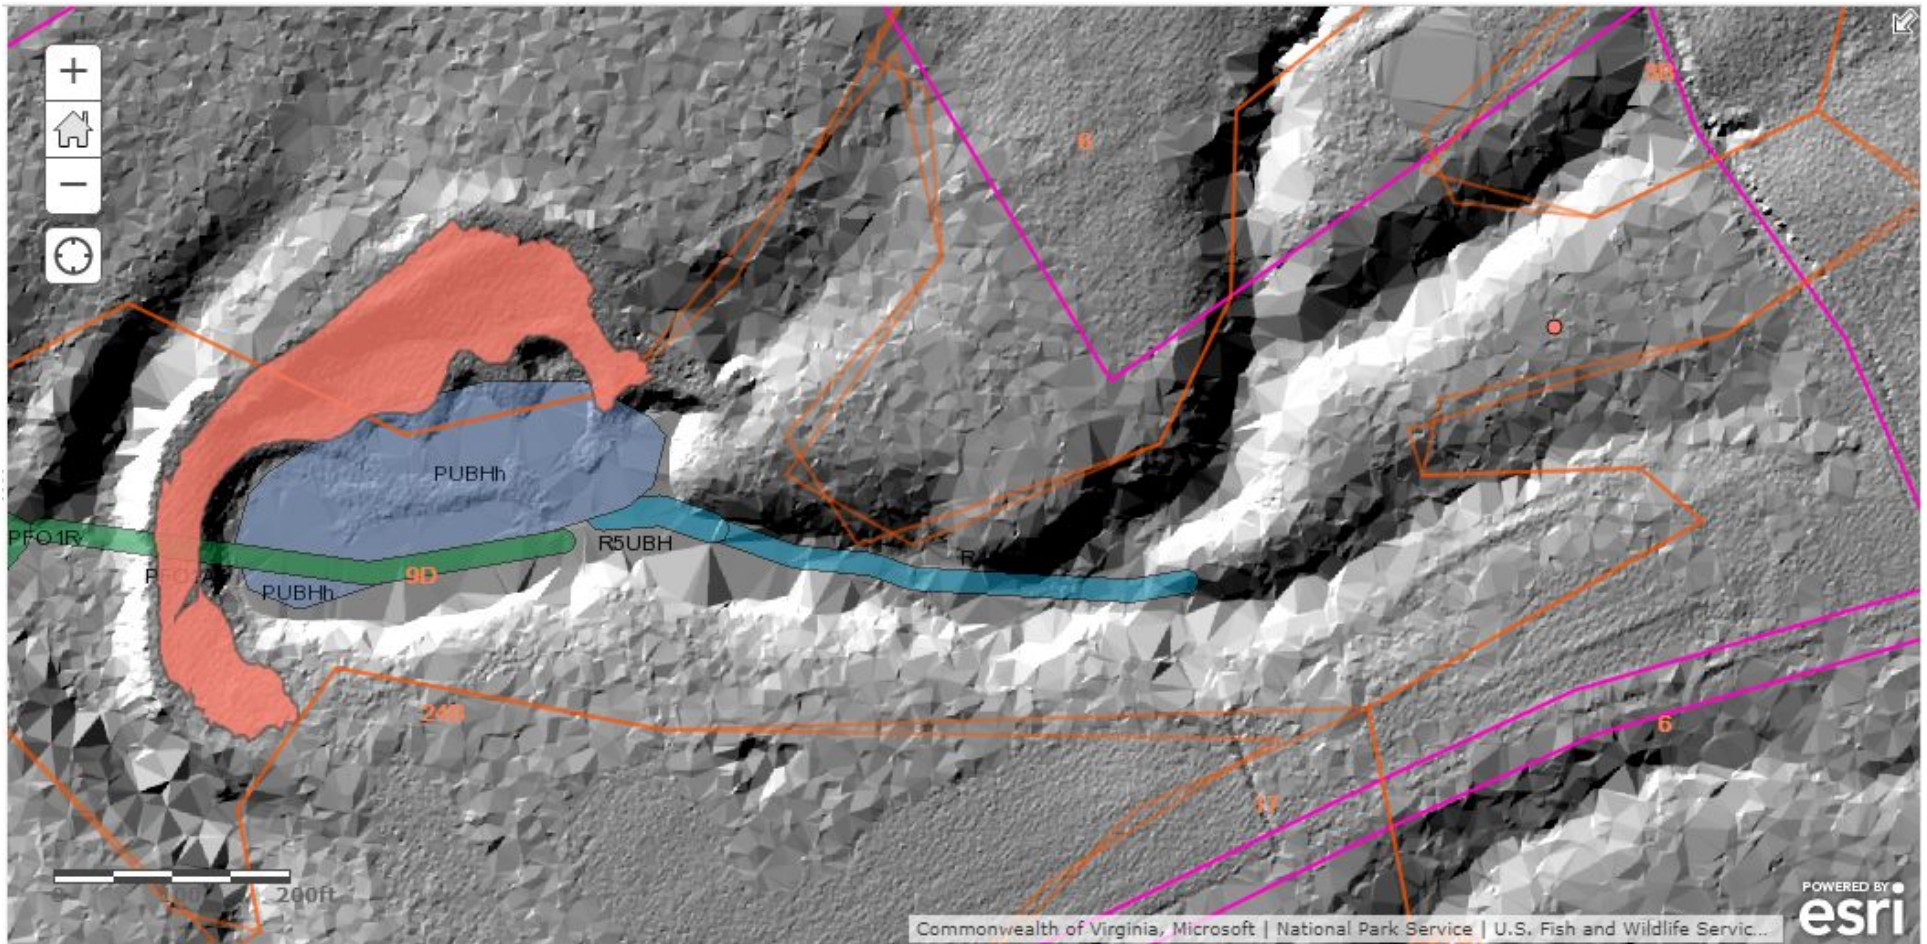
Figure 10: Full extent of the “dam” to be removed. This needs to be surveyed by a proper engineer, probably during leaf-off. We GPS'd it on 9/22/2017 under tree canopy.. Dam 2 in the woods also needs to be surveyed and it's removal or replacement with a more water and sediment pervious structure determined.

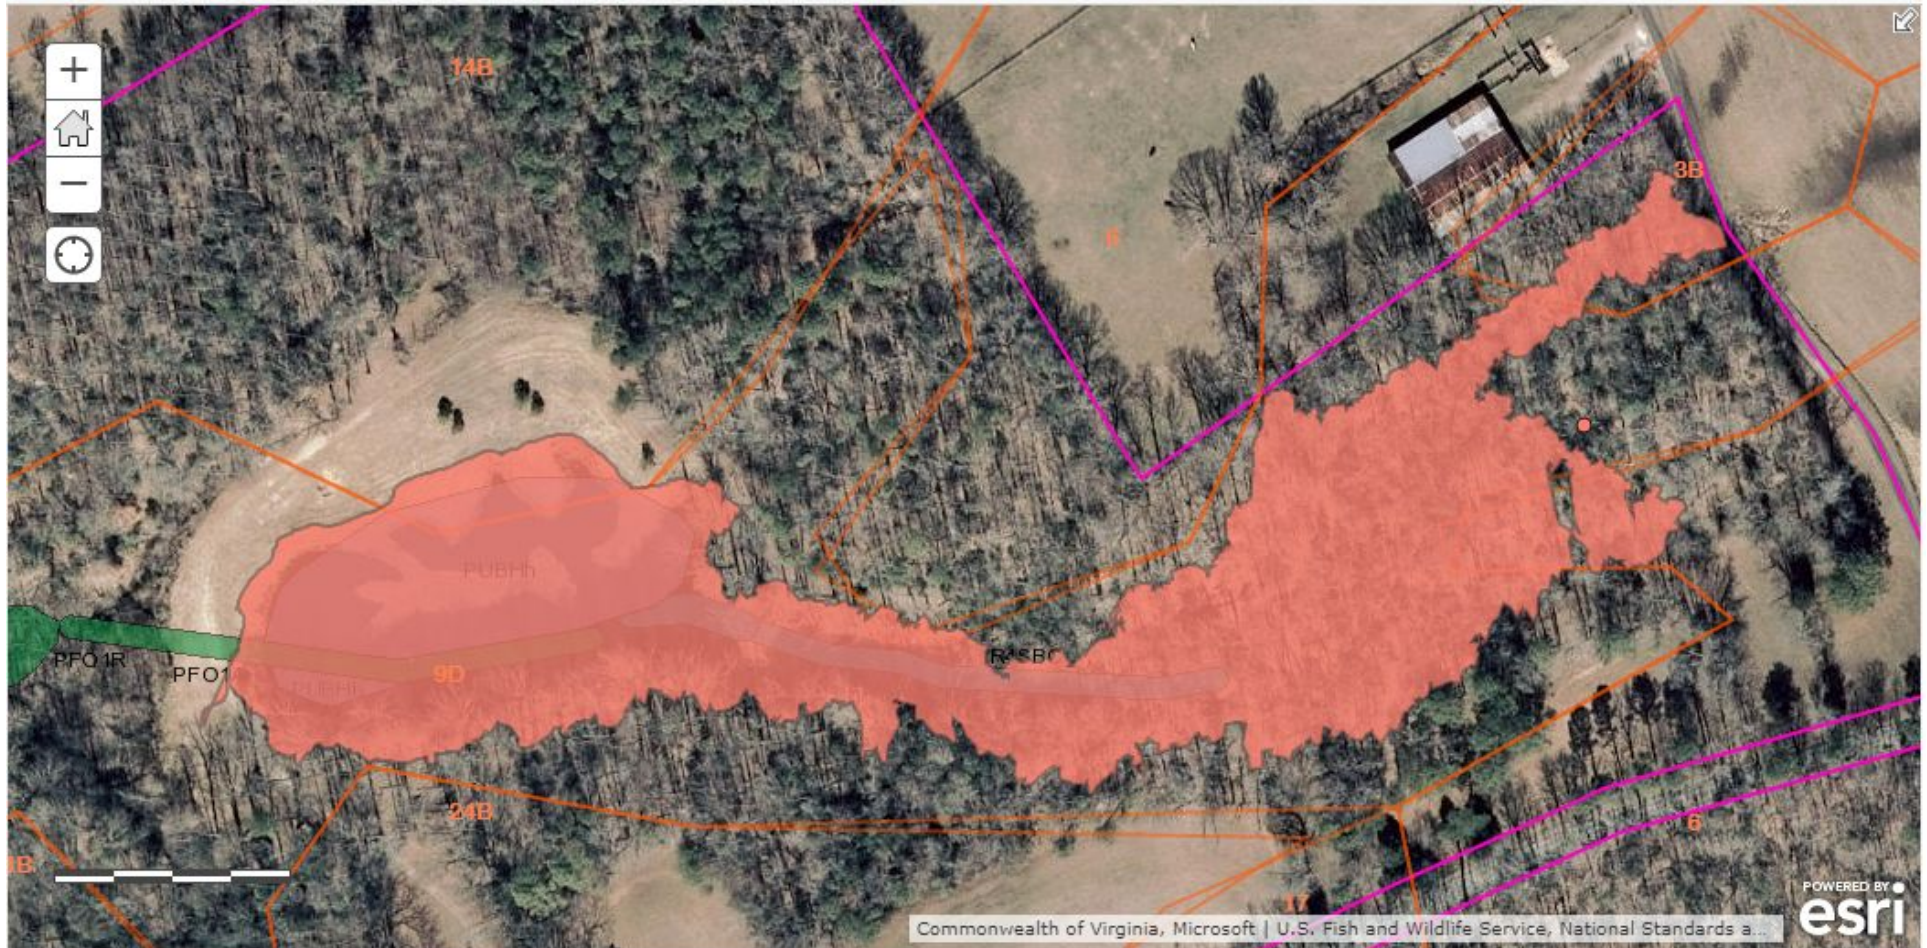
Figure 11: GPS'd extent of Leigh Creek wetlands area above the dam in WERO. This area is wetlands because it has accumulated sediment behind dams 1 and 2.

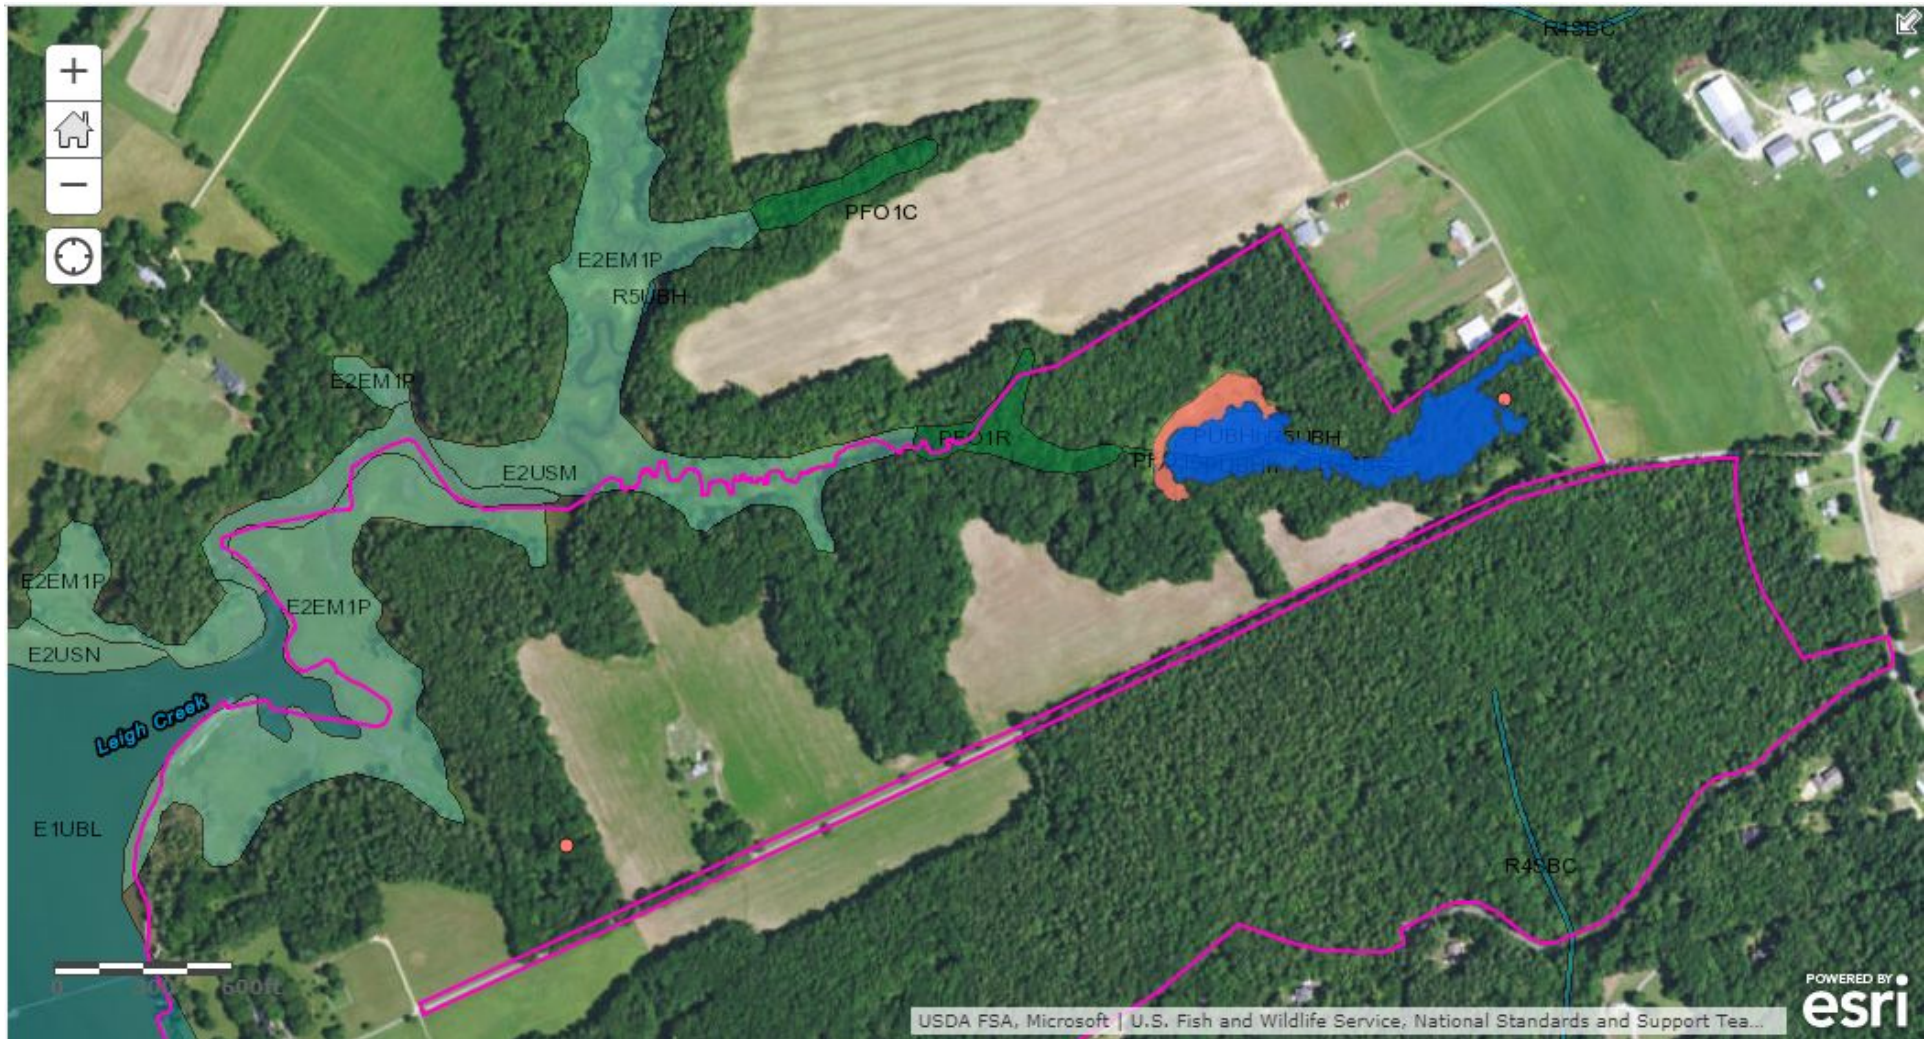
Figure 12: If the dam fails, then the dam and wetlands' sediment load becomes the dredge / fill deposited into the downstream wetlands and critical and essential fish habitat. Therefore maintaining the dam until the sediment can be dredged and the dam properly removed without spilling material into the stream is important. Funding is the issue.

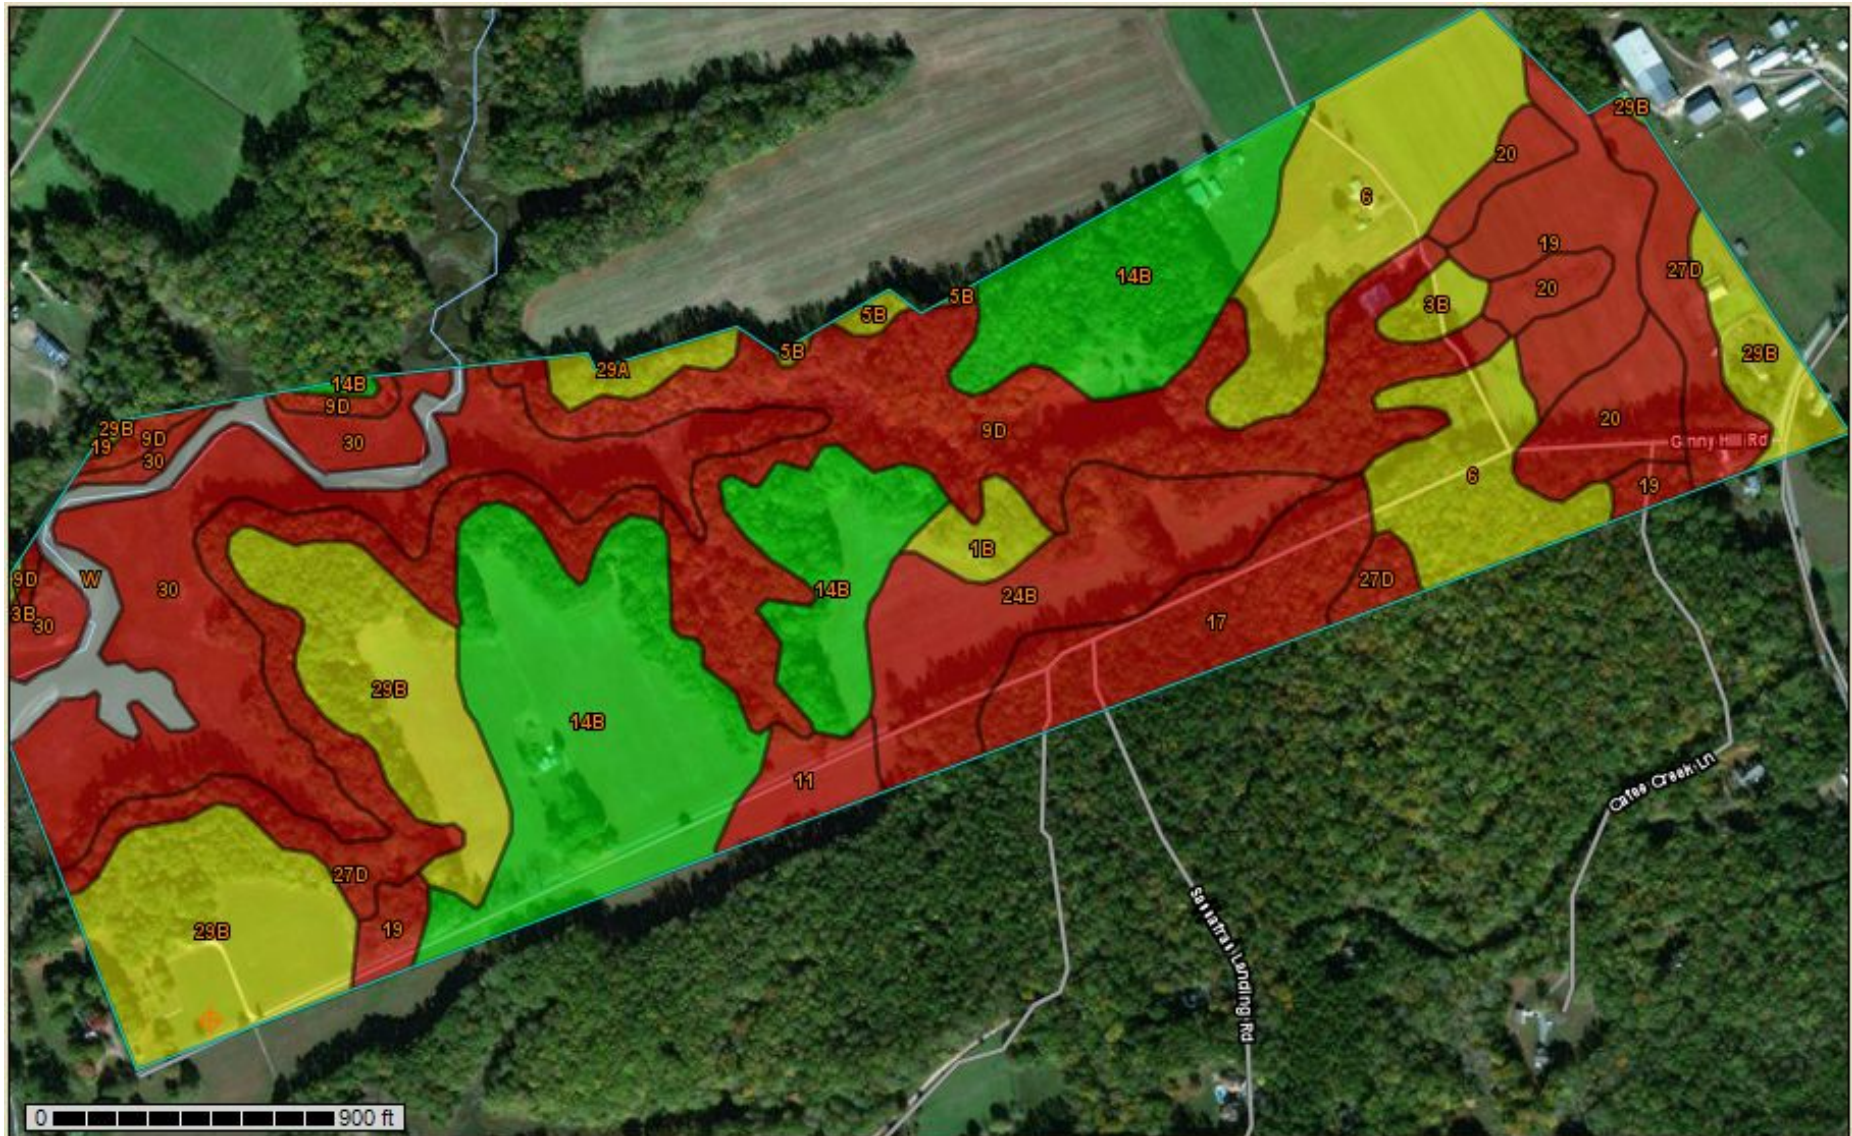
Figure 27: NRCS WebSoil Embankment / Levee / Dam suitability Rating Soil classes W, 30, 27D, 9D, and 14B correspond to Leigh Creek in WERO, and 20 corresponds to the headwaters on the neighbors' property. The soils in Leigh Creek corresponding to the dam location, 9D, are not recommended for embankment, dam, or levee construction because they are steep, piping would be an issue, and they are dusty (?).
