# Fort Barry Balloon Hangar and Motor Vehicle Sheds

## *Abbreviated Historic Structures Report*

Golden Gate National Recreation Area  
San Francisco, California

Produced by the Cultural Resources and Museum Management Division  
National Park Service

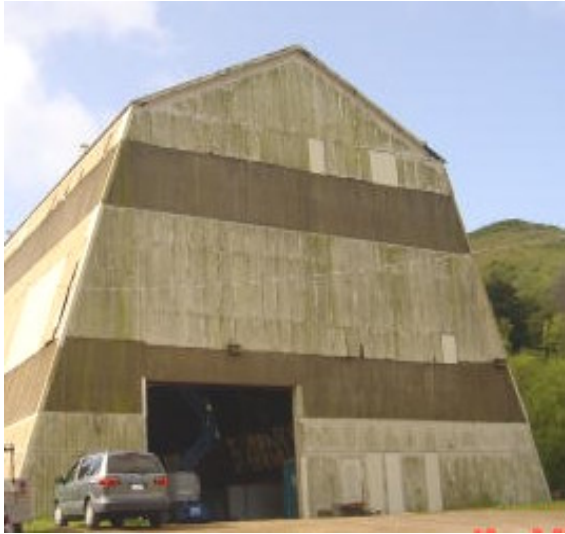
As illustrated by the photos above, the “window rows” (corrugated glass fiber sheets) at level 2 and 4 appear to be in good condition, with less than 1 percent distress.

There has been relatively recent repairs at level 5 and 3, where painted corrugated sheet metal replaced some corrugated asbestos coated iron sheets. The material is similar in appearance, but the detailing and workmanship was less than adequate. Repairs at level 1 with corrugated sheet metal were also inappropriately constructed

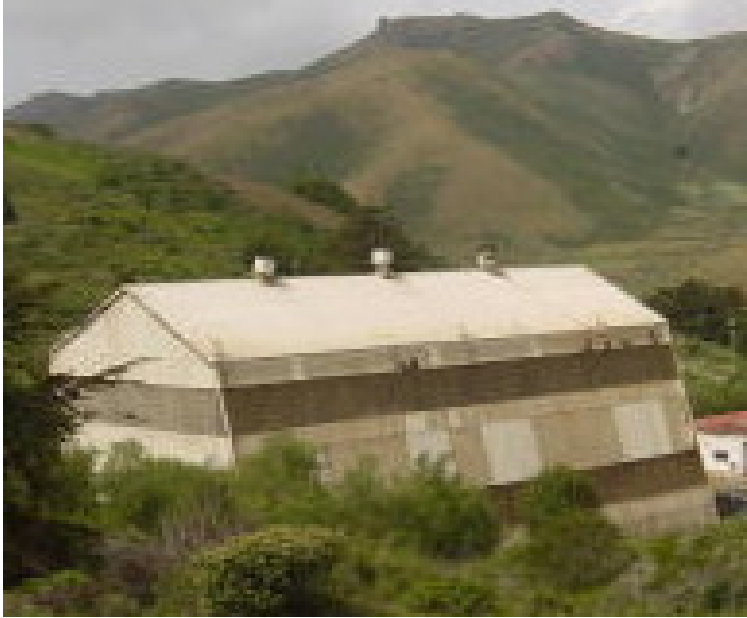
As illustrated by the photos above, the “window rows” (corrugated glass fiber sheets) at level 2 and 4 appear to be in good condition, with less than 2 percent distress. Most of the distress occurs at the bolthole attachment to structure.

There has been relatively recent repairs at level 5 and 3, where painted corrugated sheet metal replaced some corrugated asbestos coated iron sheets. The material is similar in appearance, but the detailing and workmanship was less than adequate.

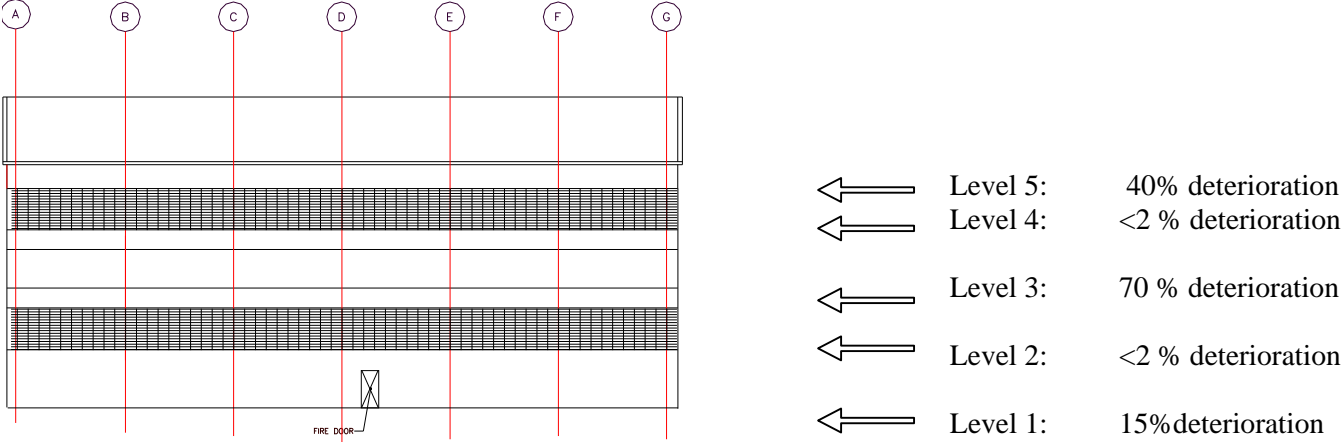
There is substantial deterioration of the asbestos siding mainly at the levels 5: the asbestos layer seems to have been delaminated and rust iron is apparent.

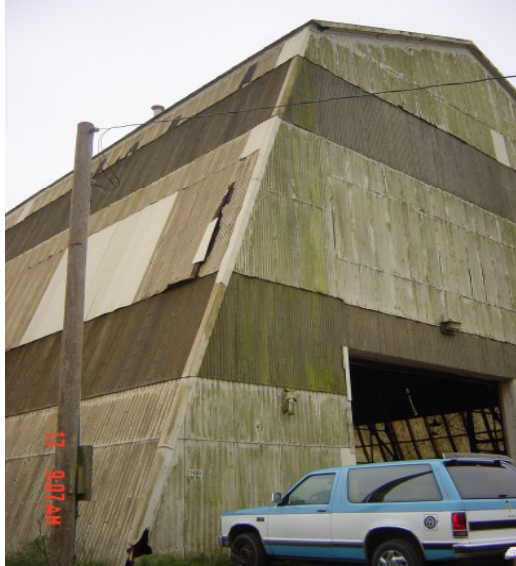
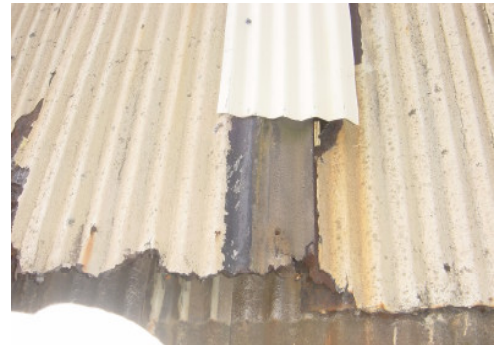
A few sheets at Level 3 became detached from structural brackets and buckled. The most extensive damage occurs at the bottom corners.

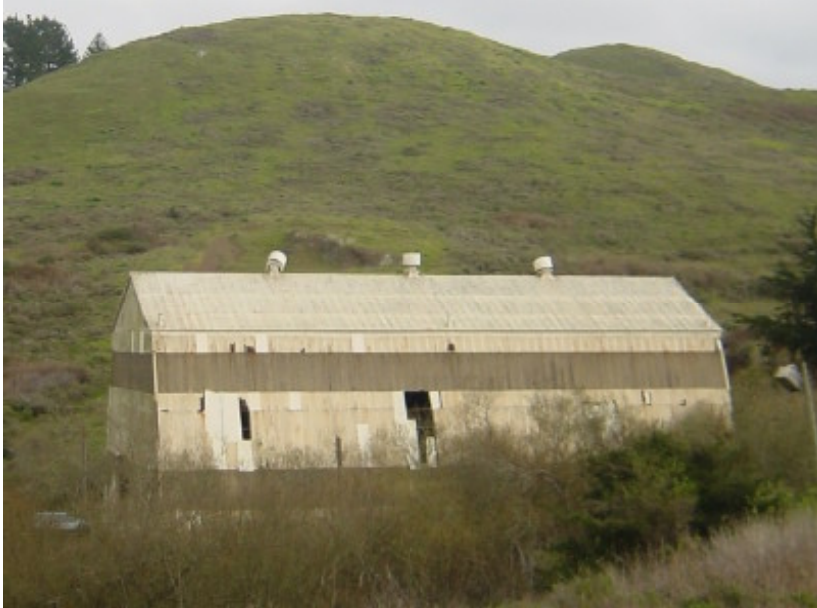
As illustrated by the photos above, the West Elevation presents the most damage. Even though there has been relatively recent extensive repairs at level 5 and 3, where painted corrugated sheet metal replaced some corrugated asbestos coated iron sheets, the inadequate detailing and installation made them temporary only; currently the replacement sheets have been ripped off and this side of the building is open to the environment in numerous places.

The “window rows” (corrugated glass fiber sheets) at level 2 and 4 appear to be in good condition, with less than 2 percent distress. Most of the distress occurs at the bolthole attachment to structure.

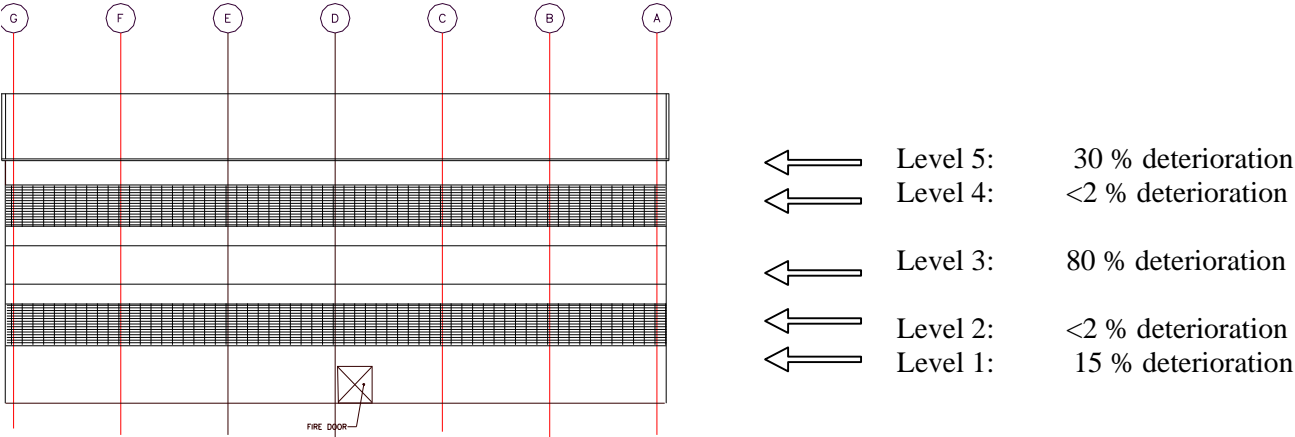
Presently, some remaining replacement panels are unstable and only partially attached to structure, thus constituting a hazardous condition, as they may fall down at any moment.

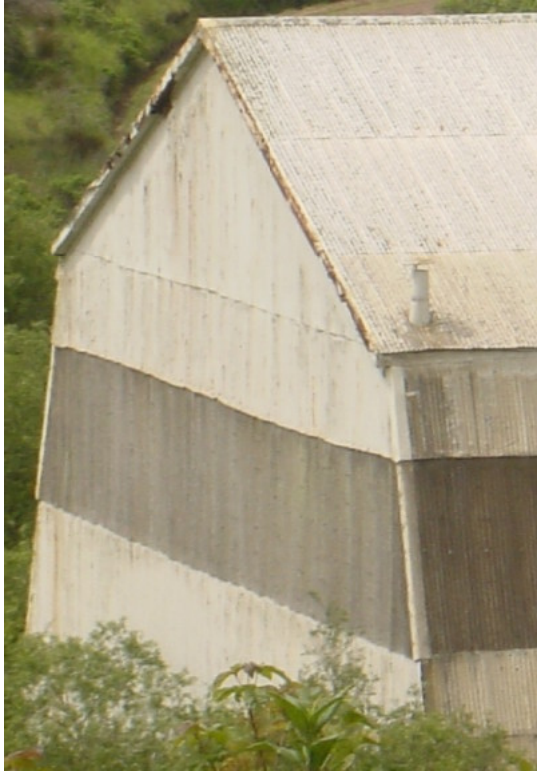
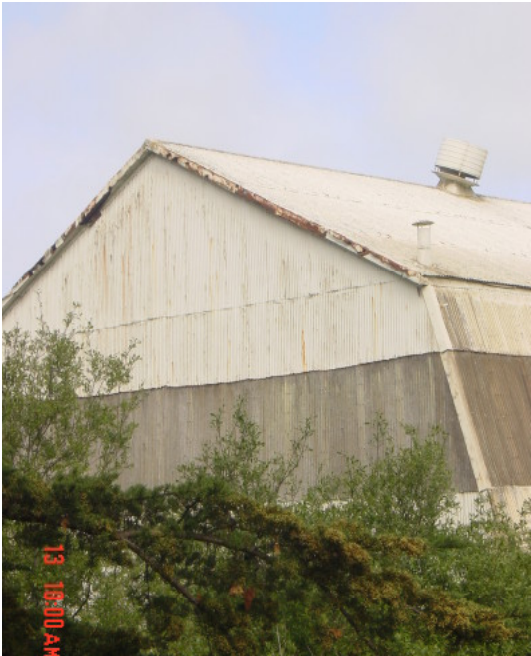
As illustrated by the photos above and insofar as the outgrown vegetation permitted full visual observation, the South Elevation presents the least damage.

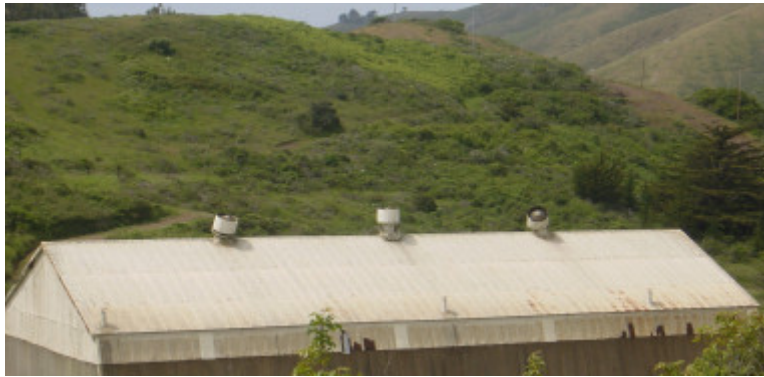
As illustrated by the photo above and insofar as visual observation was possible from the distance, the roof does not present substantial deterioration, despite being over 50 years old. A thorough cleaning of the roof is needed, as moss is present, especially toward the eaves. In addition, rust is present at seams.

The fascias on both South and North Elevation are severely rusted and should be replaced. There are no fascias or gutters on the East and West Elevations, and those should be installed to prevent water penetration. (Historic Photos shows gutters and 3 downspouts on each side).

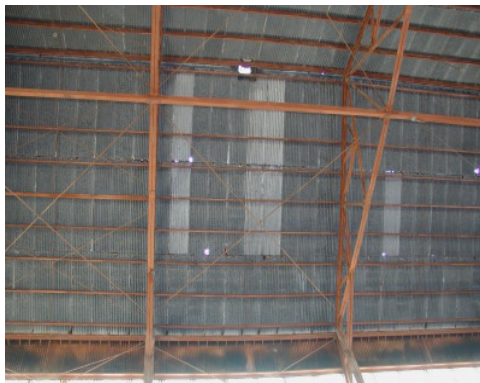
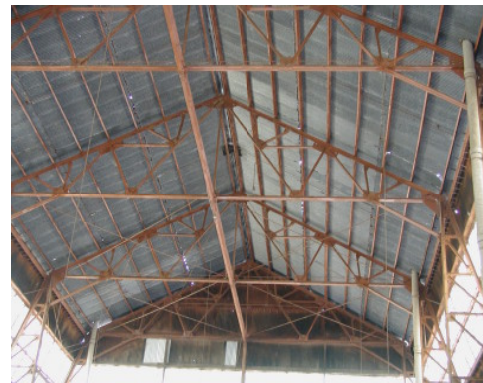
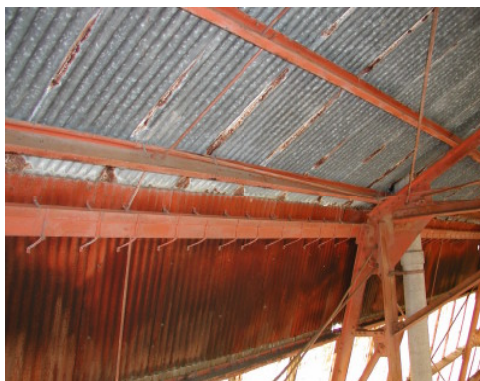
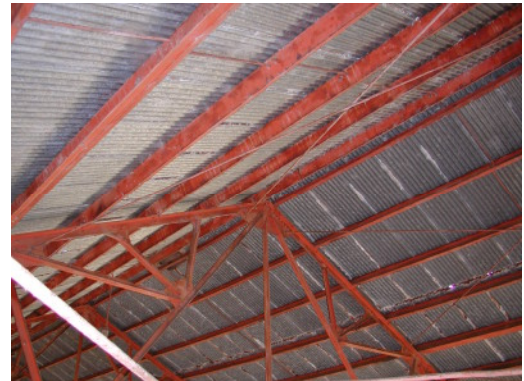
Visual observation from inside out was instrumental in assessing the roof's extent of deterioration: when looked at from inside, various size openings are visible, occurring mostly at seams, allowing water inside the structure. A larger amount of rust is present on the underside, primarily at seams. Past roof repairs are also noticeable.
