# Aquatic Invertebrate Monitoring at Pipestone National Monument, 1989–2016

Natural Resource Data Series NPS/HTLN/NRDS—2019/XXX

David E. Bowles, J. Tyler Cribbs, Janice A. Hinsey

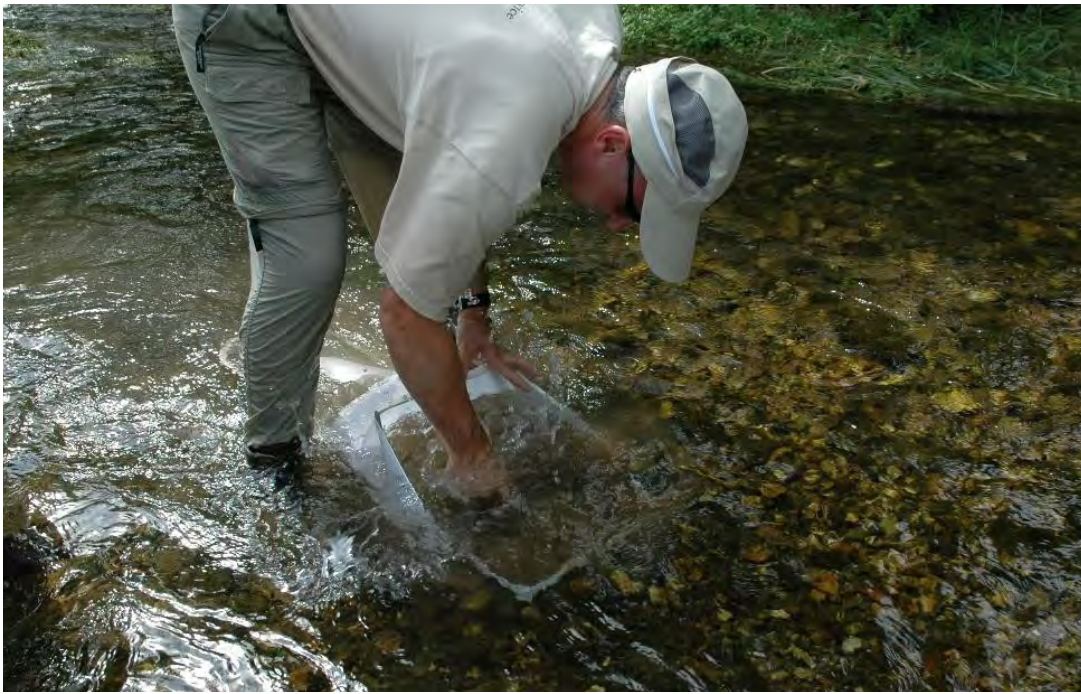
**Figure 2.** Collecting invertebrates with a Surber sampler. NPS.

Aquatic invertebrates were collected from three successive riffles with three benthic invertebrate samples collected per riffle, resulting in nine samples. A Surber stream bottom sampler (500  $\mu\text{m}$  mesh, 0.09  $\text{m}^2$ ) was used to collect the samples, and a hand-held

garden cultivation tool was used to dislodge invertebrates from the substrate (Figure 2). A soft bursh was used to dislodge invertebrates attached to large substrate. Samples were sorted in the laboratory following a subsampling routine described in Bowles et al. (2008). Taxa were identified to the lowest practical taxonomic level (usually genus) and counted.
