CRM

VOLUME 15 • NO. 6
1 9 9 2

Cultural Resources Management
Information for
Parks, Federal Agencies,
Indian Tribes, States,
Local Governments and the
Private Sector

CPS/PWC/NPS: Sharing Information and Experiences

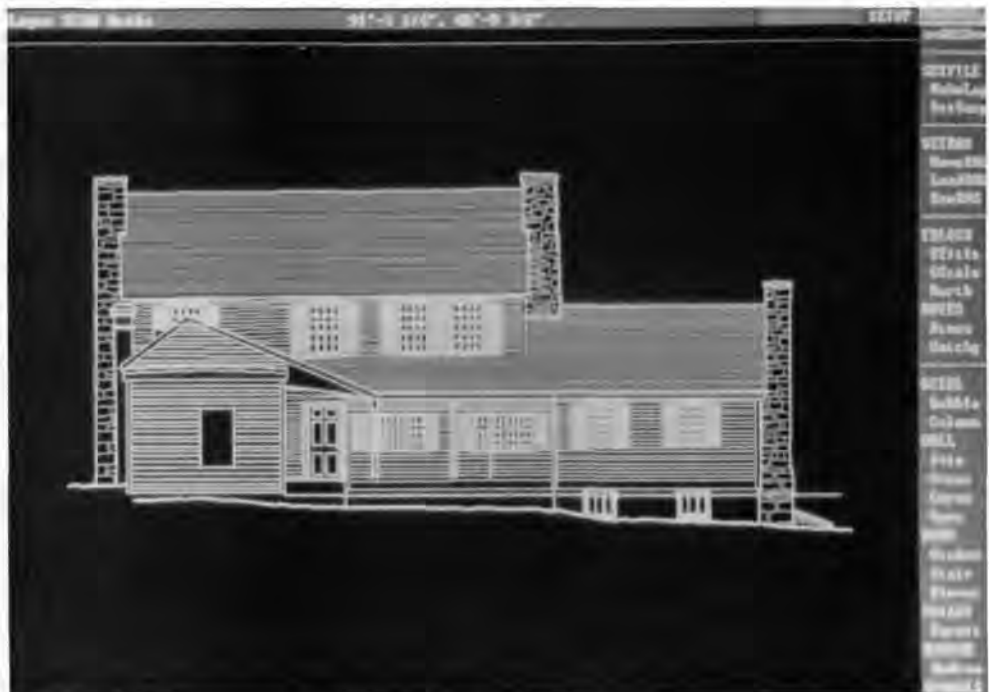
After the new lines are added to the drawing with aid of the scanned photo and AutoCAD, the north elevation of White Haven gives the appearance of the home before the 1940 demolition of the addition.

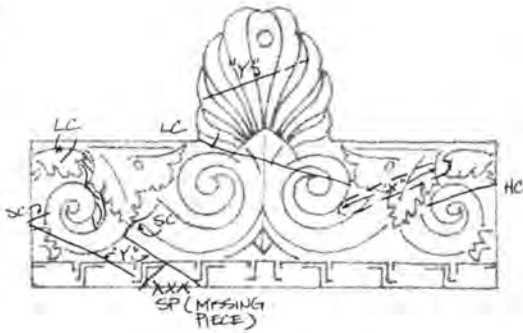
NOTES (CN): * ALL CRACKS ARE SC, UNLESS OTHERWISE NOTED.

* STONE IS IN BAD SHAPE - LOTS OF CRACKS

* CRACKS ARE PACKED WITH DIRT #

* POSSIBLE FRACTURE - TIP "SHELL" SEEMS READY TO DETACH & FALL! - WATCH

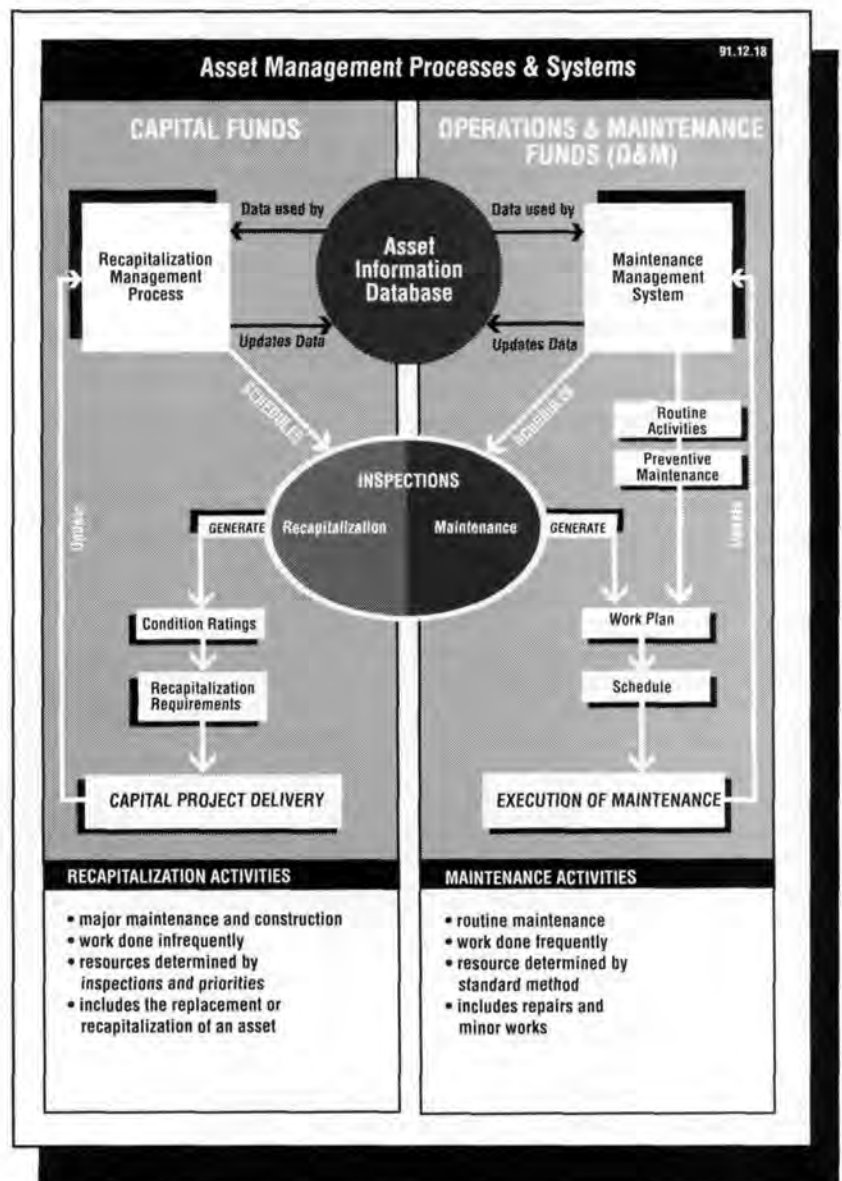
Figure 1.

Asset Management Process				
Recapitalization Management Process				
Asset Condition Rating				
Ratings	Criteria			
	Health & Safety	Risk to Asset	Level of Service	Urgency
Good	Normal Risk	Normal O&M Procedures	Normal Operation	5 Years +
Fair	Slight Increase in Risk	Minor Deterioration	Reduced Operation	3-5 Years
Poor	Significant Risk	Significant Deterioration	Restricted Operation	1-2 Years
Closure	High Risk	Major Deterioration	Non-Operational	Immediate Action Req'd

essential that a common "language" be established for all asset categories. The condition rating matrix is illustrated in figure 2.

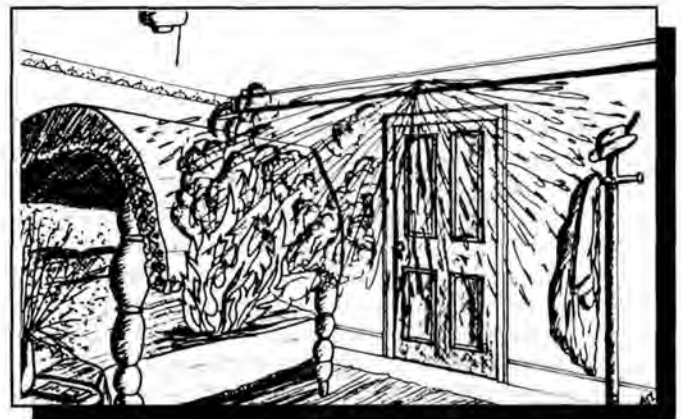
Guest room protection using sidewall residential sprinkler supplied by plastic pipe concealed in a boxed-in cornice. Maramede Inn, Middletown, MD.

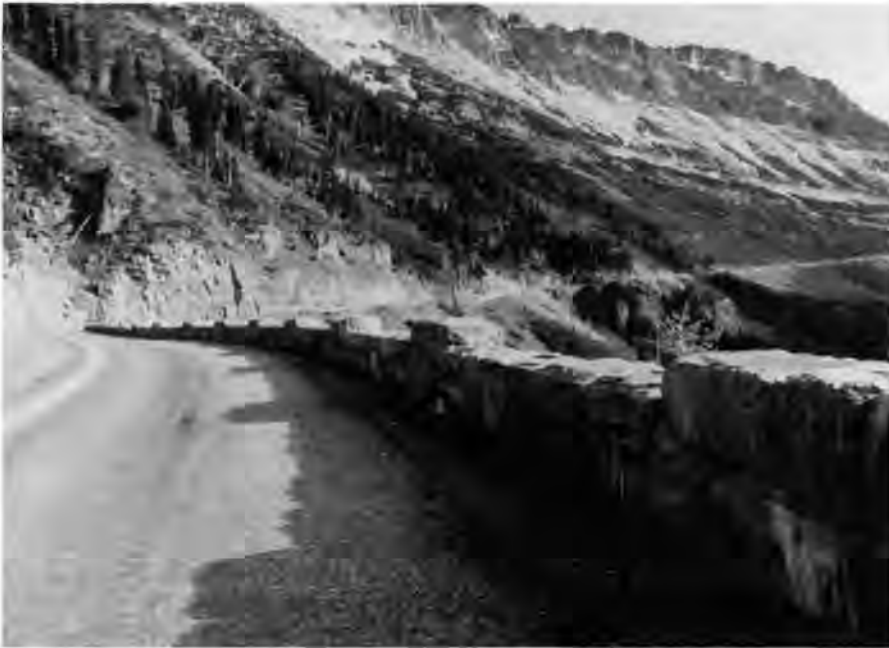
Typical masonry guardwall.

Second, Federal Highways agreed to determine through computer modeling the height of a new concrete reinforced guardwall that will be acceptable in resisting impact and breaching. If that modeling suggests that a lower height is acceptable, that type of reinforced wall will be crash tested. For both conditions the issues are

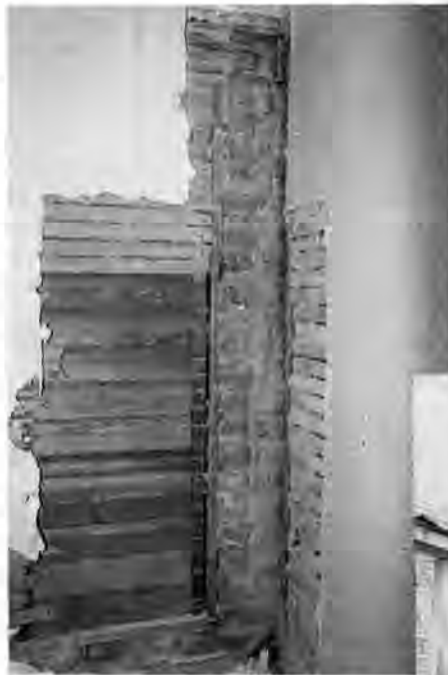
Mumma Farm House, Antietam National Battlefield, MD. The braced frame of the structure was discovered while siding repairs were underway. Drawings and photographs were made to document the framing system before the siding was replaced.

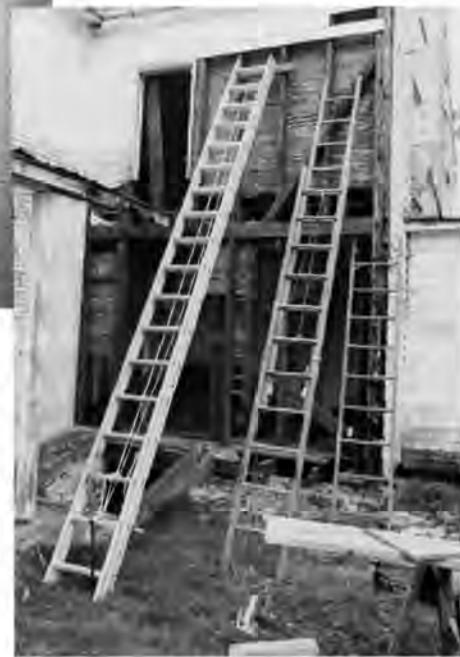
Mumma Farm House, Antietam National Battlefield, MD. A former window location was discovered during the removal of interior plaster. This feature should be recorded prior to the replastering of the wall surface. Photos by Thomas Vitanza, Williamsport Preservation Training Center, National Park Service, 1992.

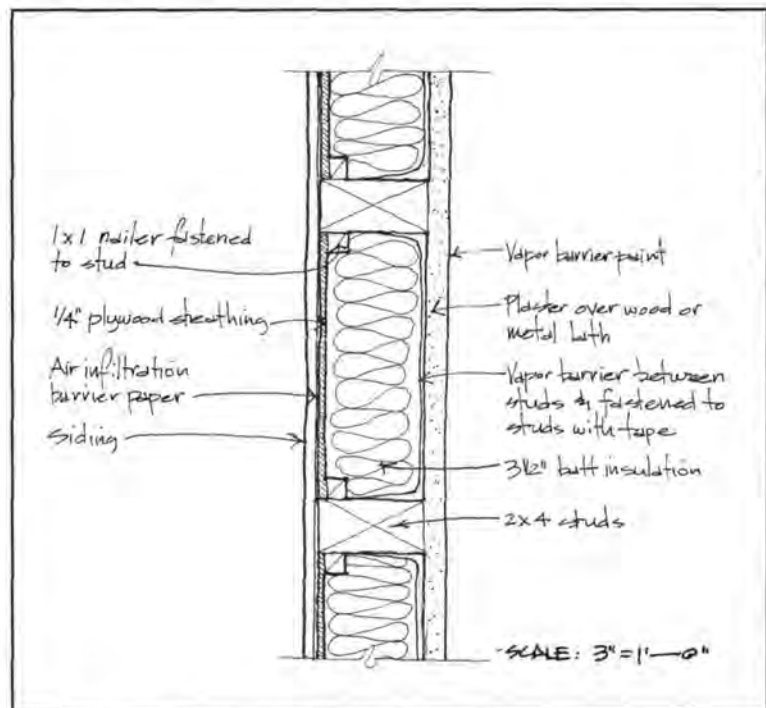
Figure 1. Typical perimeter wall plan section of the Lincoln Home after 1988 restoration work. Note that the vapor barrier is discontinuous at the studs. Field note drawing by the author.

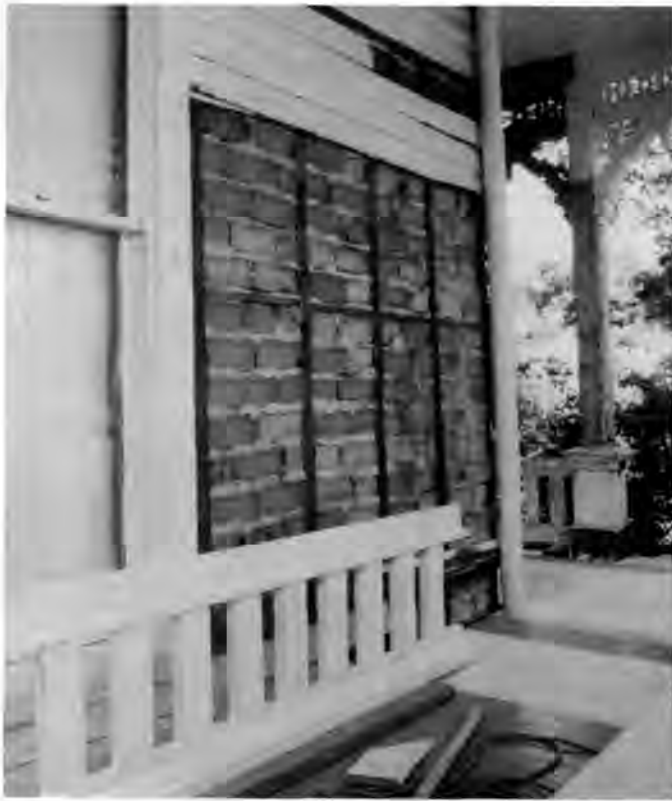
Figure 2. Cavity wall brick infill or "nogging" on the Truman home. This unique element would be sacrificed if insulation were to be installed. Photo by the author.

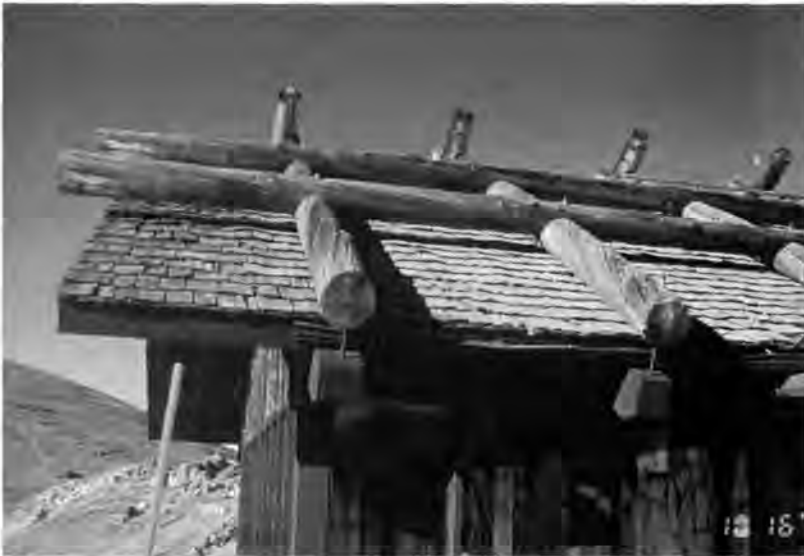
Figure 1 The log snow guards on the Rocky Mountain National Park visitors' center allow snow to accumulate without introducing further stresses to the roof system.

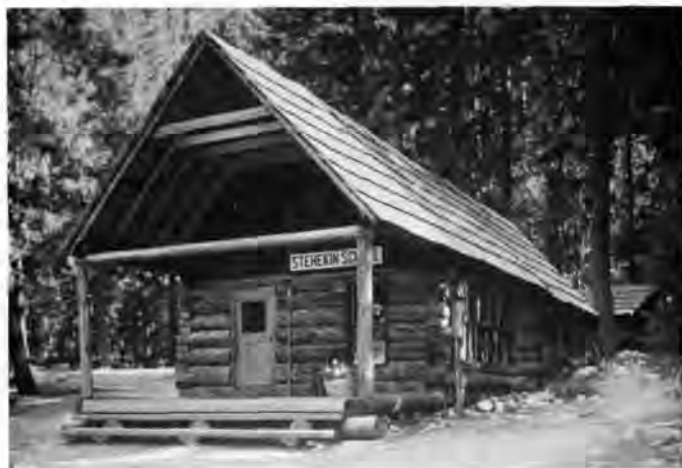
Figure 2 In the North Cascades, a distinct style of cabin has evolved that allows both light and people to enter a snow bound building.

With snow periodically and unpredictably breaking loose and falling from the building roof and walls, pedestrians entering and leaving the facility may be in some peril. Standard gutters, snow-guards, and diverters that offer effective protection on the low-sloped roofs of the dry snow regions are unable to withstand the force of the heavy wet snow accumulation on the steeper roofs; furthermore, these details can also contribute to unwelcome ice damming problems during the spring thaw. In deep-snow areas, moving the building entrances to the gable ends is an adaptation that addresses these hazards. Icicle formation and snow corncicing are two additional problems that are commonly encountered. Where 24-hour period snowfalls are high or drifting snows are the norm, outward-opening doors are impractical, even on public buildings (figure 2).

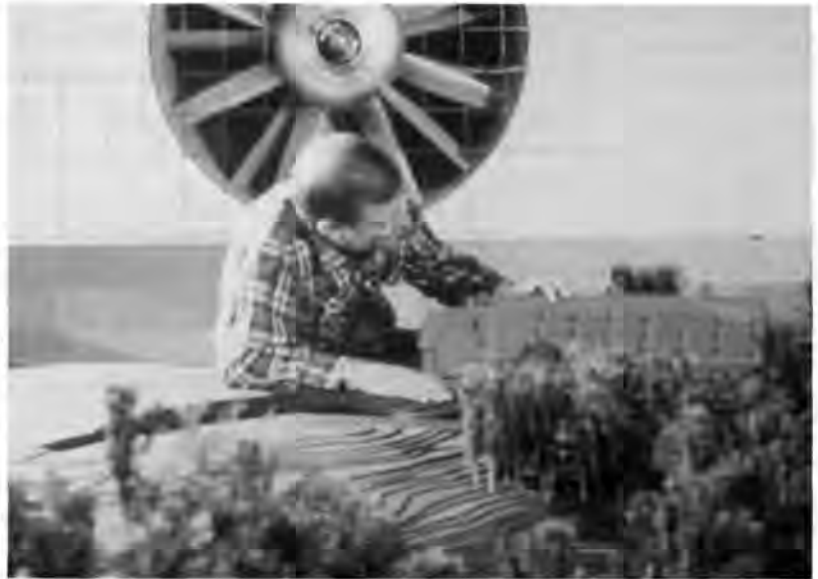
Figure 3. Wind tunnel testing can be useful in predicting the behavior of snow around a building.

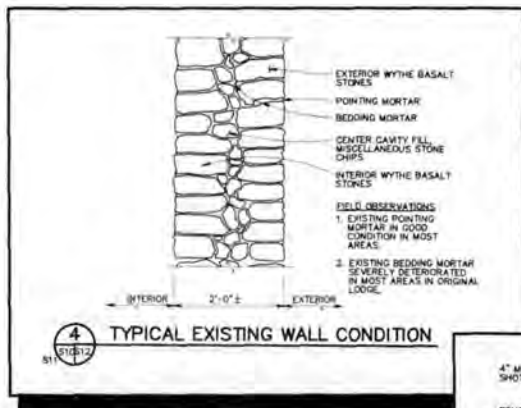
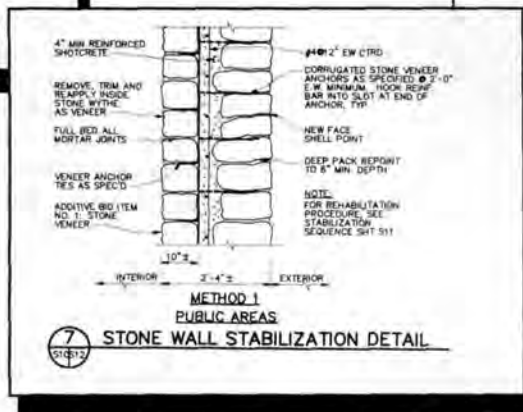
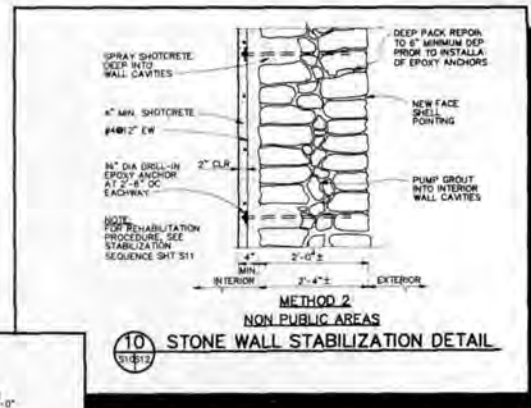
Two techniques were employed for stabilizing un-reinforced stone masonry walls of the lodge (see details). The stone appearance was sacrificed where the interior would not be seen by visitors. A 4" reinforced application of shotcrete anchored to the interior side of the repointed stone wall provided the necessary reinforcement. Where both interior and the exterior stone surfaces of walls would be seen, the exterior was thoroughly repointed, then the inner wythe was dismantled. A reinforced shotcrete core was built and the inner wythe, after stone trimming, was then relaid. All 700 perimeter feet of the building's stone walls were underpinned with a 5' spread footing, after initial masonry stabilization. This was done in nominal 6' increments involving excavation, compacting soils, forming and pouring reinforced concrete, waterproofing, and backfilling. Throughout the building undersized floor members were replaced with larger ones or 'sisters' installed to enhance the strength of the floor diaphragms.

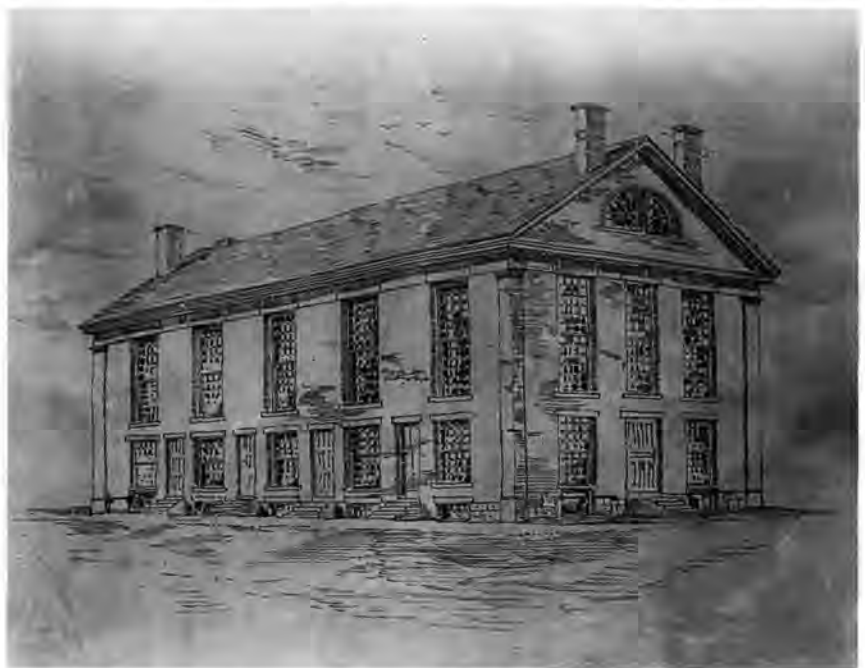
Figure 1. Conjecture drawing (1894) of the original Town House as constructed in 1830. Drawing by F.W. Stickney, architect.

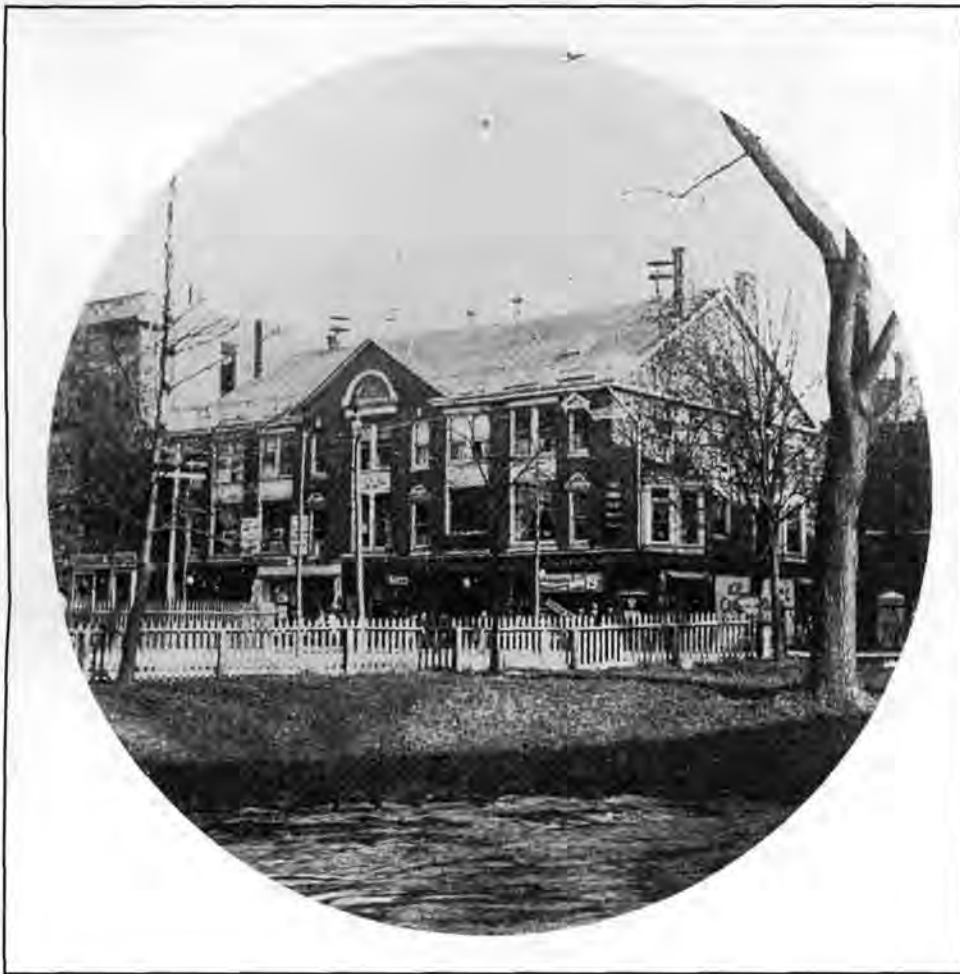
Figure 2. Ca. 1896-1900 photo showing the Old City Hall after the 1896 remodeling.

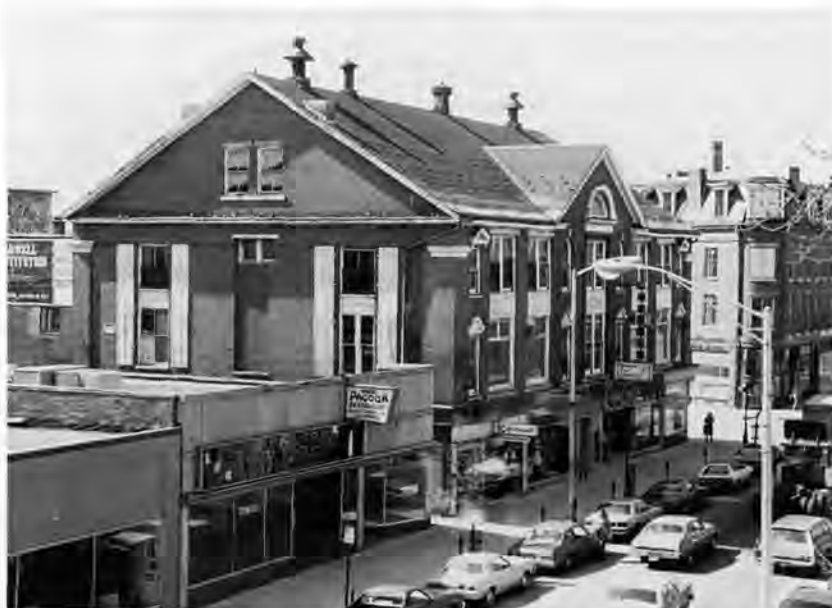
Figure 3. Old City Hall prior to rehabilitation. Photo by Harlan D. Unrau, National Park Service, 1979.
