The Secretary  
of the Interior's  
Standards for  
Rehabilitation &

# Illustrated Guidelines for Rehabilitating Historic Buildings

U.S. Department of the Interior  
National Park Service  
Cultural Resources  
Heritage Preservation Services

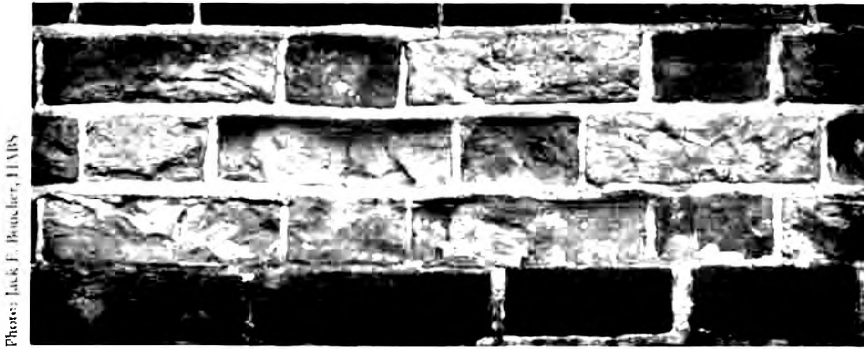
*Too hard and inflexible a mortar has caused this soft, 18th century brick to spall.*

Repointing with mortar of high portland cement content (unless it is the content of the historic mortar). This can often create a bond that is stronger than the historic material and can cause damage as a result of the differing coefficient of expansion and the differing porosity of the material and the mortar.

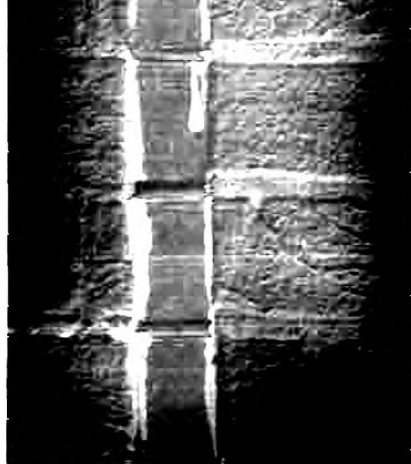
*When this brick wall was sand-blasted, a down-spout (since removed) protected the original smooth surface of the center strip from damage.*

Sandblasting brick or stone surfaces using dry or wet grit or other abrasives. These methods of cleaning permanently erode the surface of the material and accelerate deterioration.

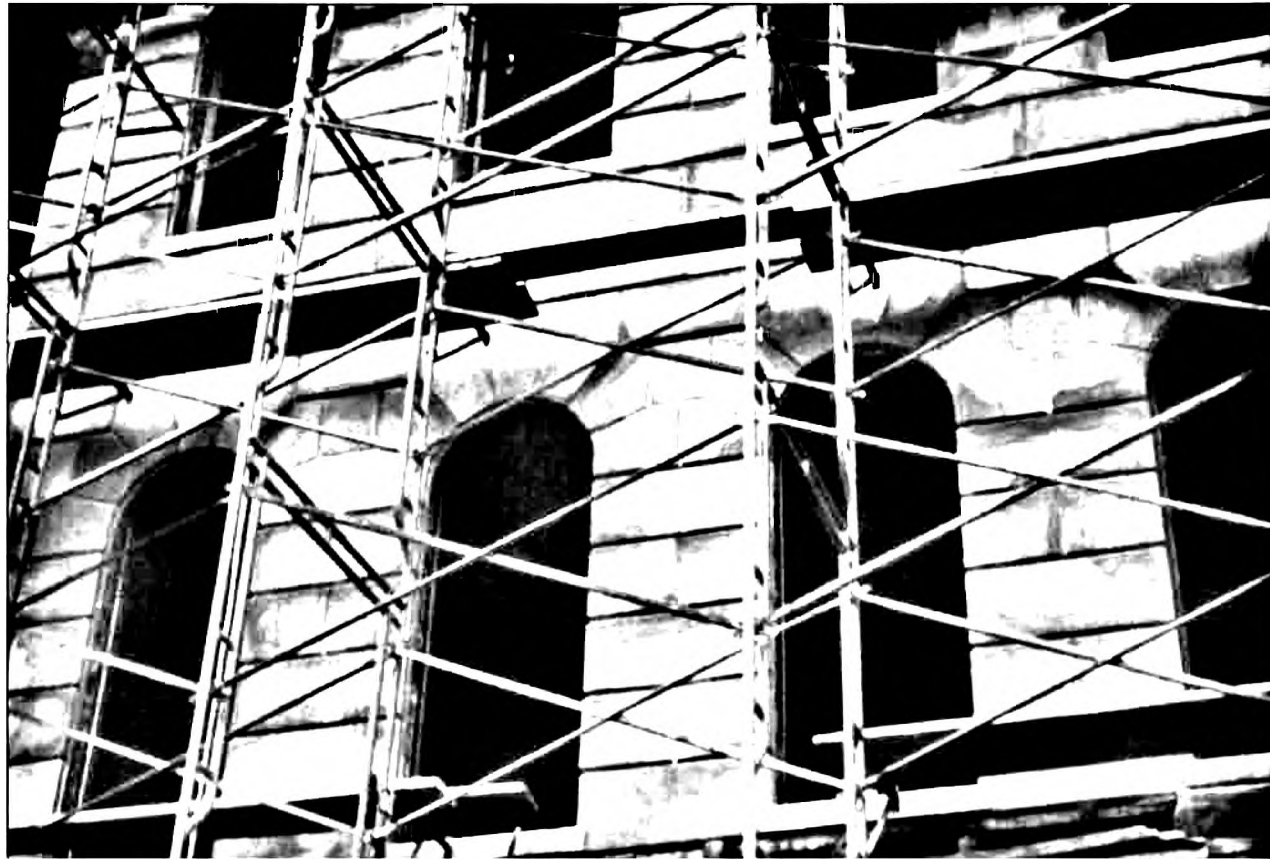
*Composite patching with a cementitious mixture is being used to repair eroded areas of this sandstone facade.*

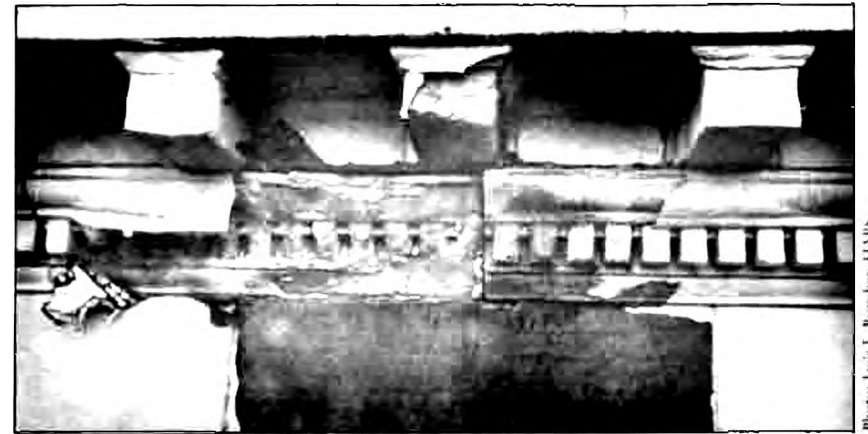
*Moisture from a faulty roof and drainage system has been trapped inside this limestone cornice by a waterproof coating, causing severe damage to the stone.*

Applying waterproof, water repellent, or non-historic coating such as stucco to masonry as a substitute for repointing and masonry repairs. Coatings are frequently unnecessary, expensive, and may change the appearance of historic masonry as well as accelerate its deterioration.

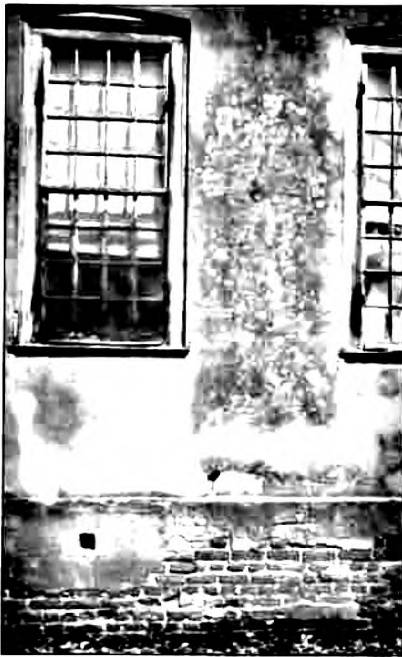
*Excessive moisture has damaged not only the stuccoed wall surface, but also the brick substrate.*

Repairing stucco by removing the damaged material and patching with new stucco that duplicates the old in strength, composition, color, and texture.

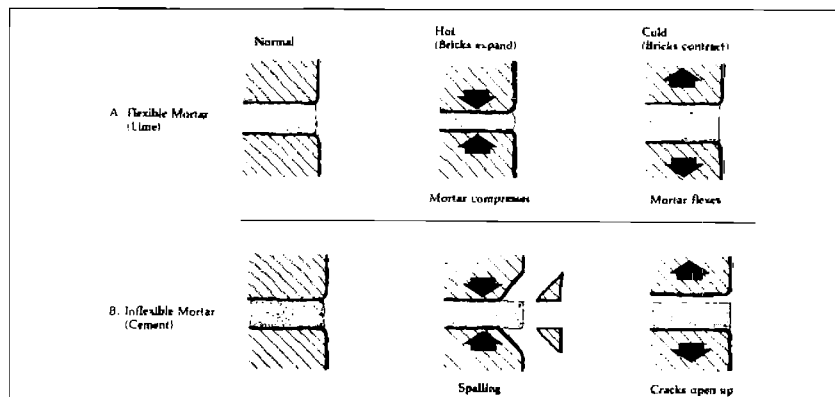
*Flexible mortar expands and contracts with temperature changes. Bricks bonded by inflexible mortar tend to spall at the edges in hot weather and separate from the mortar when it is cold. Temperature fluctuations result in cracks which permit water to enter, causing additional deterioration.*

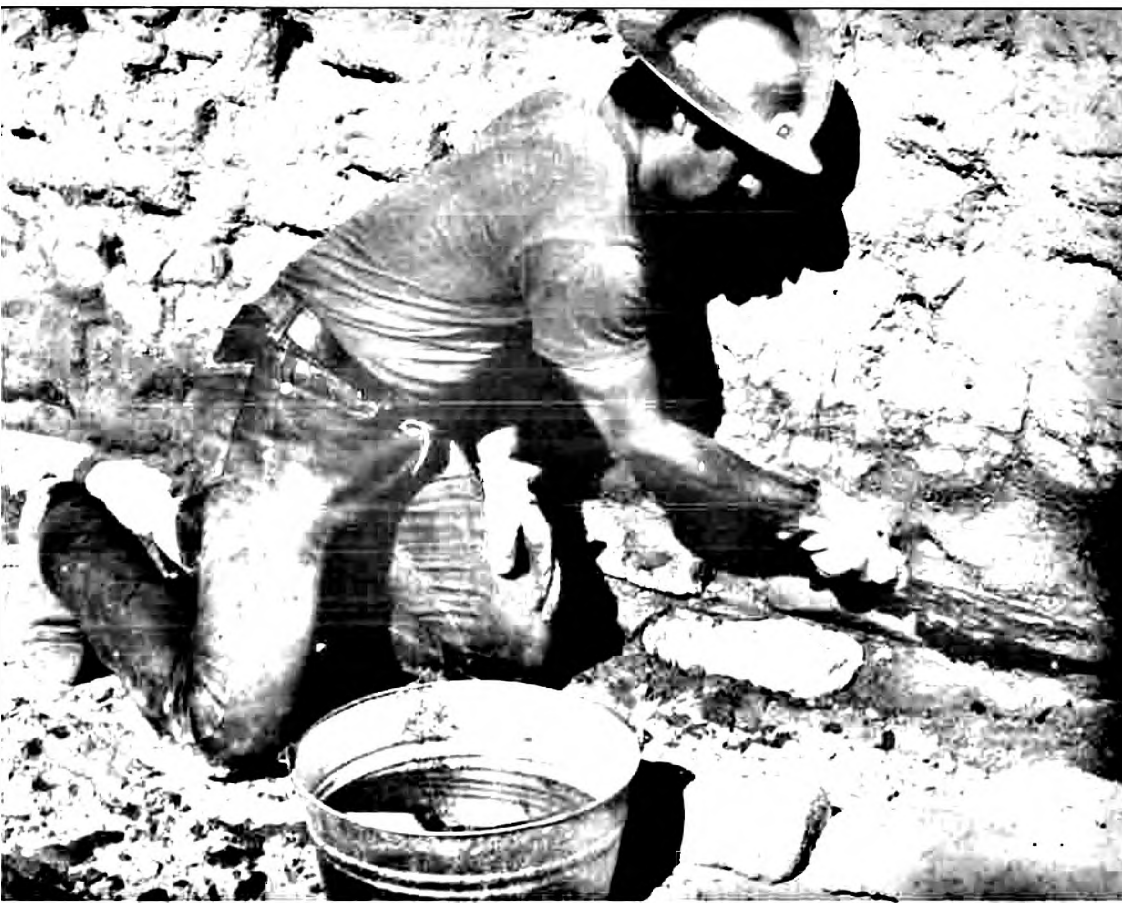
*Caving—the hollowing out of an adobe wall just above grade—may be caused by standing rainwater, rainwater splash-up from the ground, or by salts deposited in the adobe by moisture evaporation. This adobe wall is being patched in the traditional manner with adobe mud.*

Applying cement stucco to unfired, unstabilized adobe. Because the cement stucco will not bond properly, moisture can become entrapped between materials, resulting in accelerated deterioration of the adobe.

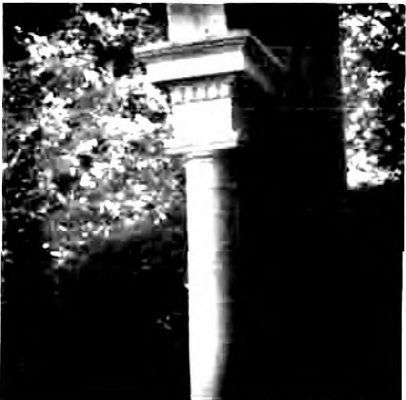
*To replace deteriorated portions of the column, strips of new wood were milled to conform to the shape and appearance of the old column framework, glued in place, then back-primed and painted.*

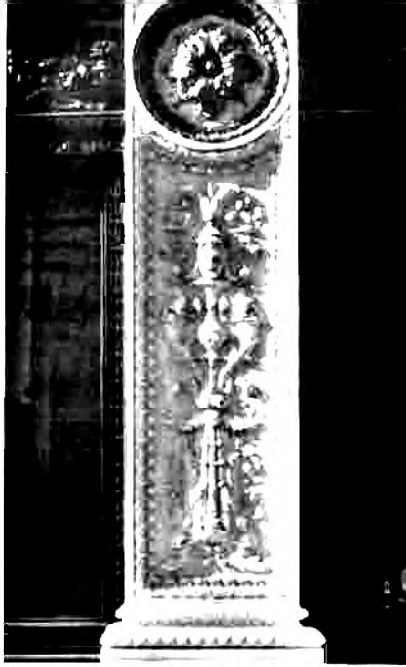
*The decorative cast-iron storefront column was sandblasted in order to remove flaking paint and rust prior to repainting. Unlike soft metals such as copper and tin, which are damaged by abrasive cleaning, sandblasting is an appropriate method for cleaning cast iron, a very hard metal.*

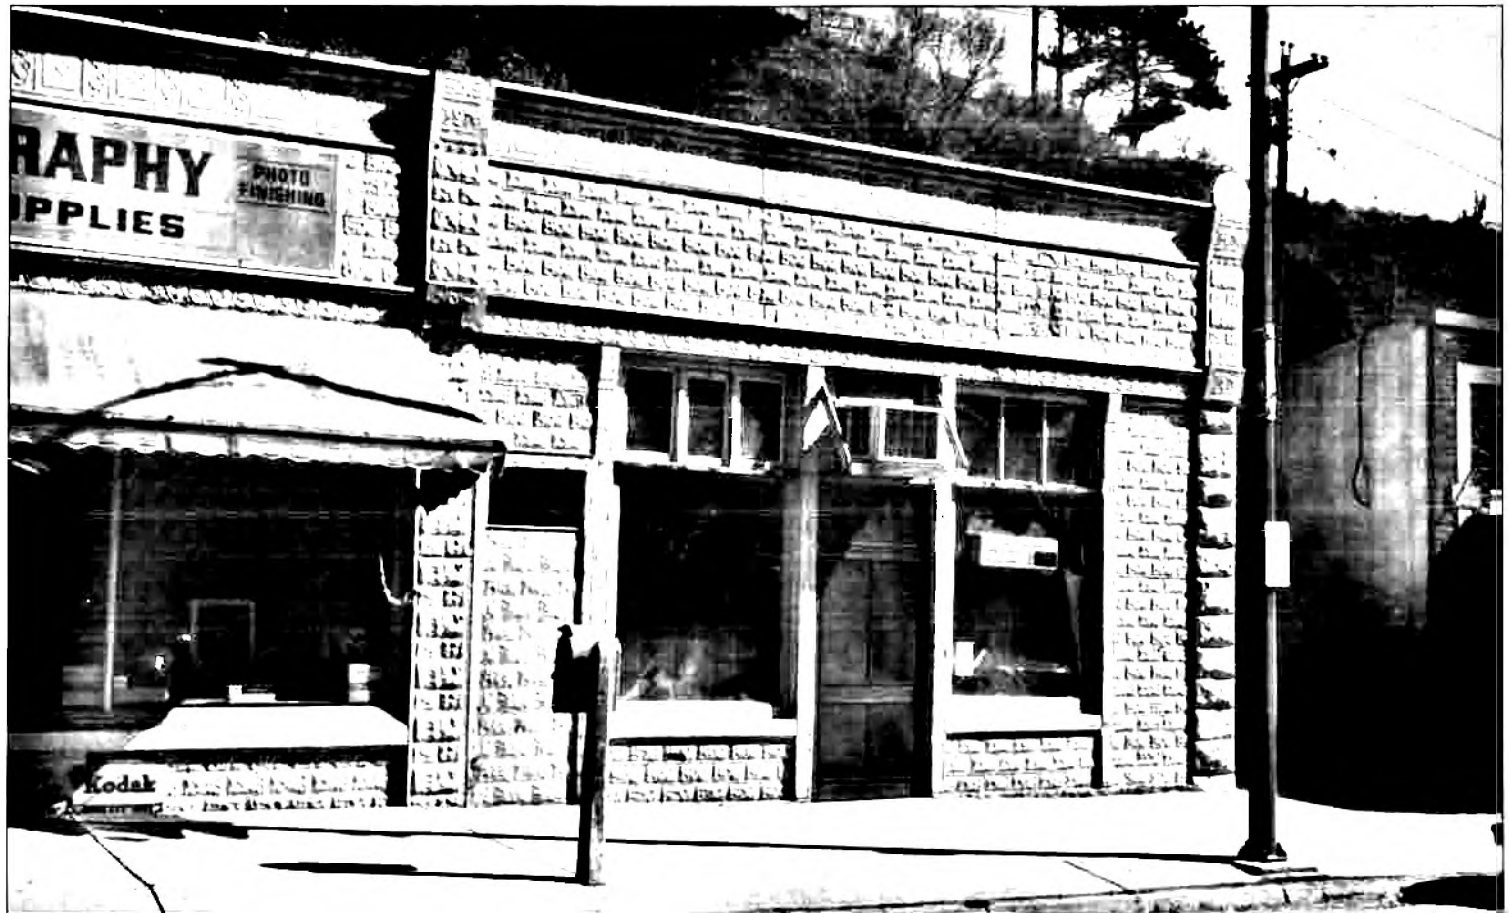
*Although these pressed metal storefronts have been well maintained over the years, gaps in the seams between the metal sheets above the door and slight stains along the cornice line indicate a possible roof leak. The roof should be investigated and repaired before the moisture results in rust and more severe metal deterioration.*

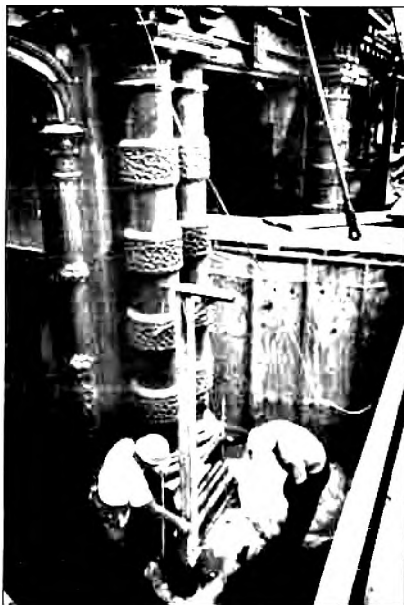
*The cast-iron columns of this theater are being repaired during rehabilitation. Some of the cast iron elements such as the smaller, non-structural columns missing from the bay on the right will be replaced with a lightweight substitute material such as cast aluminum, an acceptable alternative according to the Standards.*

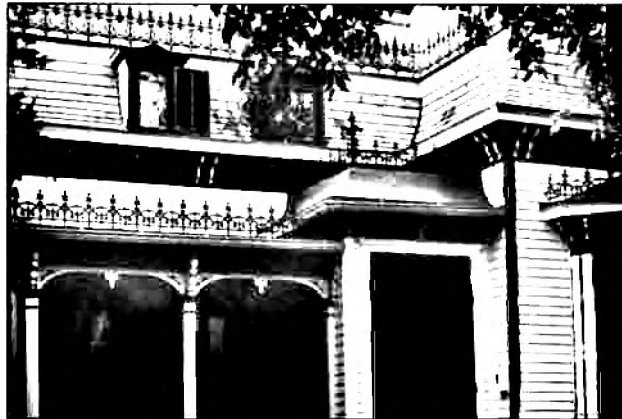
*This well-maintained mansard roof displays its handsome and varied decorative detailing—cast-iron cresting, wood shingles, and pedimented dormers.*

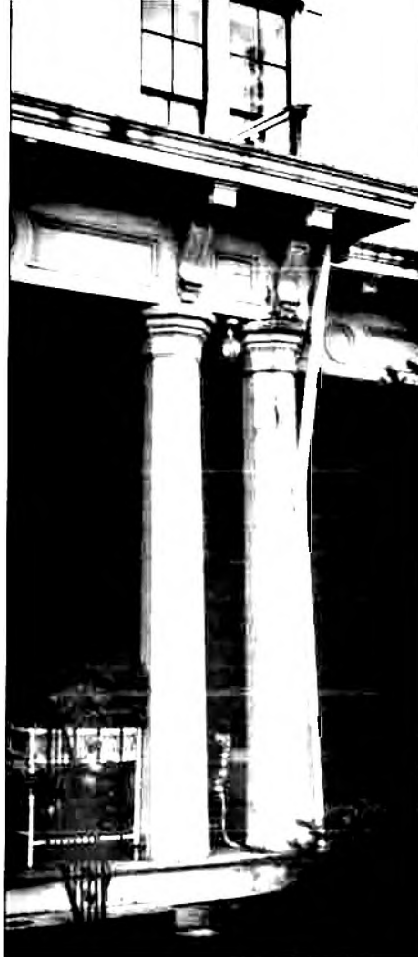
*The roof drainage system has been neglected for such a long time that, as a result, the wood cornice and a porch column are both severely deteriorated.*

Failing to clean and maintain gutters and downspouts properly so that water and debris collect and cause damage to roof fasteners, sheathing, and the underlying structure.

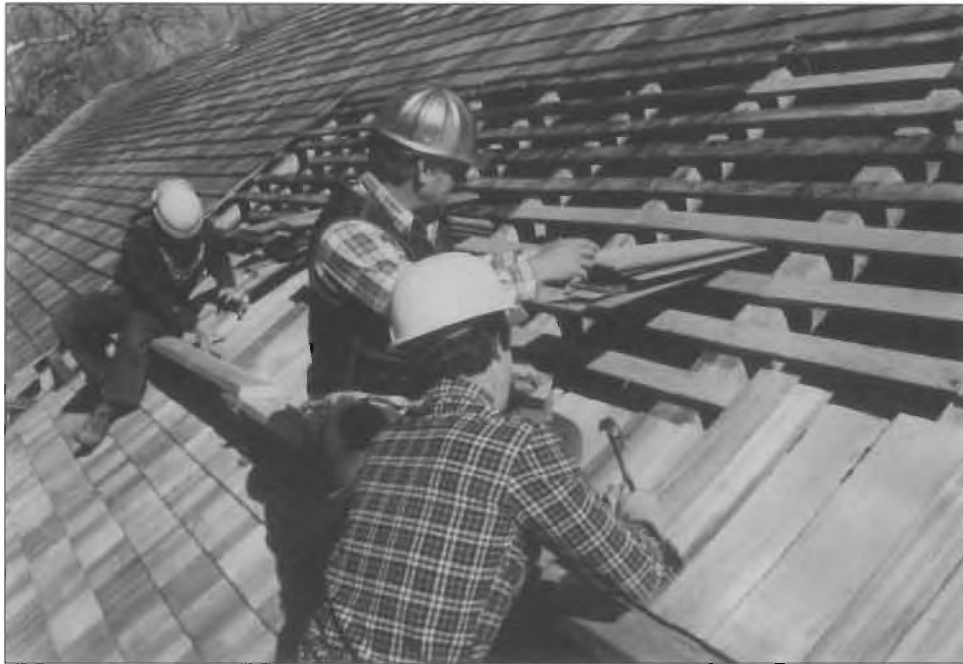
*The size, shape, and detailing of the historic shingles as well as the method of fabrication and installation were carefully researched prior to selecting this new wood-shingle roofing.*

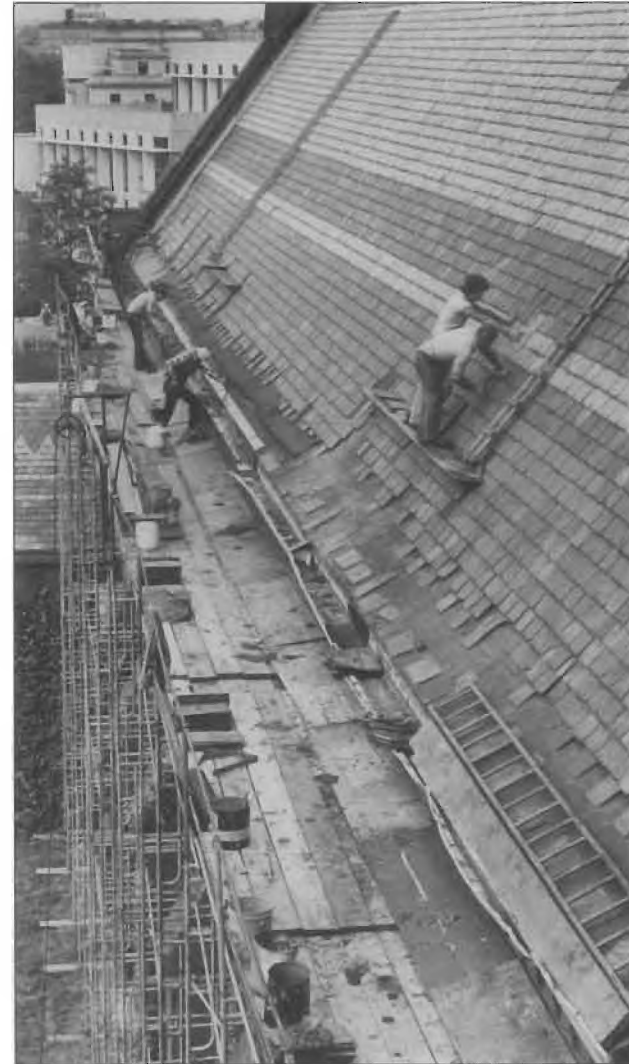
*Workmen are in the process of removing deteriorated roofing slates and replacing them with new matching slates.*

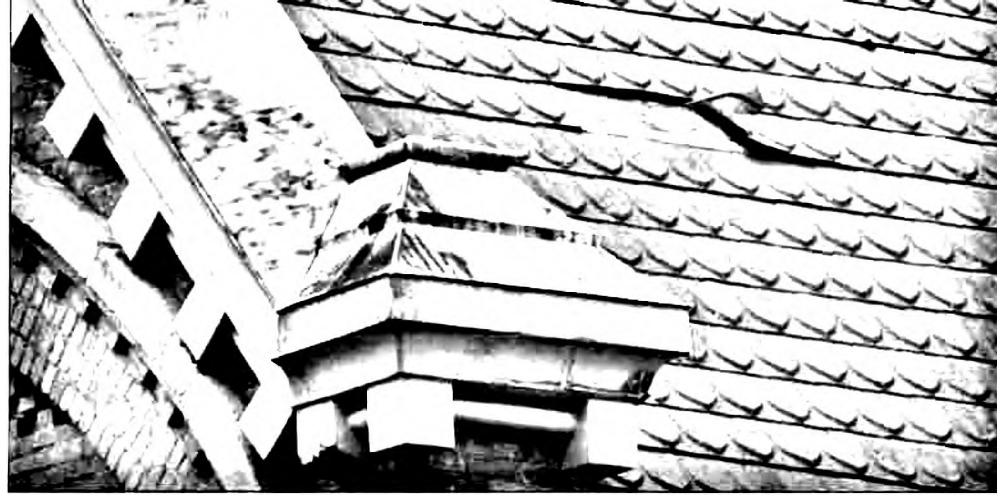
*New galvanized sheet-iron shingles will need to be reproduced using the pattern of the original shingle.*

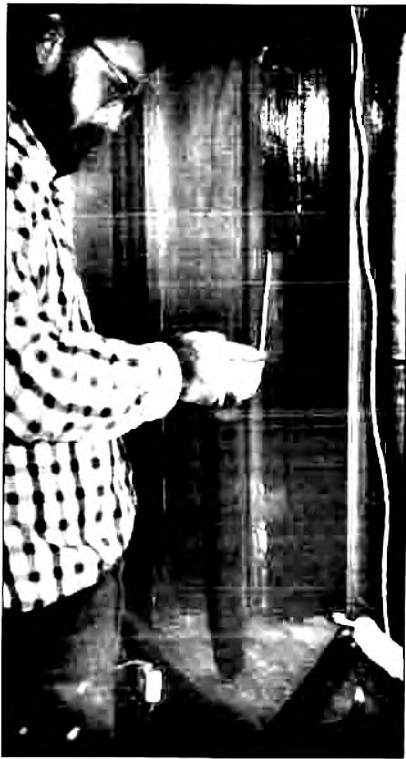
Maintaining a historic window may include work as basic as replacing a sash cord.

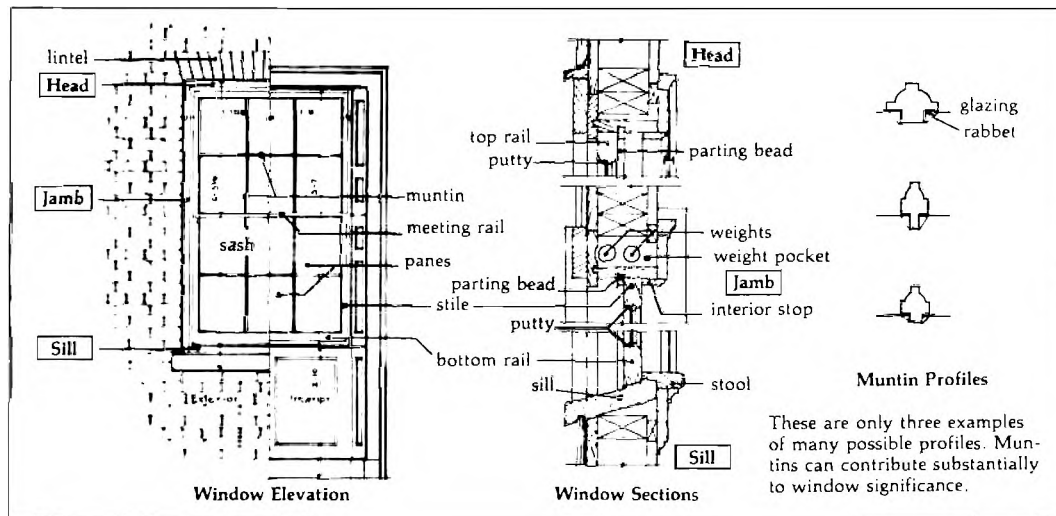
These drawings identify individual parts and fabrication details of a historic wooden double-hung window.

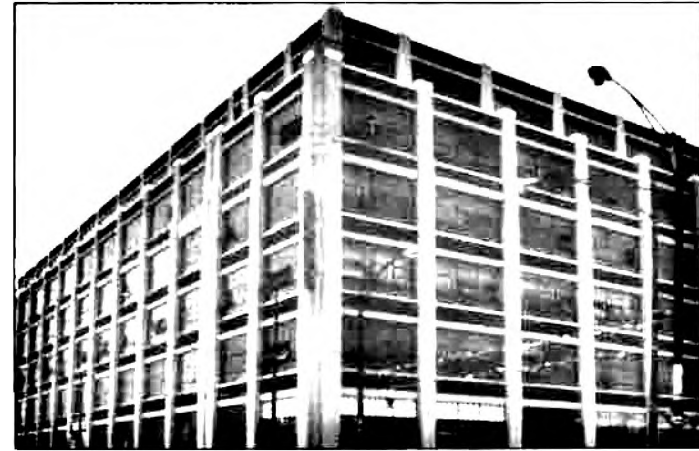
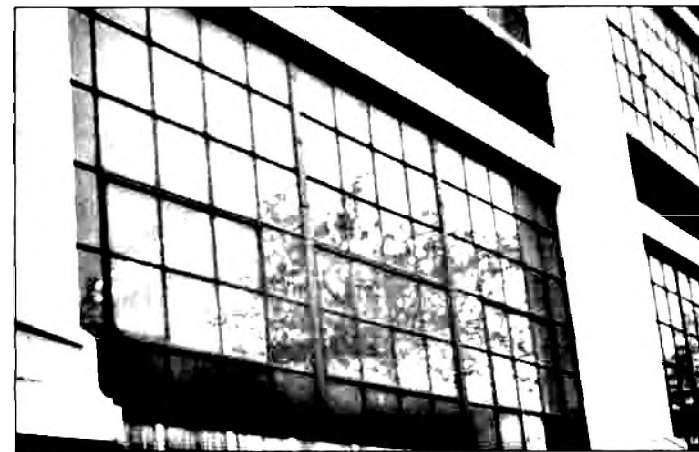
*The steel pivot windows in this historic manufacturing building were replaced with new windows which matched the multi-lighted originals.*

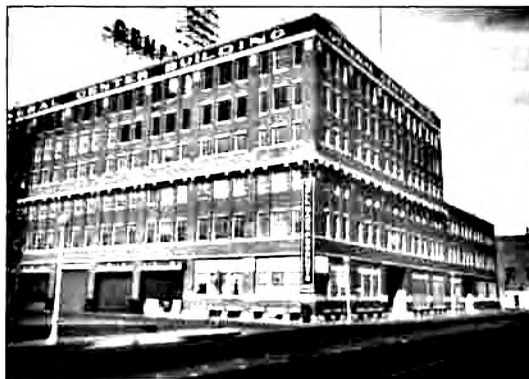
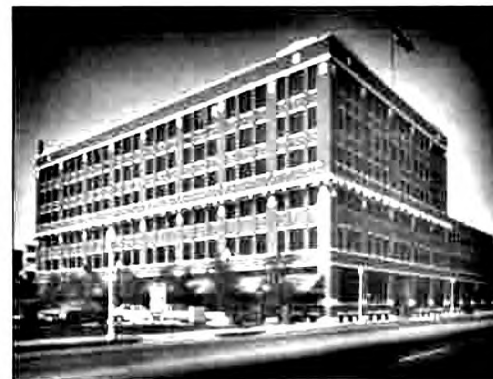
*When the six-over-six windows were replaced with inappropriate single sheets of tinted glass, the historic industrial character of this building was lost.*

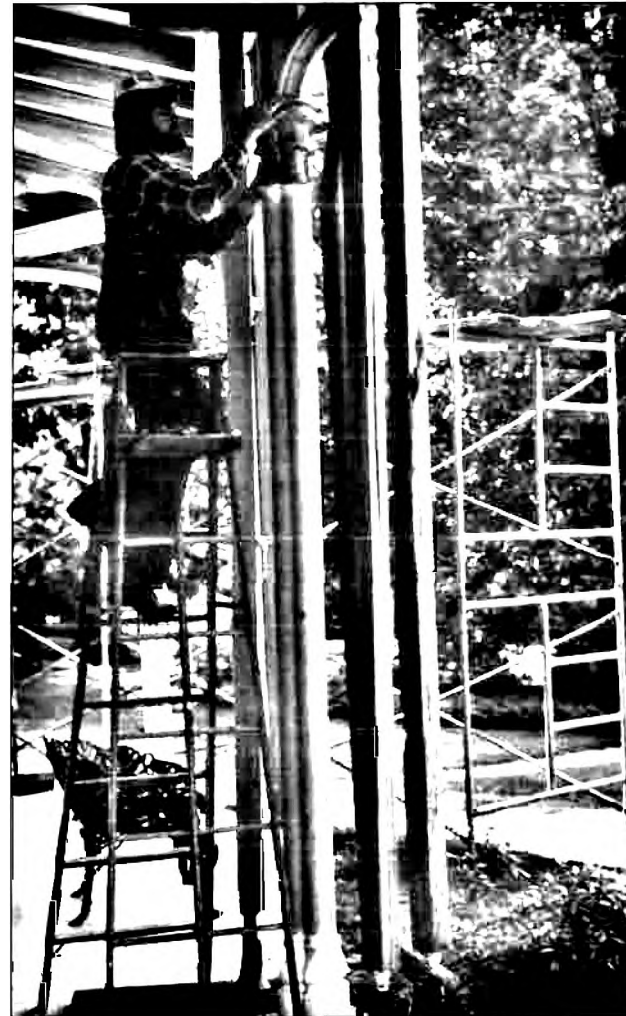
*Careful inspection of porch features such as these column capitals is necessary before initiating a rehabilitation project.*

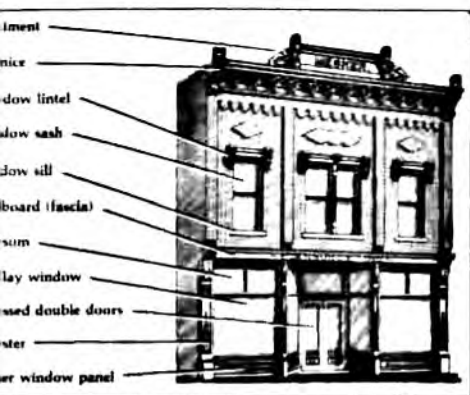
*These architectural details are typical of historic commercial buildings (this particular one is No. 4016 in the George L. Mesker and Company catalog of 1905). The design utilized both cast and galvanized iron.*

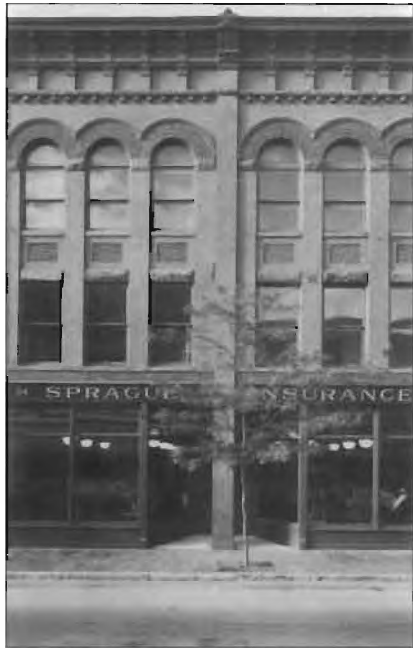
*This appropriate new storefront replaces an old one that was too deteriorated to save. It features a recessed doorway based on the historic design and respects the scale and proportion of the existing building.*
