# First in Flight, First in Automation:

NCDOT and NPS Pilot an Automated Shuttle  
at the Wright Brothers National Memorial

## **FINAL REPORT — May 2022**

DOT-VNTSC-NPS-22-02

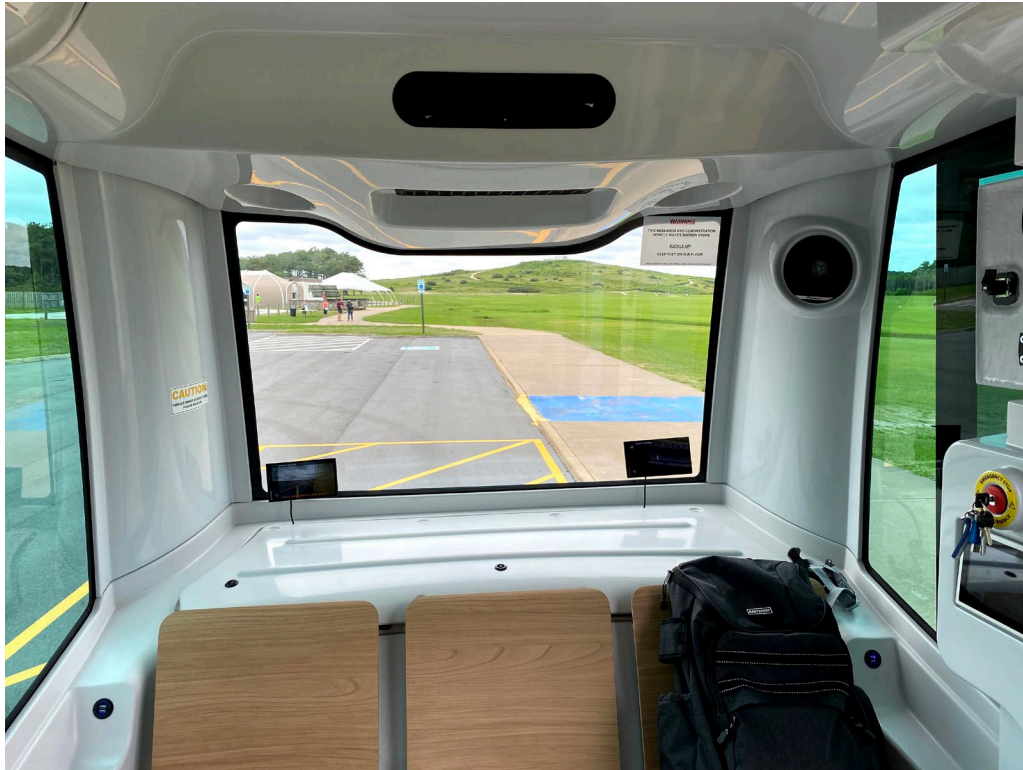
**Figure 2: Interior View of the Shuttle**  
Source: U.S. DOT Volpe Center

Figure 2 and Figure 3 show the interior and exterior of the shuttle. The shuttle was equipped with a built-in automated accessibility ramp that the safety operator could deploy when necessary (Figure 4). In addition, safety operators could lower the floor of the shuttle (kneeling the shuttle) to allow for easier boarding of visitors with limited mobility.

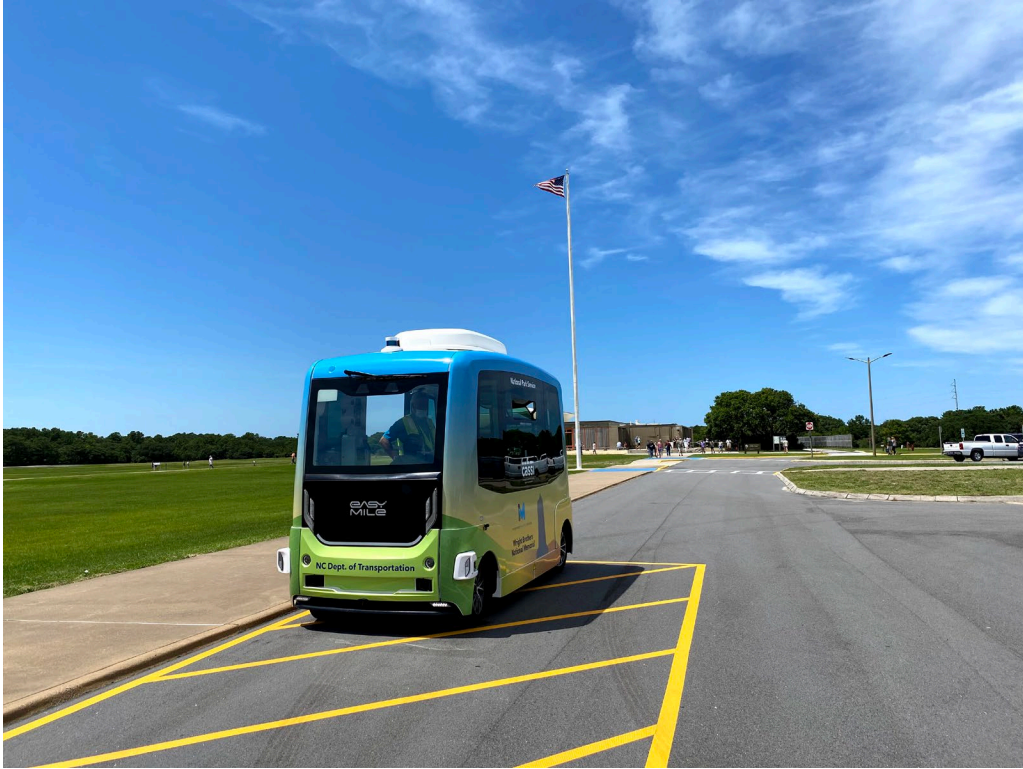
**Figure 3: Shuttle at the Visitor Center Stop**  
Source: U.S. DOT Volpe Center

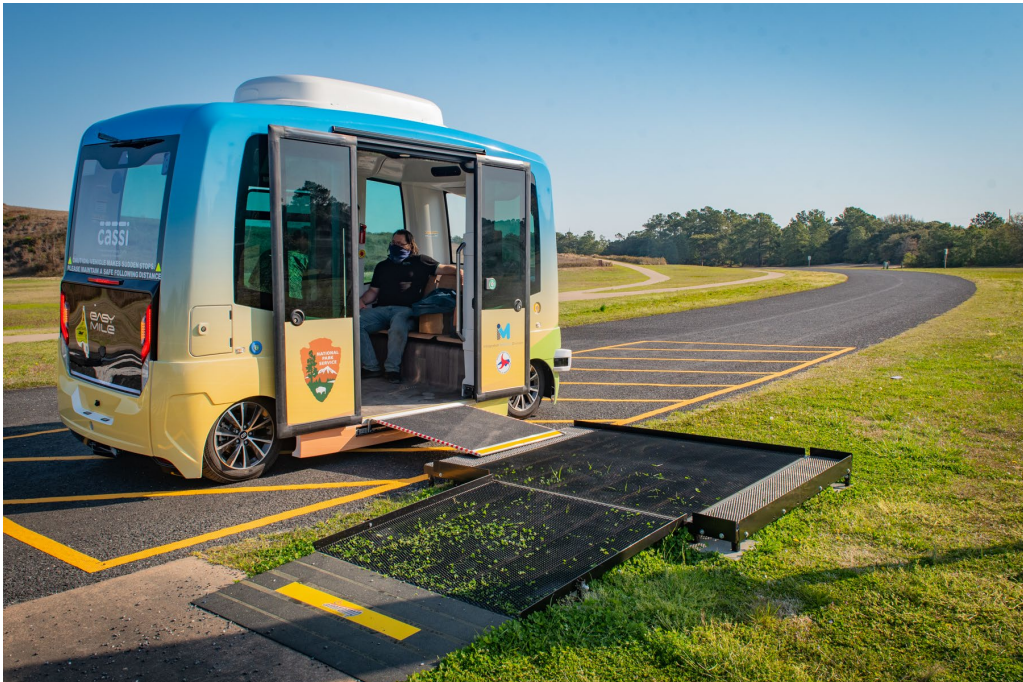
**Figure 4: The Shuttle with Its Ramp Deployed at the Sculpture Stop**  
Source: NPS

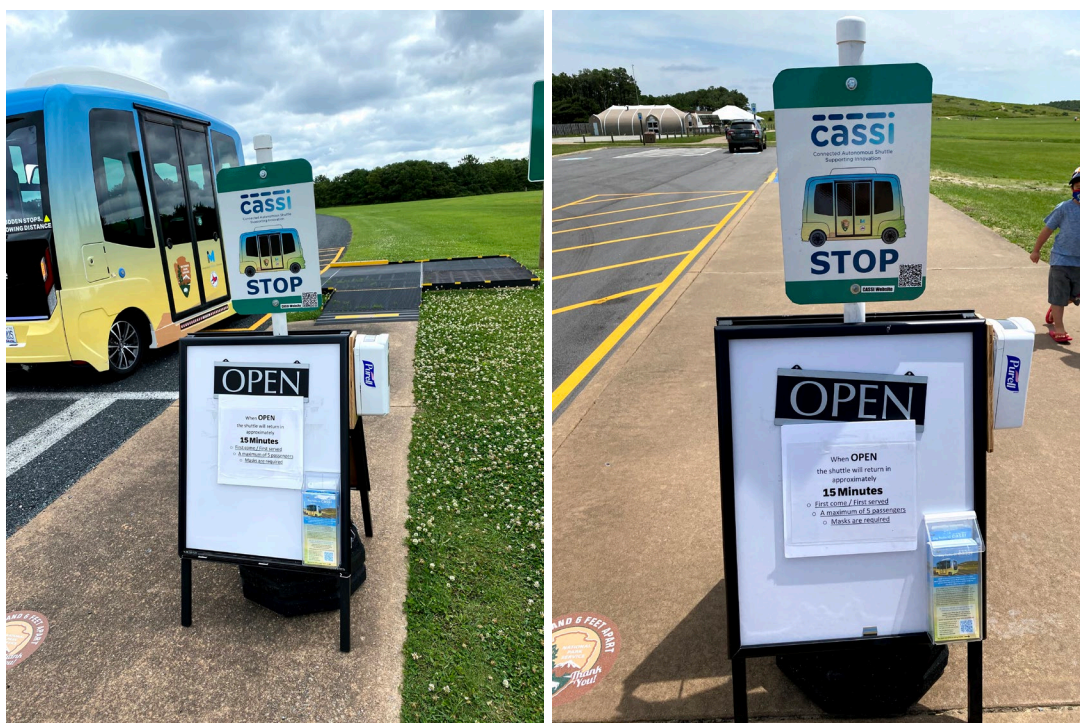
Figure 5: Signage at the Sculpture Stop (left) and at the Visitor Center Stop (right)  
Source: U.S. DOT Volpe Center

NPS staff placed sandwich board signs to indicate where shuttle stops were located and to provide guidelines and information about riding the shuttle (Figure 5). Signs included a reversible “open/closed” plaque to let visitors know if the shuttle was in service. The signage also notified visitors that:

- The shuttle ran on a 15-minute schedule (headway) when operating,
- Ridership on the shuttle was first-come, first-served, and
- Face masks were required to be worn on board (in compliance with COVID-19 safety measures).

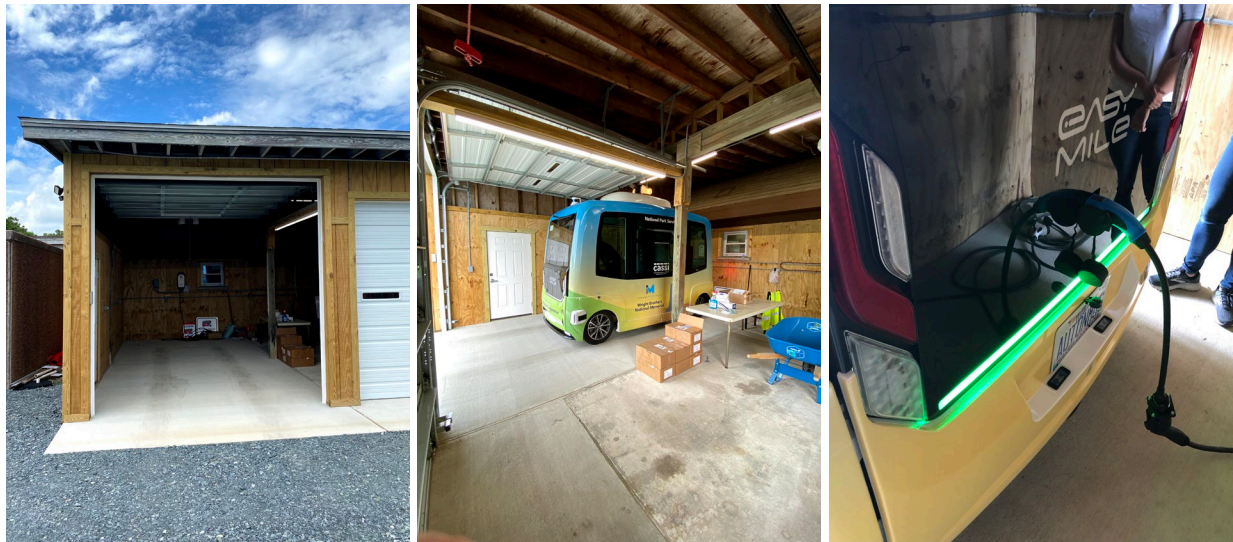
**Figure 6: Shuttle Storage Garage Exterior (left), Interior (center), and Charging Equipment (right)**  
Source: U.S. DOT Volpe Center

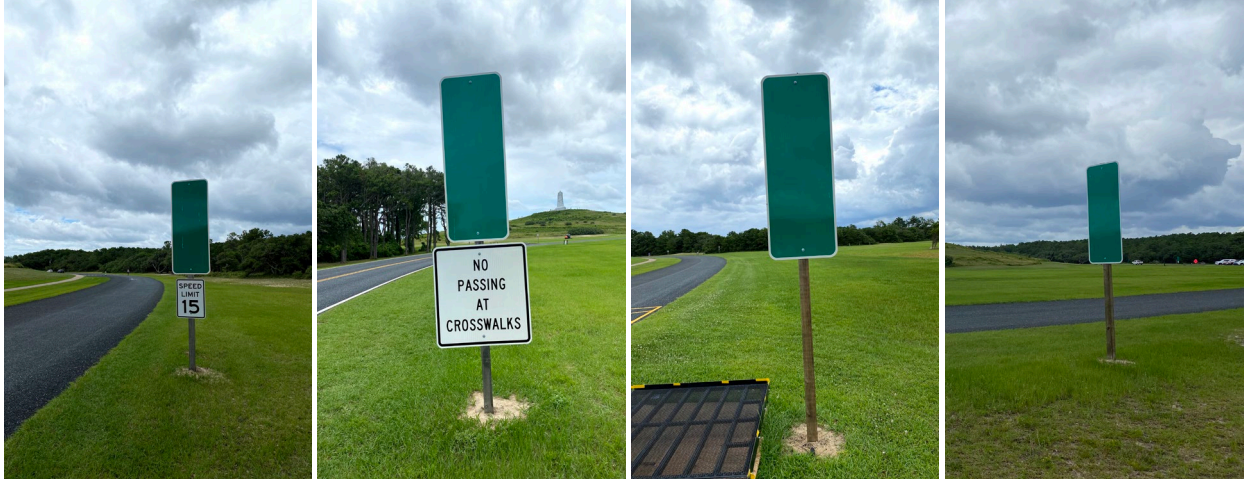
**Figure 7: The Four Localization Signs Installed Along Shuttle's Route**  
Source: U.S. DOT Volpe Center

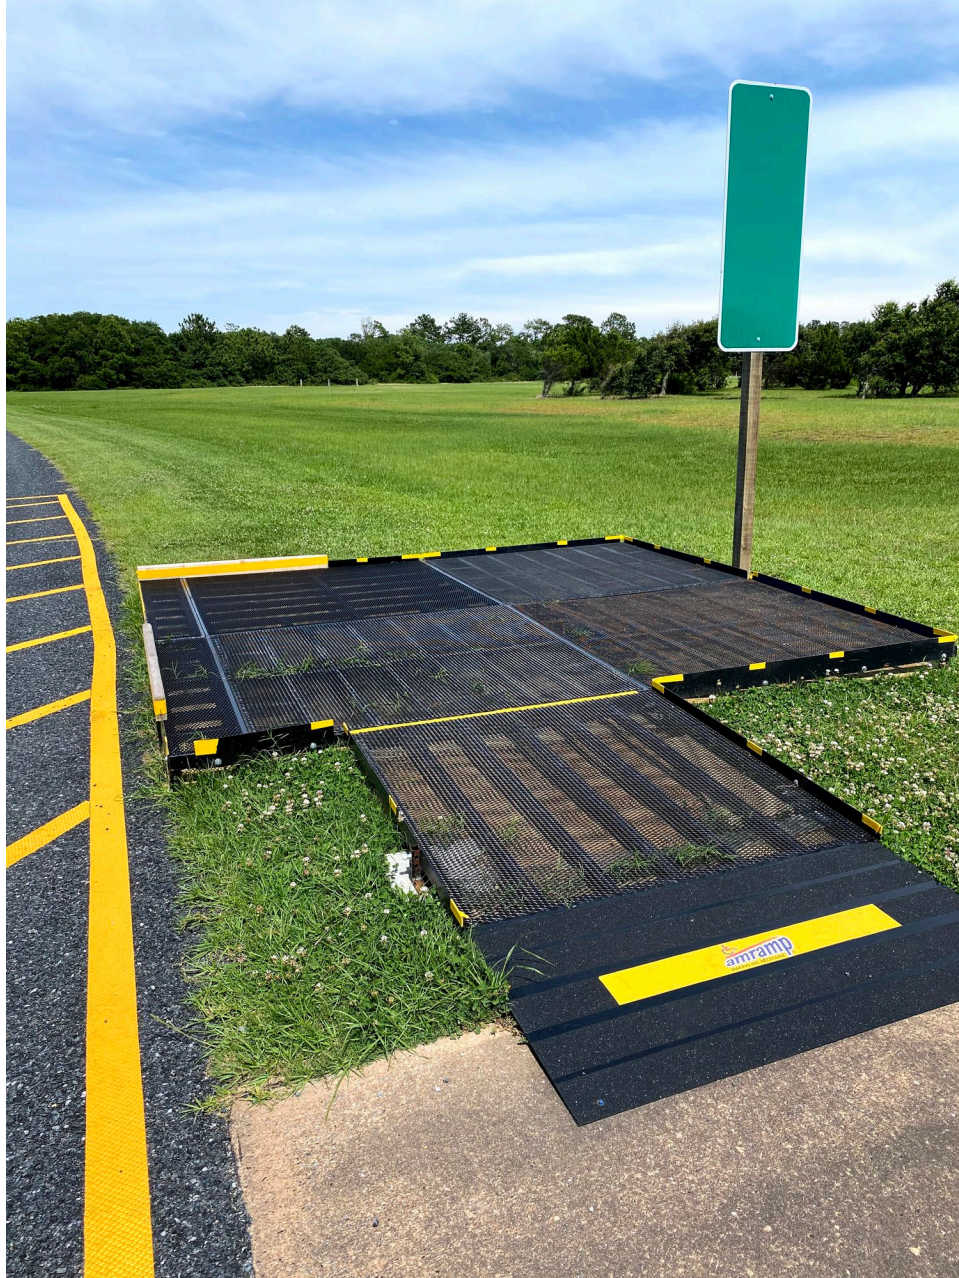
**Figure 8: Accessible Ramp and Platform Installed at Sculpture Stop**  
Source: U.S. DOT Volpe Center

The shuttle's accessibility ramp required a minimum three-foot-long section of curb (or elevated paved surface) for deployment. Such a curb did not exist at the sculpture stop, so NPS staff rented and installed a free-standing platform and wheelchair ramp at this location. The width of the initial platform was not sufficient to accommodate deployment of the accessibility ramp while also providing enough room for wheelchair maneuverability while on the platform, so the platform had to be enlarged, both of which are shown in Figure 8.

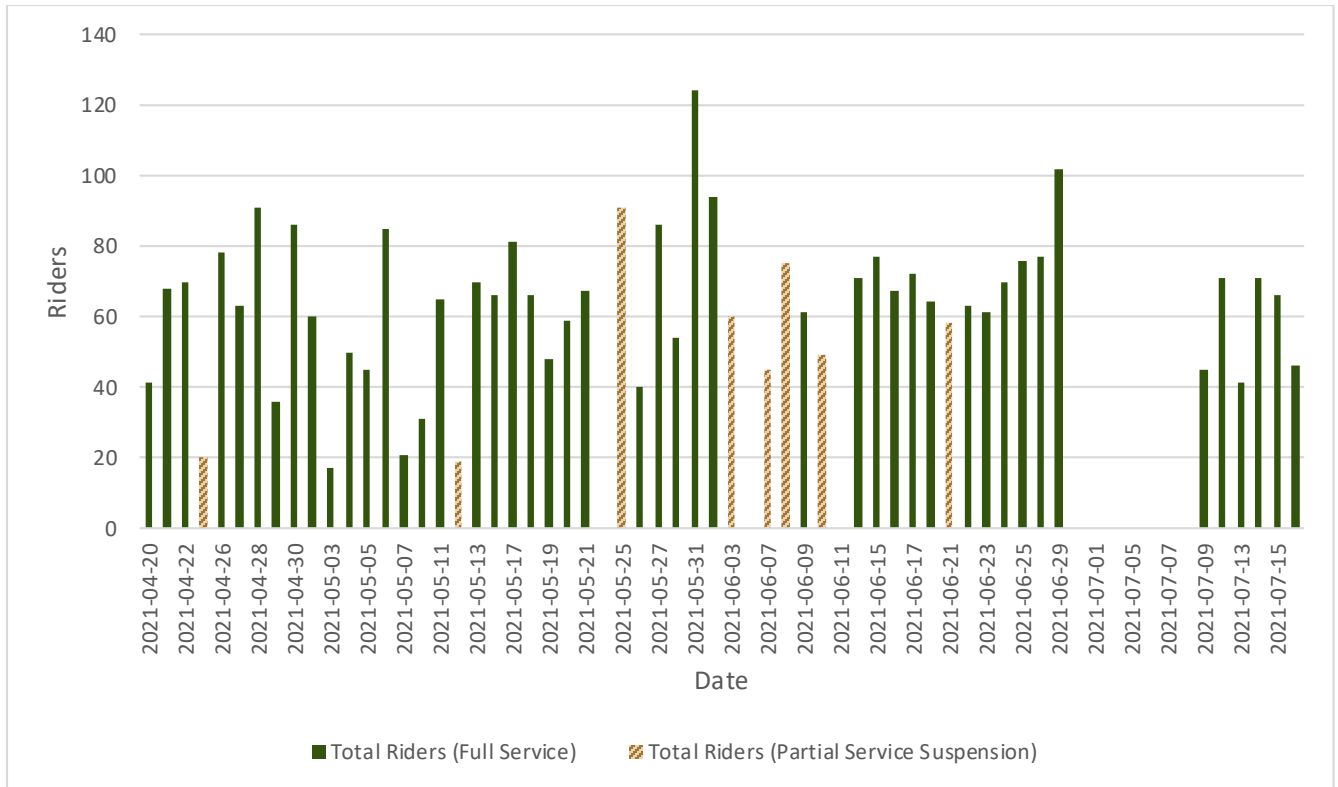
**Figure 10: CASSI Shuttle Riders per Day April-June 2021**  
 Source: Transdev and U.S. DOT Volpe Center

The shuttle was scheduled to run on weekdays from April 20 through July 16, 2021, for a total of 64 days of operation. However, due to multiple service suspensions caused by battery issues and weather conditions, the shuttle ran for 46 days with complete service, 8 days with partial service, and complete suspension of service for 10 days.<sup>18</sup> In total, the shuttle took 809 roundtrips and carried 3,380 passengers (see Table 1).

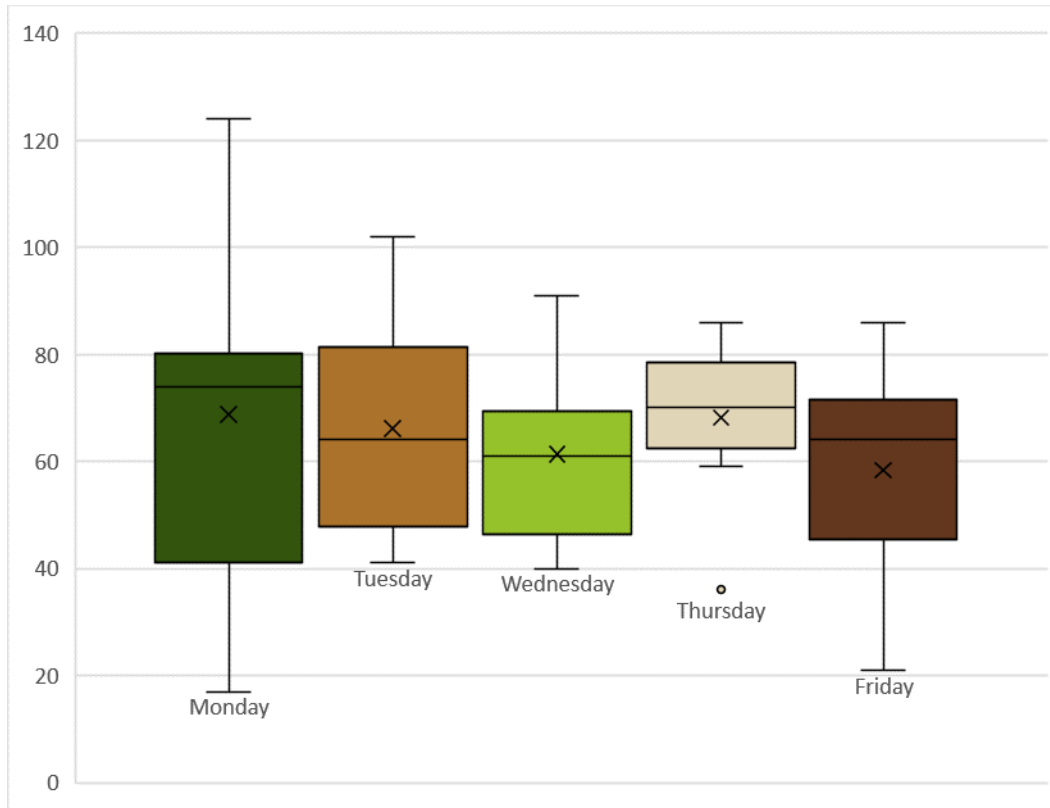
**Figure 11: CASSI Shuttle Riders by Day of the Week, Full Service**  
 Source: Transdev and U.S. DOT Volpe Center

With 3,380 total passengers and 809 total trips throughout the pilot, the shuttle carried approximately 4.2 riders per roundtrip. There was almost no variation in the average riders per roundtrip between the morning and afternoon shifts, although the afternoon shifts saw more riders and trips overall, likely due to that shift being longer. Another possible explanation for the ridership variation across shifts could be different levels of park visitation throughout the day. There was some variation by day of the week, with Mondays having approximately 10 more riders than Fridays on average; however, it is unclear why this would be the case.<sup>19</sup> Figure 11 presents a box-and-whisker chart for the ridership data on each day of the week.<sup>20</sup>

<sup>20</sup> The “box” part of a box-and-whisker graph shows, essentially, the middle 50 percent of the data. The “whiskers” that extend out from the box show the range of the bottom and top 25 percent of the data. Any dots that lay beyond the ends of the whiskers show outliers. The line through the box shows the median, and the X indicates the mean.

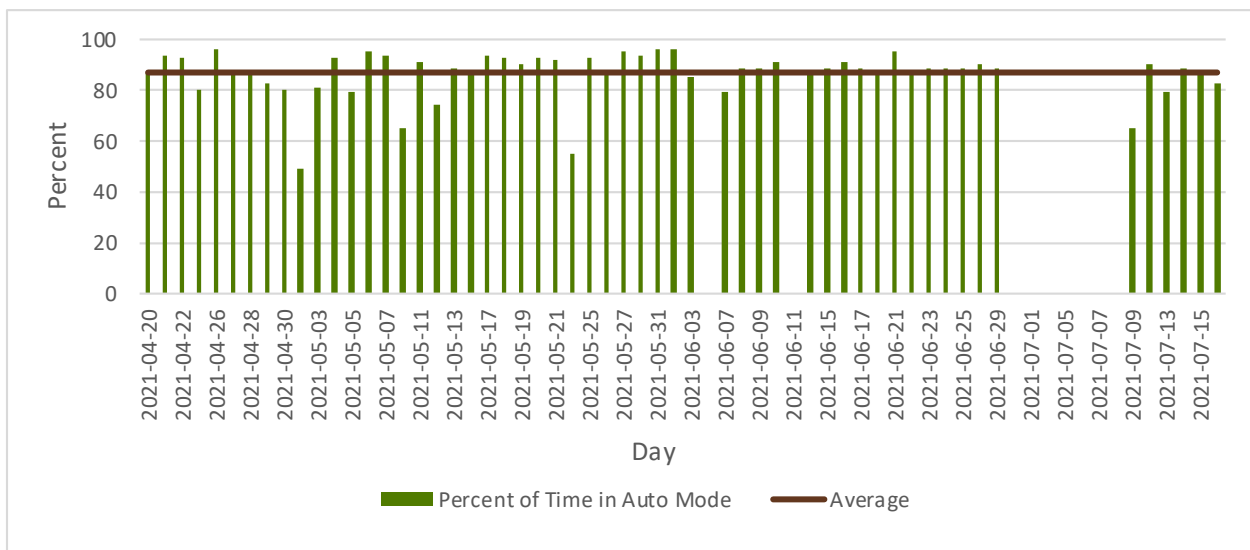
**Figure 14: Time Spent in Automated Mode**  
 Source: EasyMile and U.S. DOT Volpe Center

Even with the numerous disengagements, the vehicle operated primarily in automated mode. An average estimate across the pilot suggests that the shuttle was driving in automated mode around 87 percent of the time. This is promising, but also indicates that the automated technology is likely still far off from not requiring a safety operator to be onboard the shuttle. Figure 14 shows the percentage of time spent in automated mode plotted by day. Due to service suspensions, not all days have data.

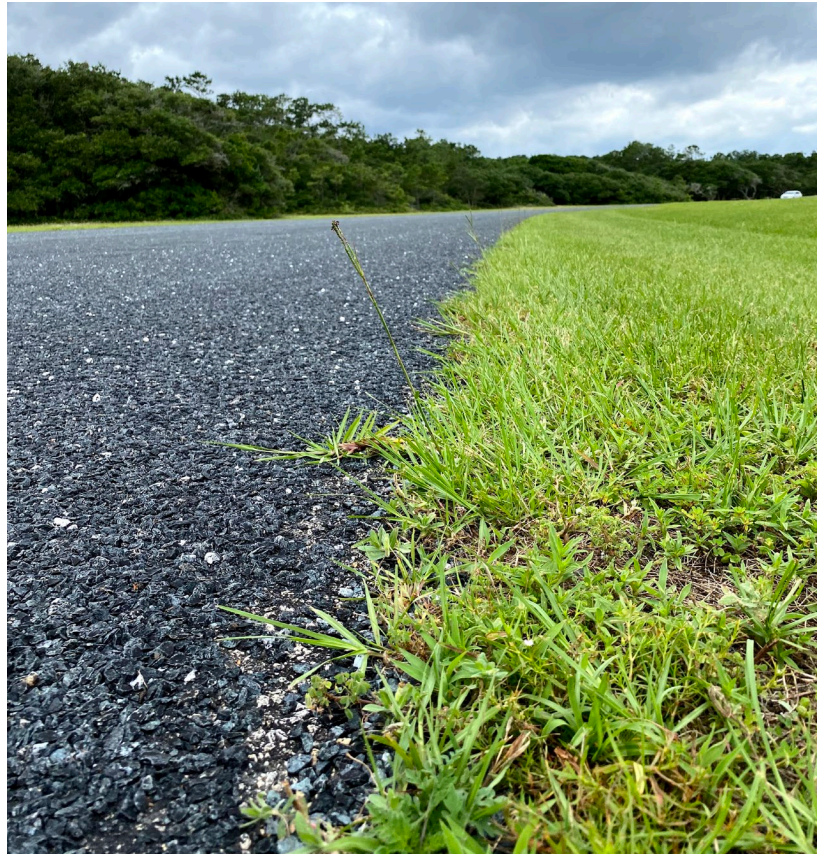
**Figure 15: Typical Example of Weeds at Roadway Edge Causing Shuttle Disengagements**  
Source: U.S. DOT Volpe Center

During the pilot, it was discovered that weeds growing within 1.5 feet of the roadway interfered with the lidar sensors on board the shuttle, causing the shuttle to repeatedly slow, stop, or disengage at multiple points along its route. Park staff then mowed the grass as frequently as every three days to address the issue (Figure 15 and Figure 16). Park staff noted that this frequency of mowing is not sustainable in the long term. In addition, before the pilot began, several tree canopies were trimmed in the northwest area of the circle to not interfere during the pilot. These trees and related vegetation were monitored during the concurrent growing season.

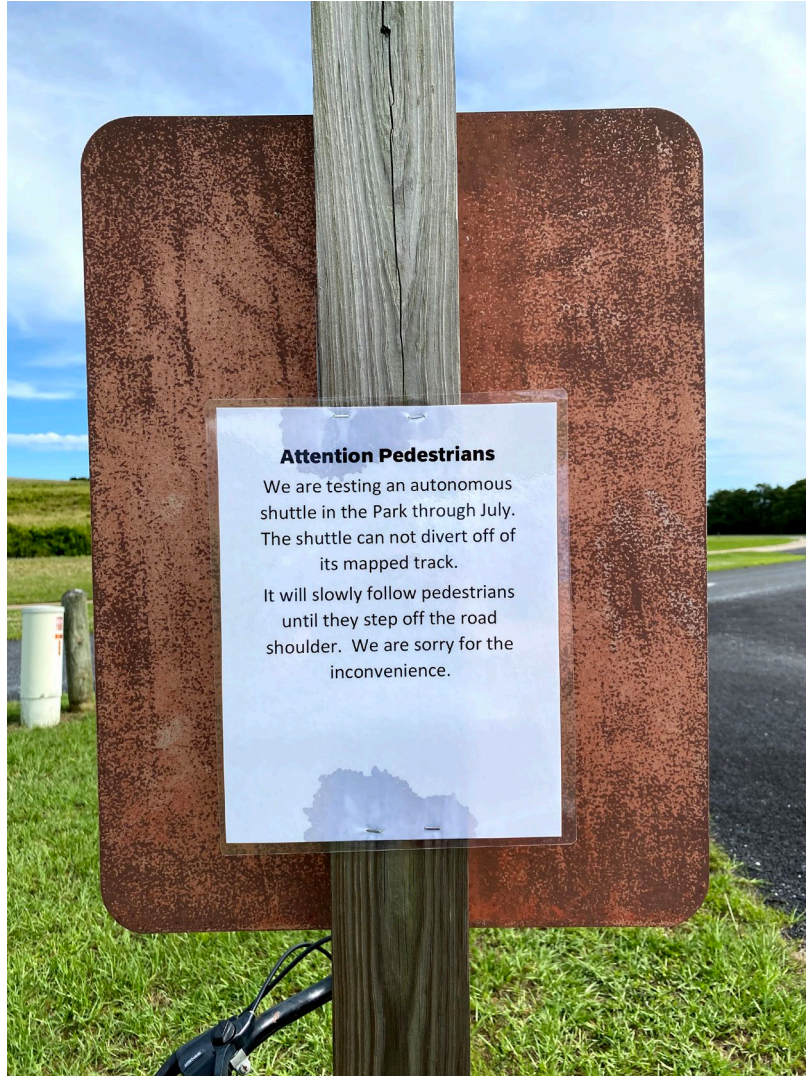
**Figure 19: Notification Sign to Pedestrians Indicating That the Shuttle Will Not Pass Them in the Roadway**  
Source: U.S. DOT Volpe Center

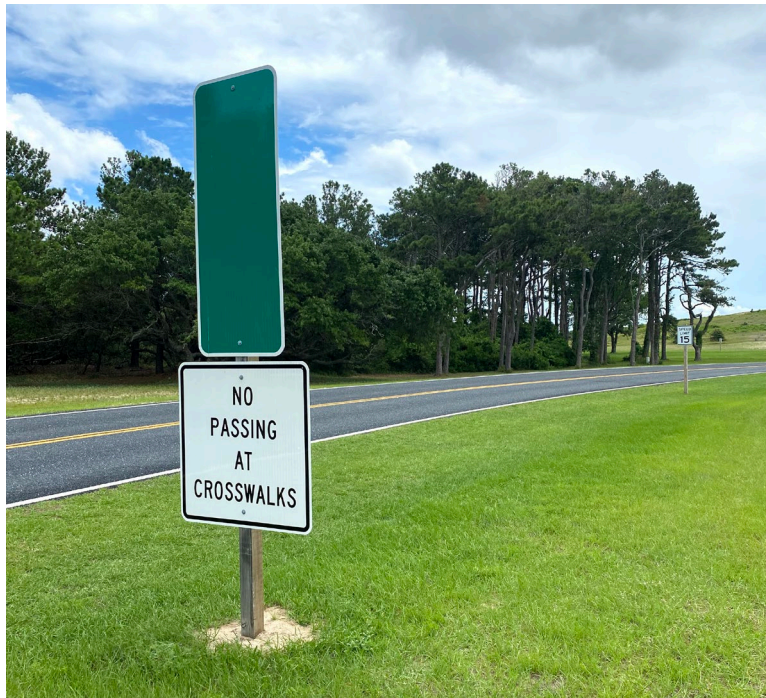
**Figure 20: Signage Instructing Drivers Not to Pass Shuttle at Crosswalks**  
Source: U.S. DOT Volpe Center

Most visitors walked through the Memorial by starting at the visitor center and continuing south down the walkway toward the Wright Brothers Monument. Pedestrians must cross a marked crosswalk across Memorial Loop to walk toward the Monument (see site map, Figure 1). Drivers attempted to pass the shuttle as the shuttle yielded to pedestrians in the crosswalk, creating an unsafe environment for the pedestrians and the shuttle operation. Park staff resolved this issue by placing orange cones, an MUTCD-

compliant crosswalk sign, and a custom sign instructing drivers not to pass at crosswalks (Figure 20 and Figure 21).<sup>28</sup>

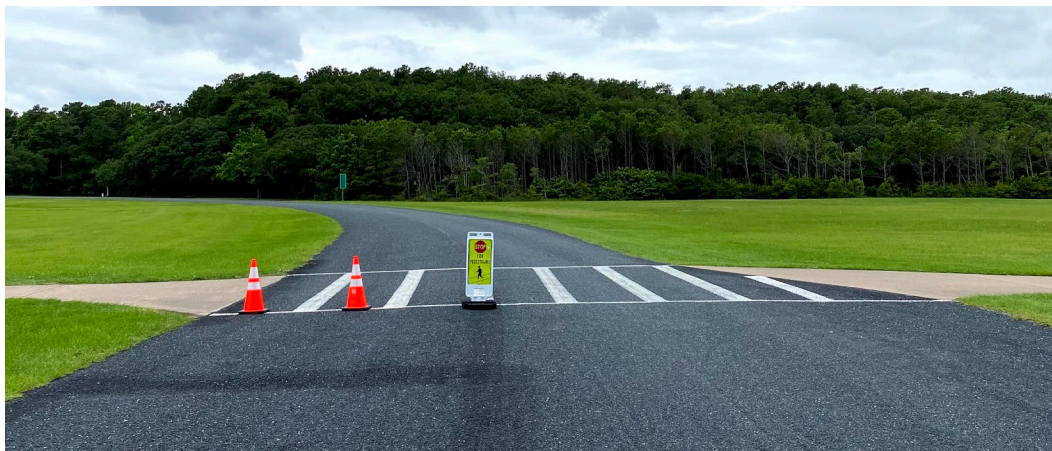
**Figure 21: Cones and Signage Placed at High-Traffic Pedestrian Crossing**  
Source: U.S. DOT Volpe Center

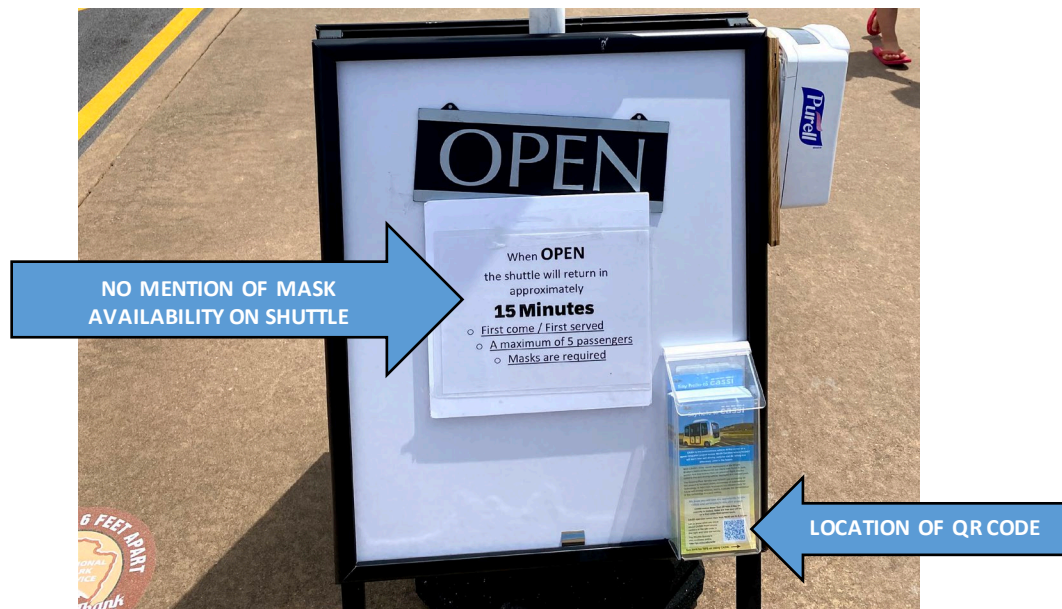
Figure 22: Signage at Visitor Center Stop Displaying an "Open" Status  
Source: U.S. DOT Volpe Center

Some issues related to signage at the shuttle stops were reported by park staff. Signage (Figure 22) was lacking some relevant information, which led to some visitor confusion about the CASSI route and the rules for riding. The following items were observed at the shuttle stops:

- Signs stated that masks were required onboard but did not inform visitors that masks were available on the shuttle. Some visitors returned to their vehicles to grab masks or walked away from the shuttle stop because they did not have masks with them.
- The QR code which linked to the online CASSI tracker was too small and easy to miss. As a result, many visitors did not know they could track the shuttle's location in real time.
- Visitors were observed queuing for the shuttle even when it was not in service due to the operator's lunch break or inclement weather. This often occurred because the operator did not change the operating status sign from "open" to "closed."
