Preservation of Tuzigoot Pueblo

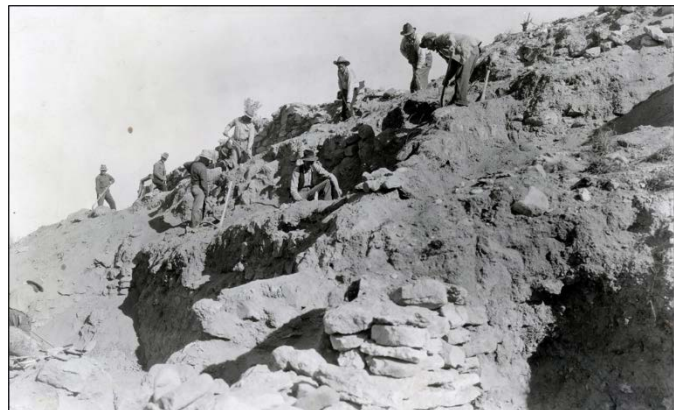
Figure 2: Excavation of Tuzigoot Pueblo, 1933. Photo NPS

the excavation was provided by the Civil Works Administration (CWA), a depression-era program. Out-of-work laborers from the local communities of Clarkdale and Cottonwood were paid to assist Caywood and Spicer with the excavation. The goals of the project included the collection of artifacts and the exposure of ancient walls.

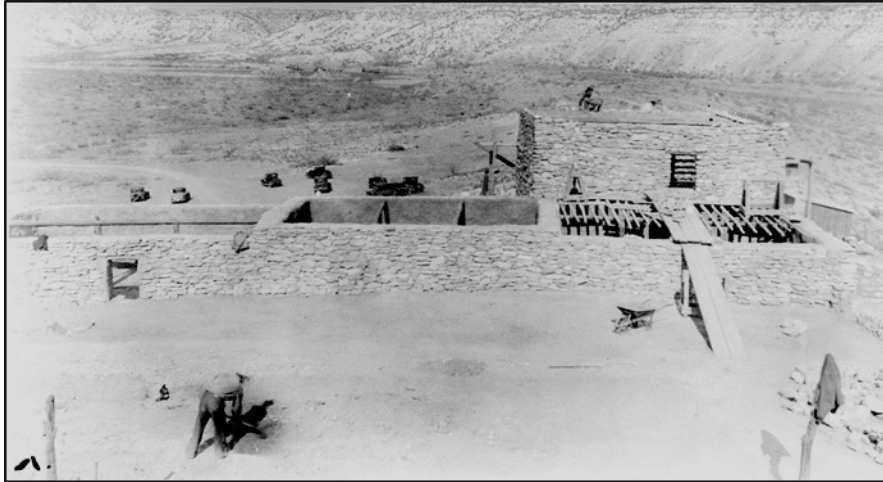
Figure 3: Reconstruction of Group IV at Tuzigoot Pueblo, 1934. Photo NPS

During the excavation, Caywood and Spicer divided the pueblo into six groups, labeled I-VI. Following the excavation, masonry walls were partially reconstructed and rooms in Group IV were completely rebuilt. The rebuilt rooms were intended to show visitors what the pueblo looked like while occupied, but the overall appearance was incongruous with the rest of the ruin.

Additionally, the reconstructed roofs began to leak as early as 1939. Leaky roofs and deterioration caused by powder-post beetles forced the National Park Service to deconstruct group IV in 1942.

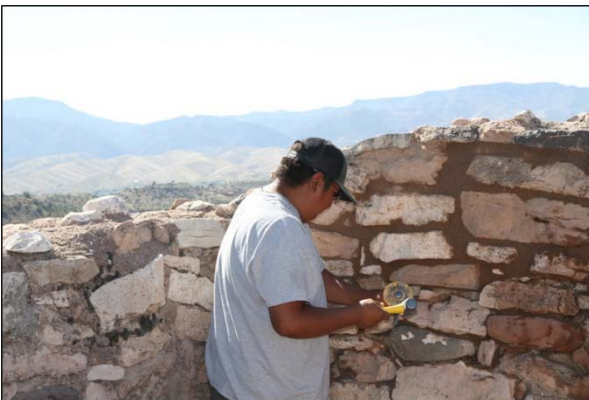
Figure 4: Preservation Mason removing portland cement by hand to preserve the original fabric of the wall. Photo NPS

Walls at the Tuzigoot Pueblo require constant maintenance and stabilization to remain standing. Over the last 85 years, 9 major stabilization campaigns have been completed. The materials used by workers from 1933-1998 included large amounts of Portland cement, a material that is very hard. Over time, Portland cement can damage original building stones and cause walls to become unstable. If left untreated, these walls could collapse.

Beginning in 1998, Preservation Masons began removing all the extremely hard Portland cement. Masons use hammers and chisels to remove the old material and replace it with a new mixture of clay, sand and a small percentage of concrete. This mixture is called “soil cement” and creates softer and more breathable mortar joints, protecting original stones and allowing the wall to dry more quickly.

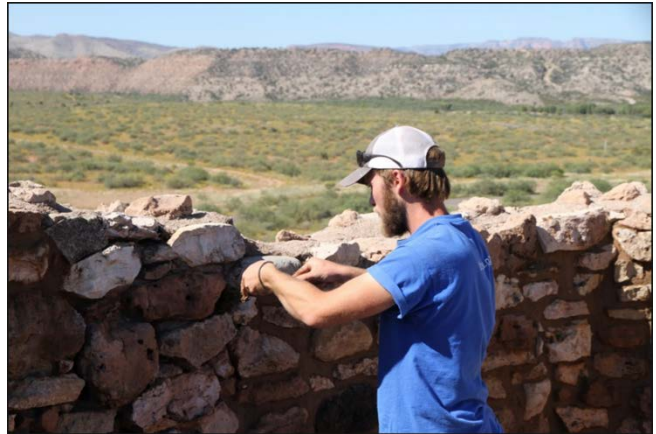
Figure 5: Preservation Intern replacing historic concrete mortar with soil cement to stabilize the wall. Photo NPS
