## WERO Dam Removal and Habitat Restoration:

*Initial Wetland Delineation Trip Report and Planning Status Summary 9/22/2017*

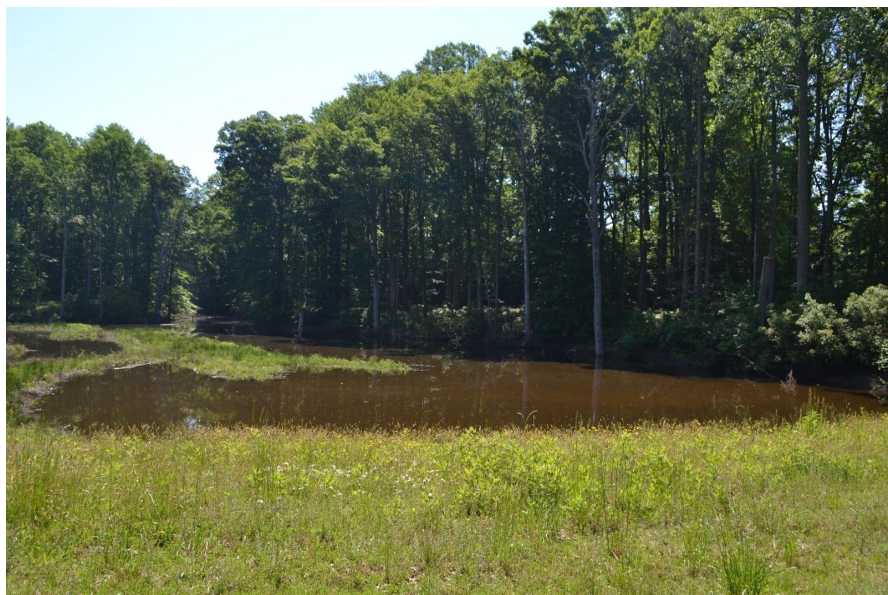
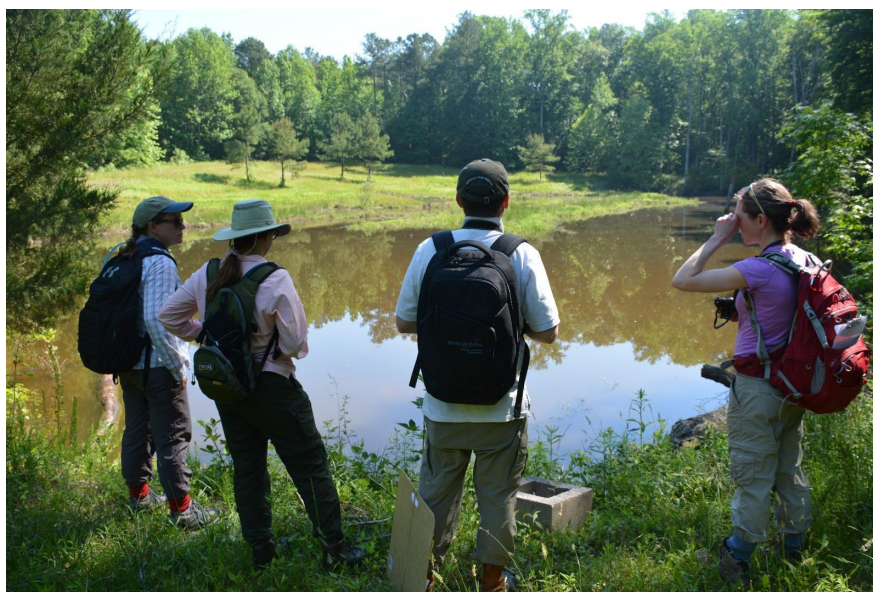
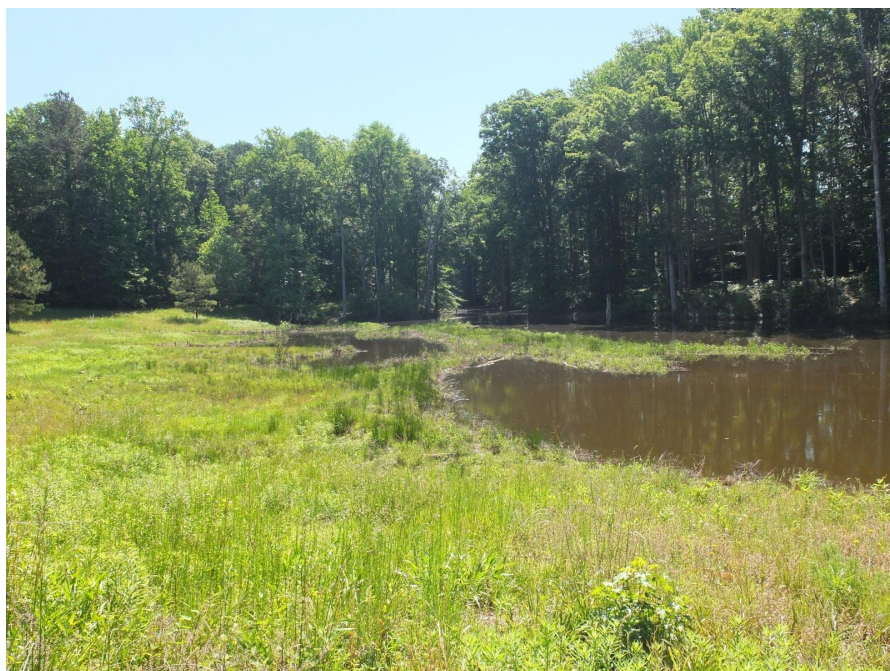
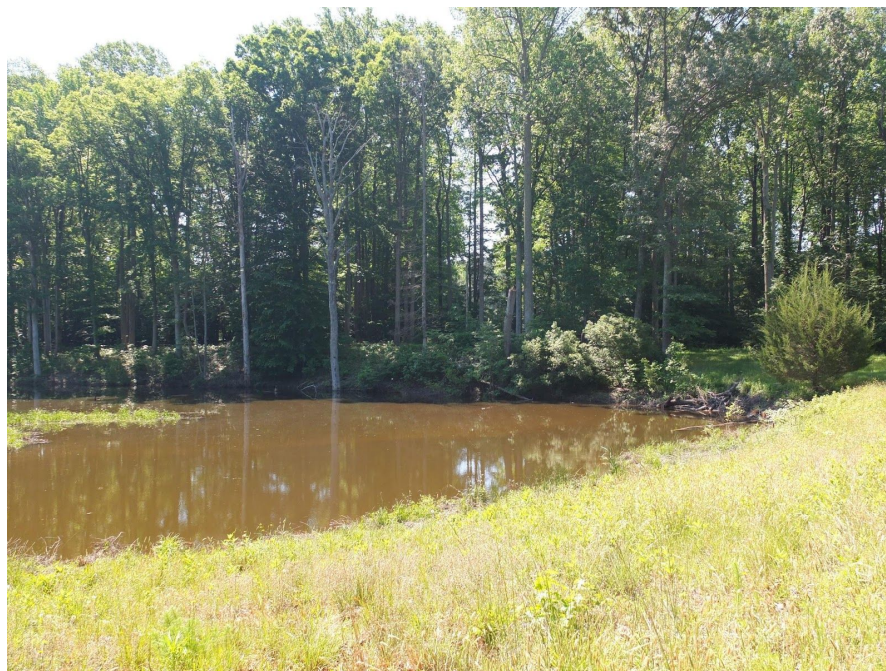
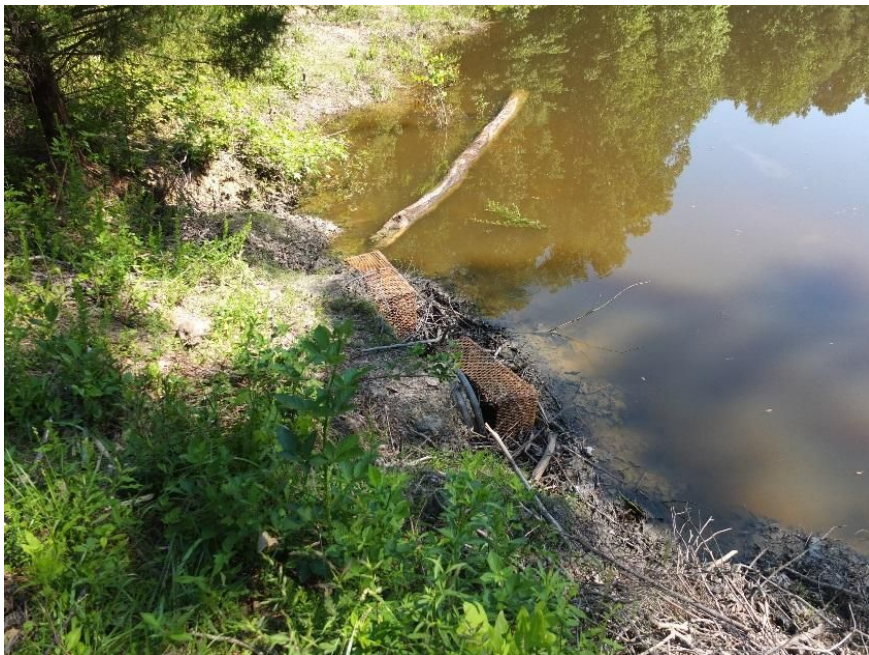
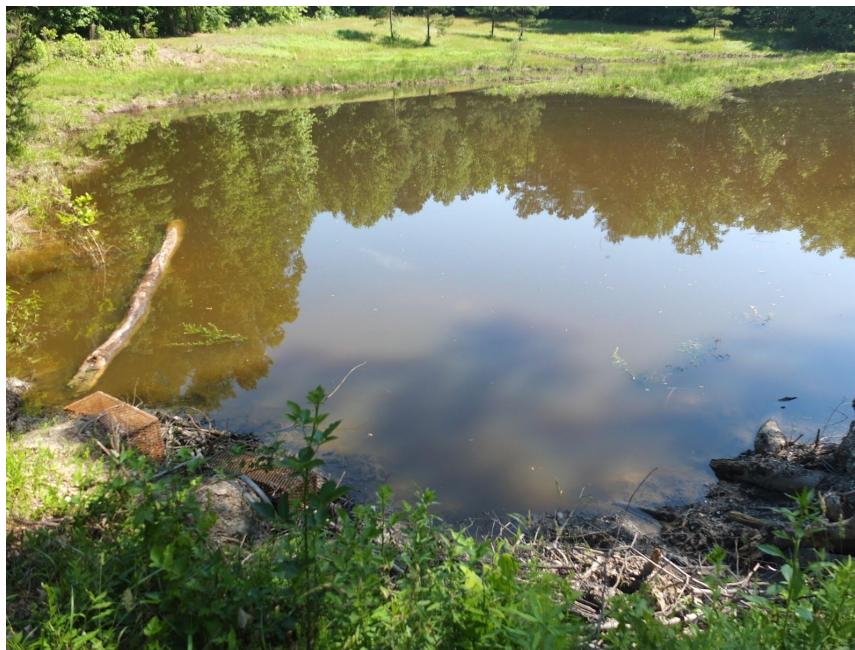
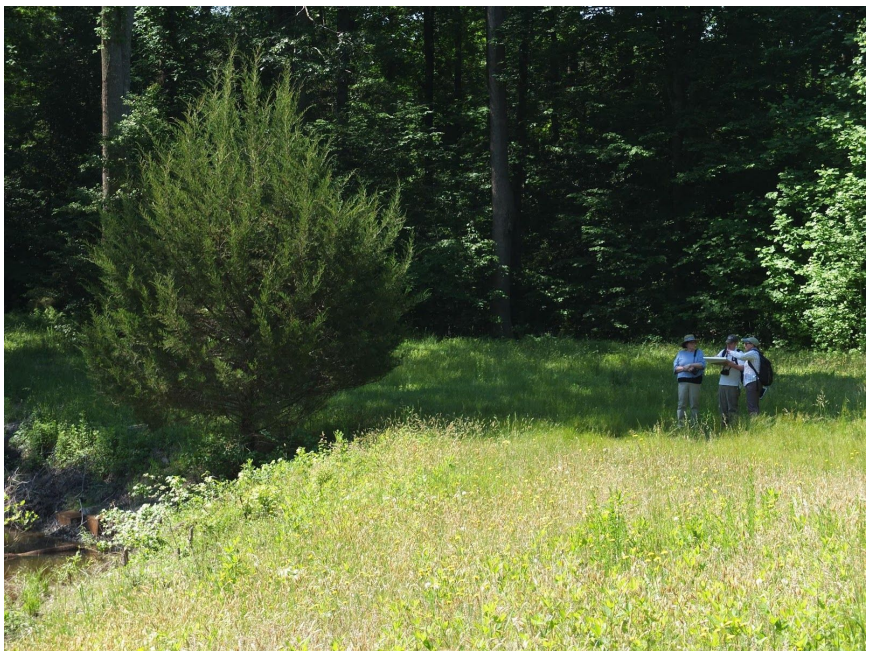
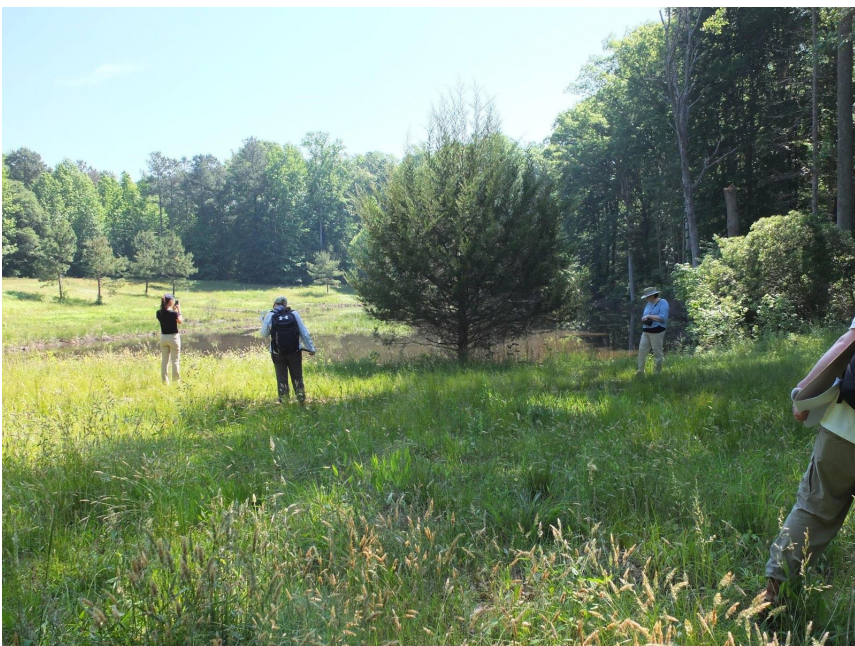
Figure 3: Images above and below are from the Rapid Assessment team in April 2017

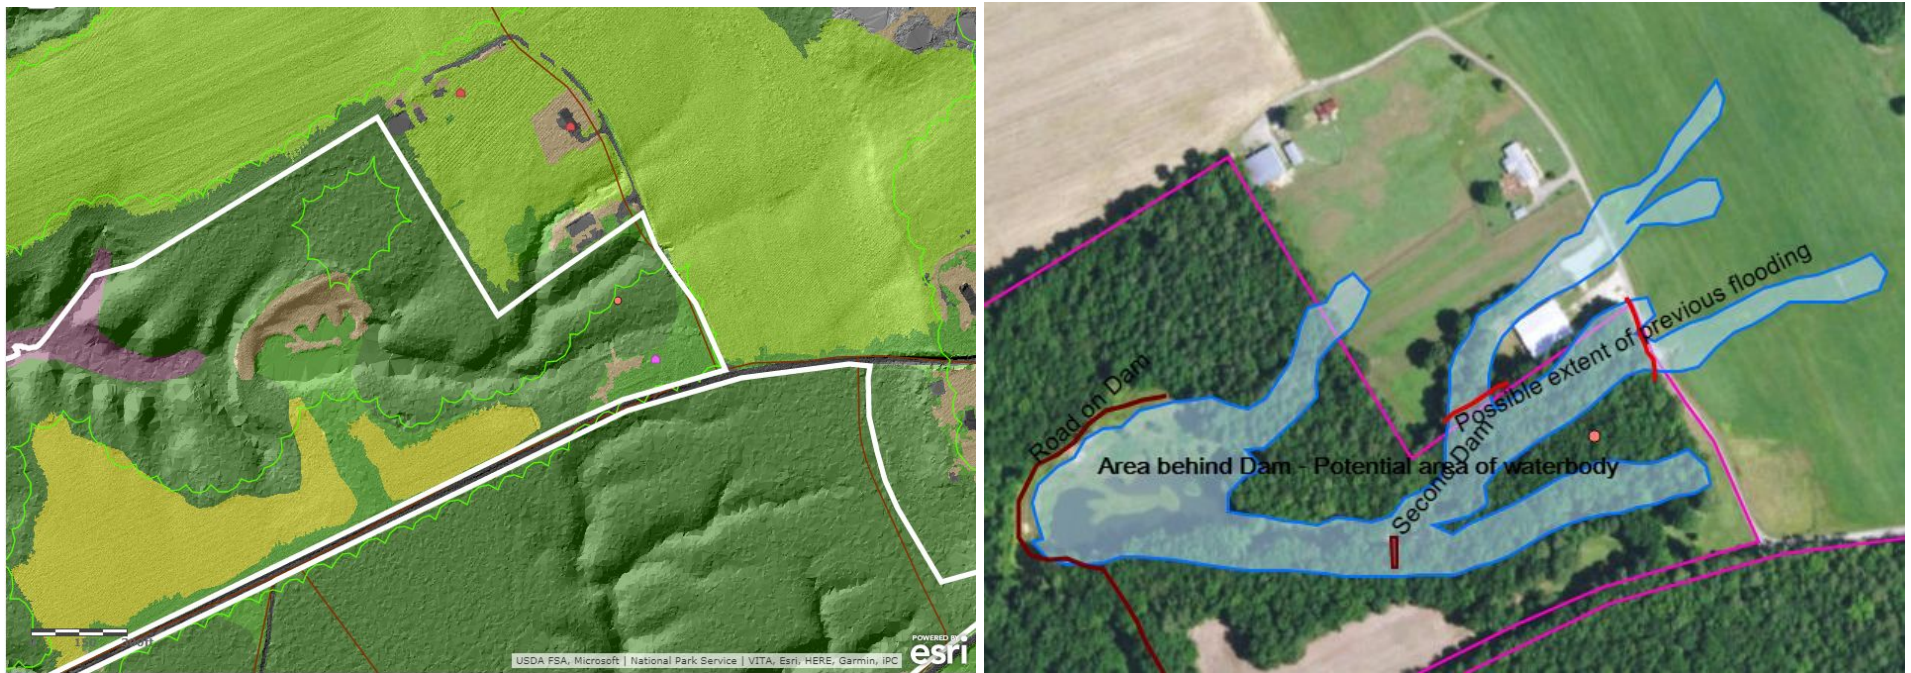
Figure 13: Left image: WERO as depicted in ArcGIS Online NPS layers and tools, including boundary survey (white line), LIDAR hillshade, and Virginia Land Cover data. The elevation difference between the dam and the downstream channel is evident in this image. The filled red circle indicates a spring. The headwaters appear to be springfed and those of the portion of Leigh Creek feeding the dam pond begin on the neighbors' properties in the northeast / top right corner of the image. Right image: Freehand drawn impoundment area behind the downstream dam (in blue), road and downstream dam (in brown), approximate location of second dam (brown rectangle), and reported extent of previous flooding. Note location of red circle indicating spring on the top of the hill between tributaries. Spring locations requires verification.

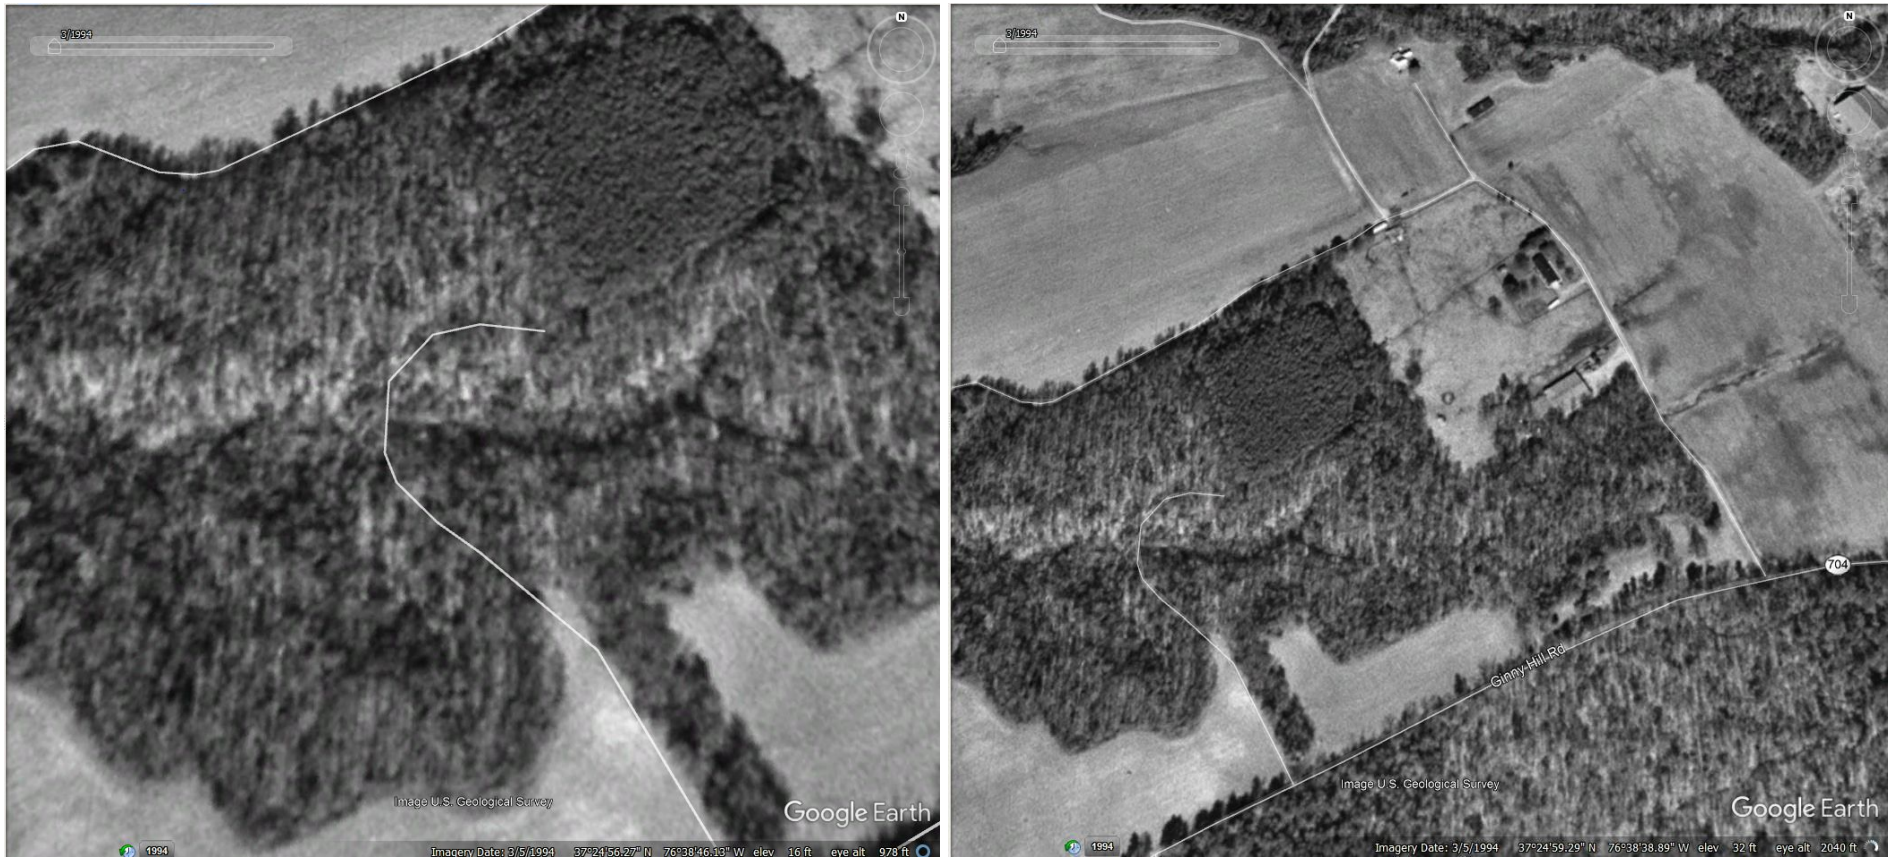
Figure 14: Google Earth Pro image of 3051 Ginney Hill Road, Gloucester, VA in March 1994. Note the road that follows the current (2017) line of the dam. This road is not depicted on any of the park documentation. And the dam was not present in 1994. The agricultural development of the headwaters was in place in 1994, and the headwaters are very clear on the neighbors' properties.

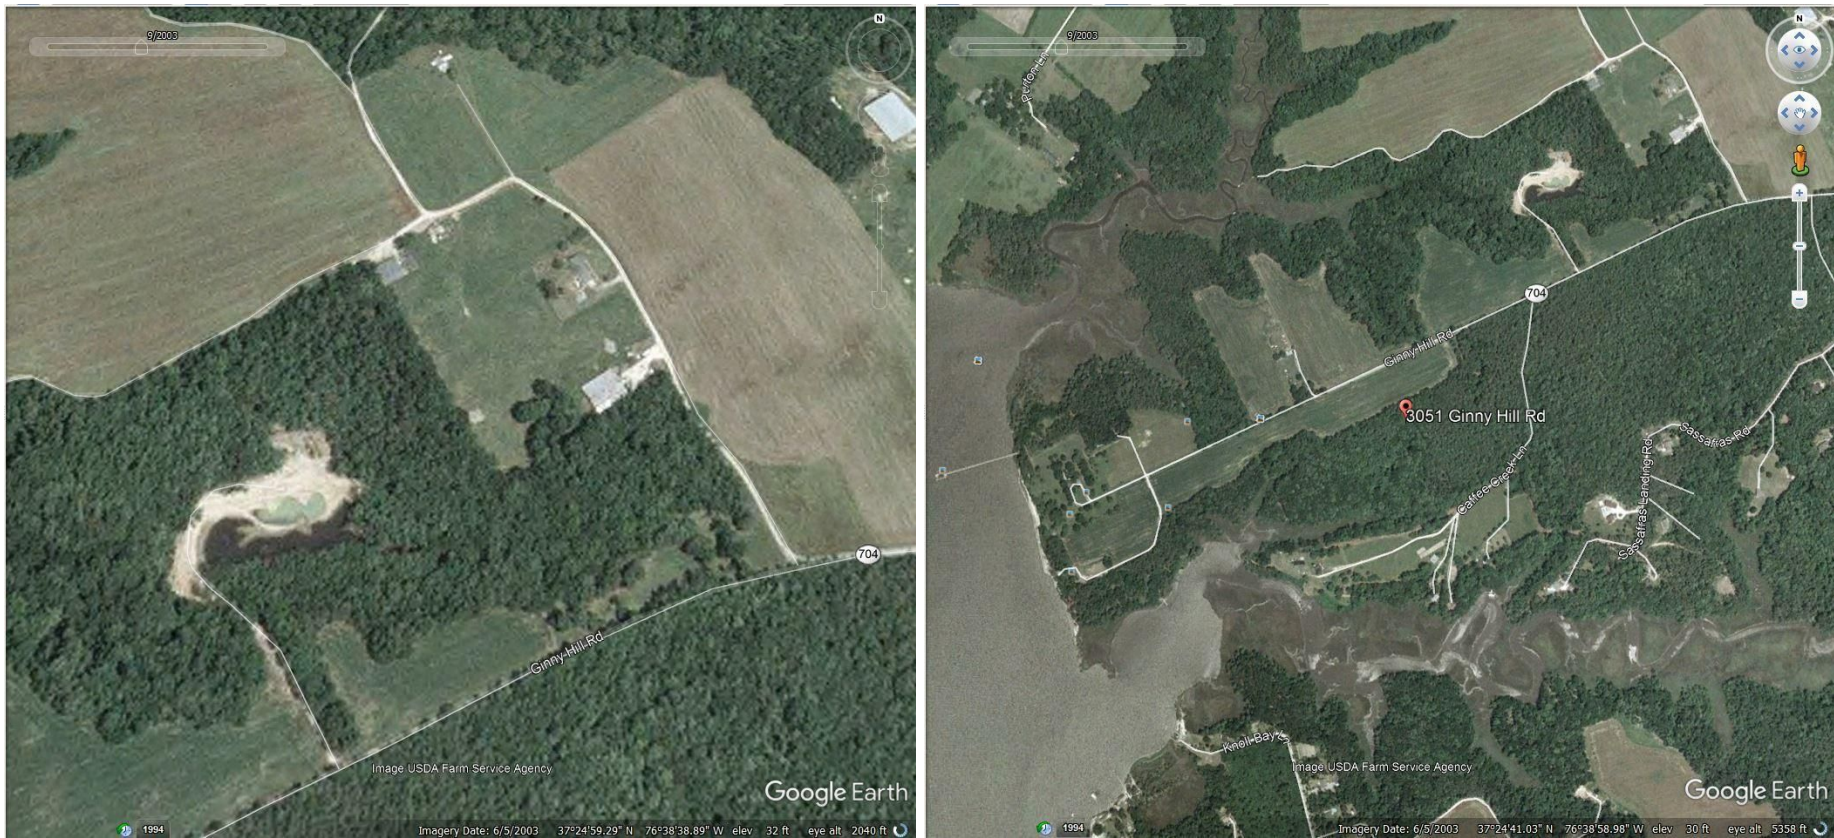
Figure 15: By June 2003, the next available Google Earth imagery, the dam was in place. Water level in the downstream portion of the WERO branch of Lewis Creek is lower.

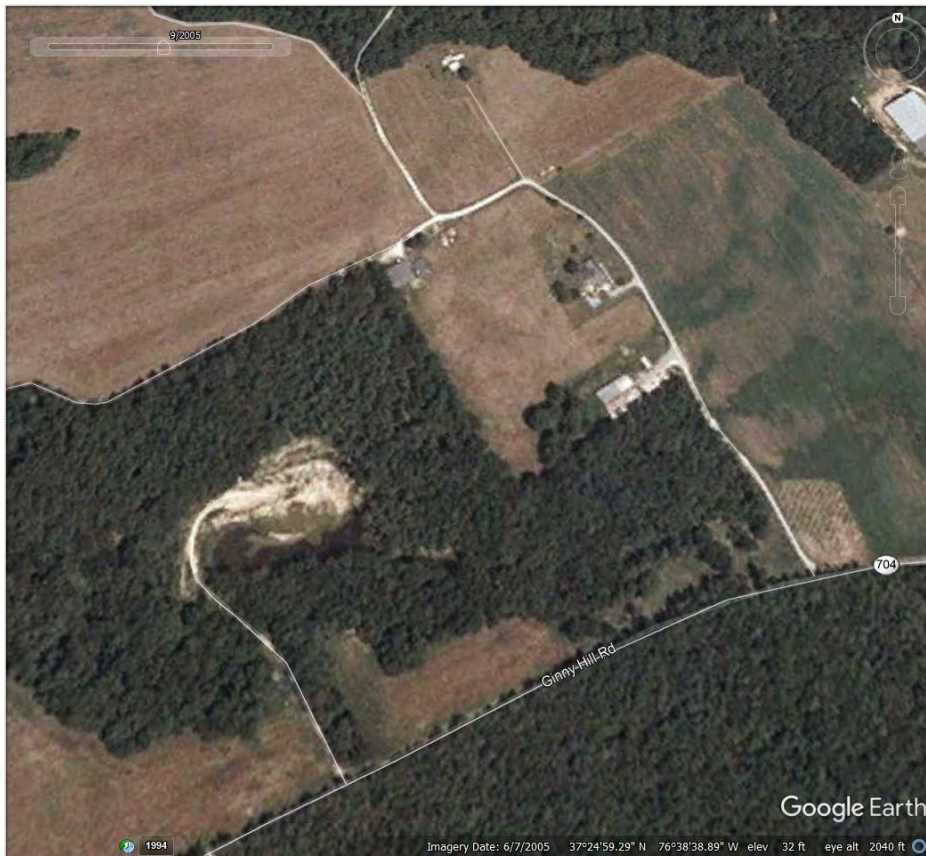
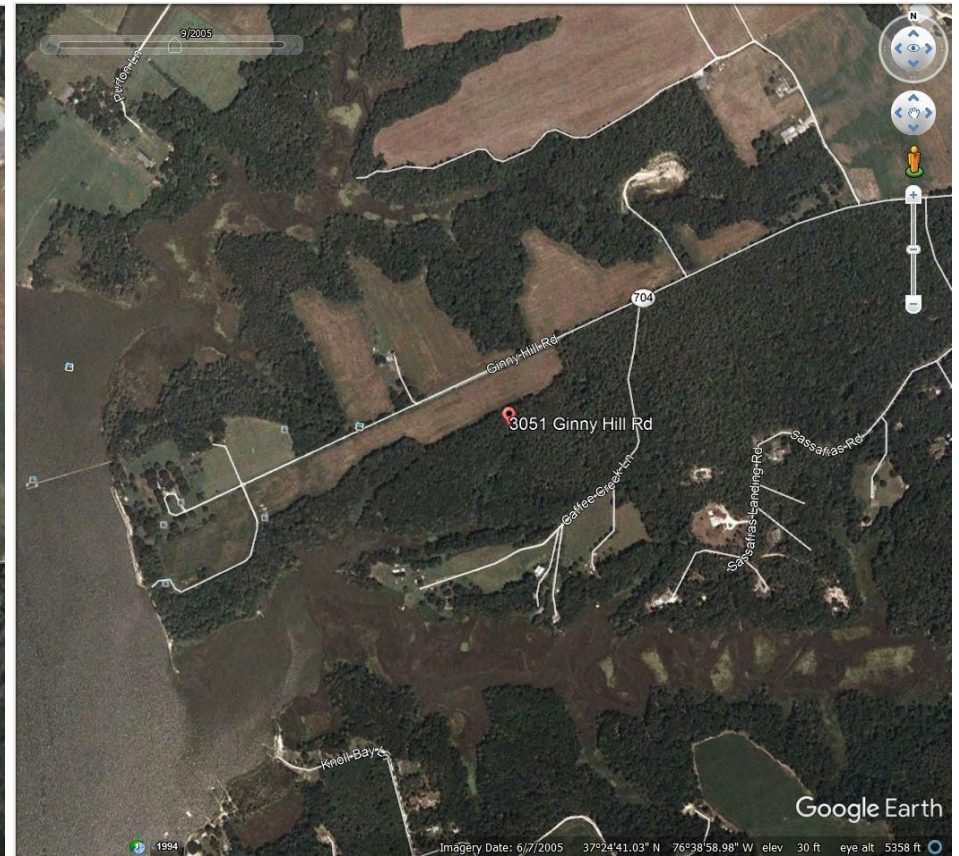
Figure 16: June 2005, work on the dam continues

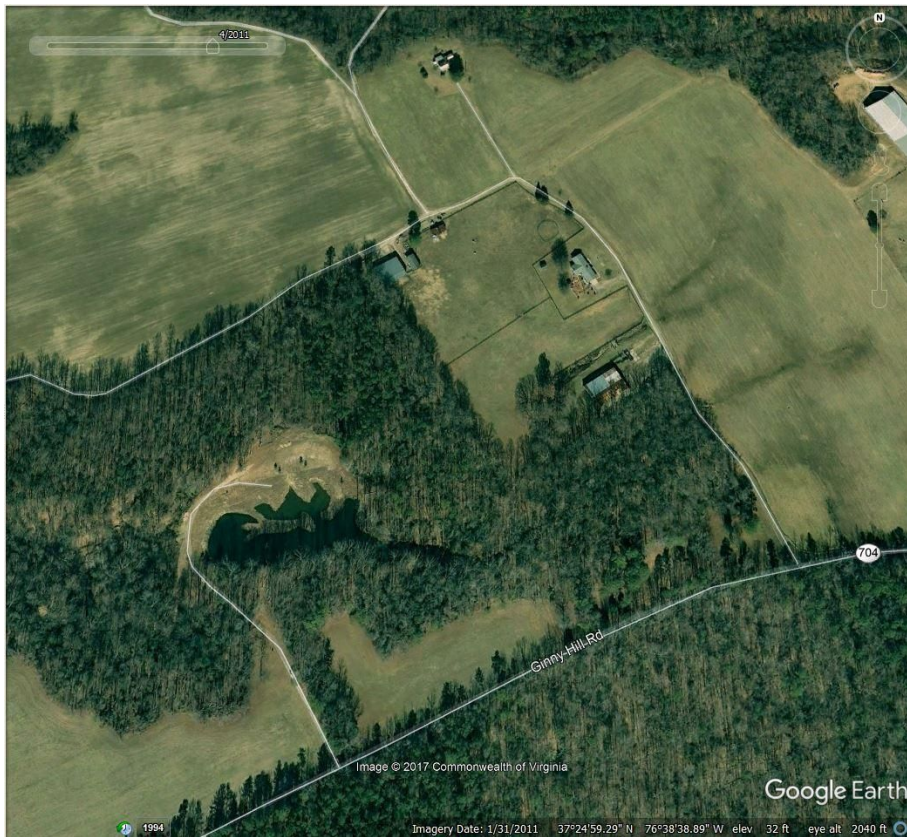
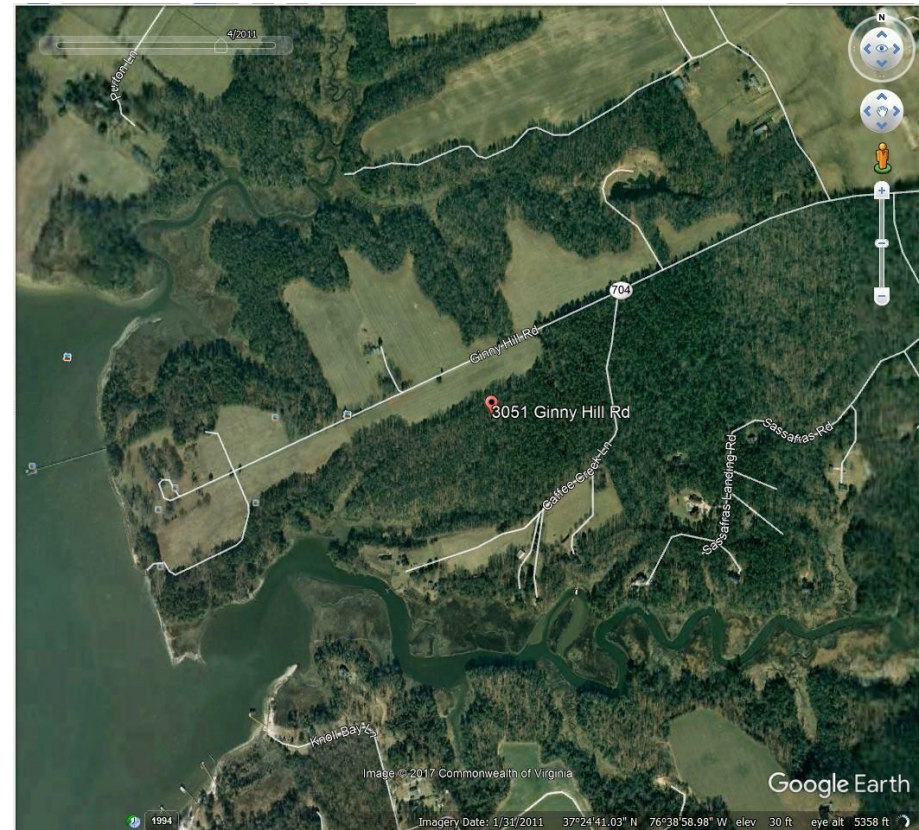
Figure 21: January 2011, from this point on vegetation grows in somewhat but there are no discernible changes in the pond and dam configuration. the field in which the headwaters are located does appear to change in wet and dry and vegetation conditions.

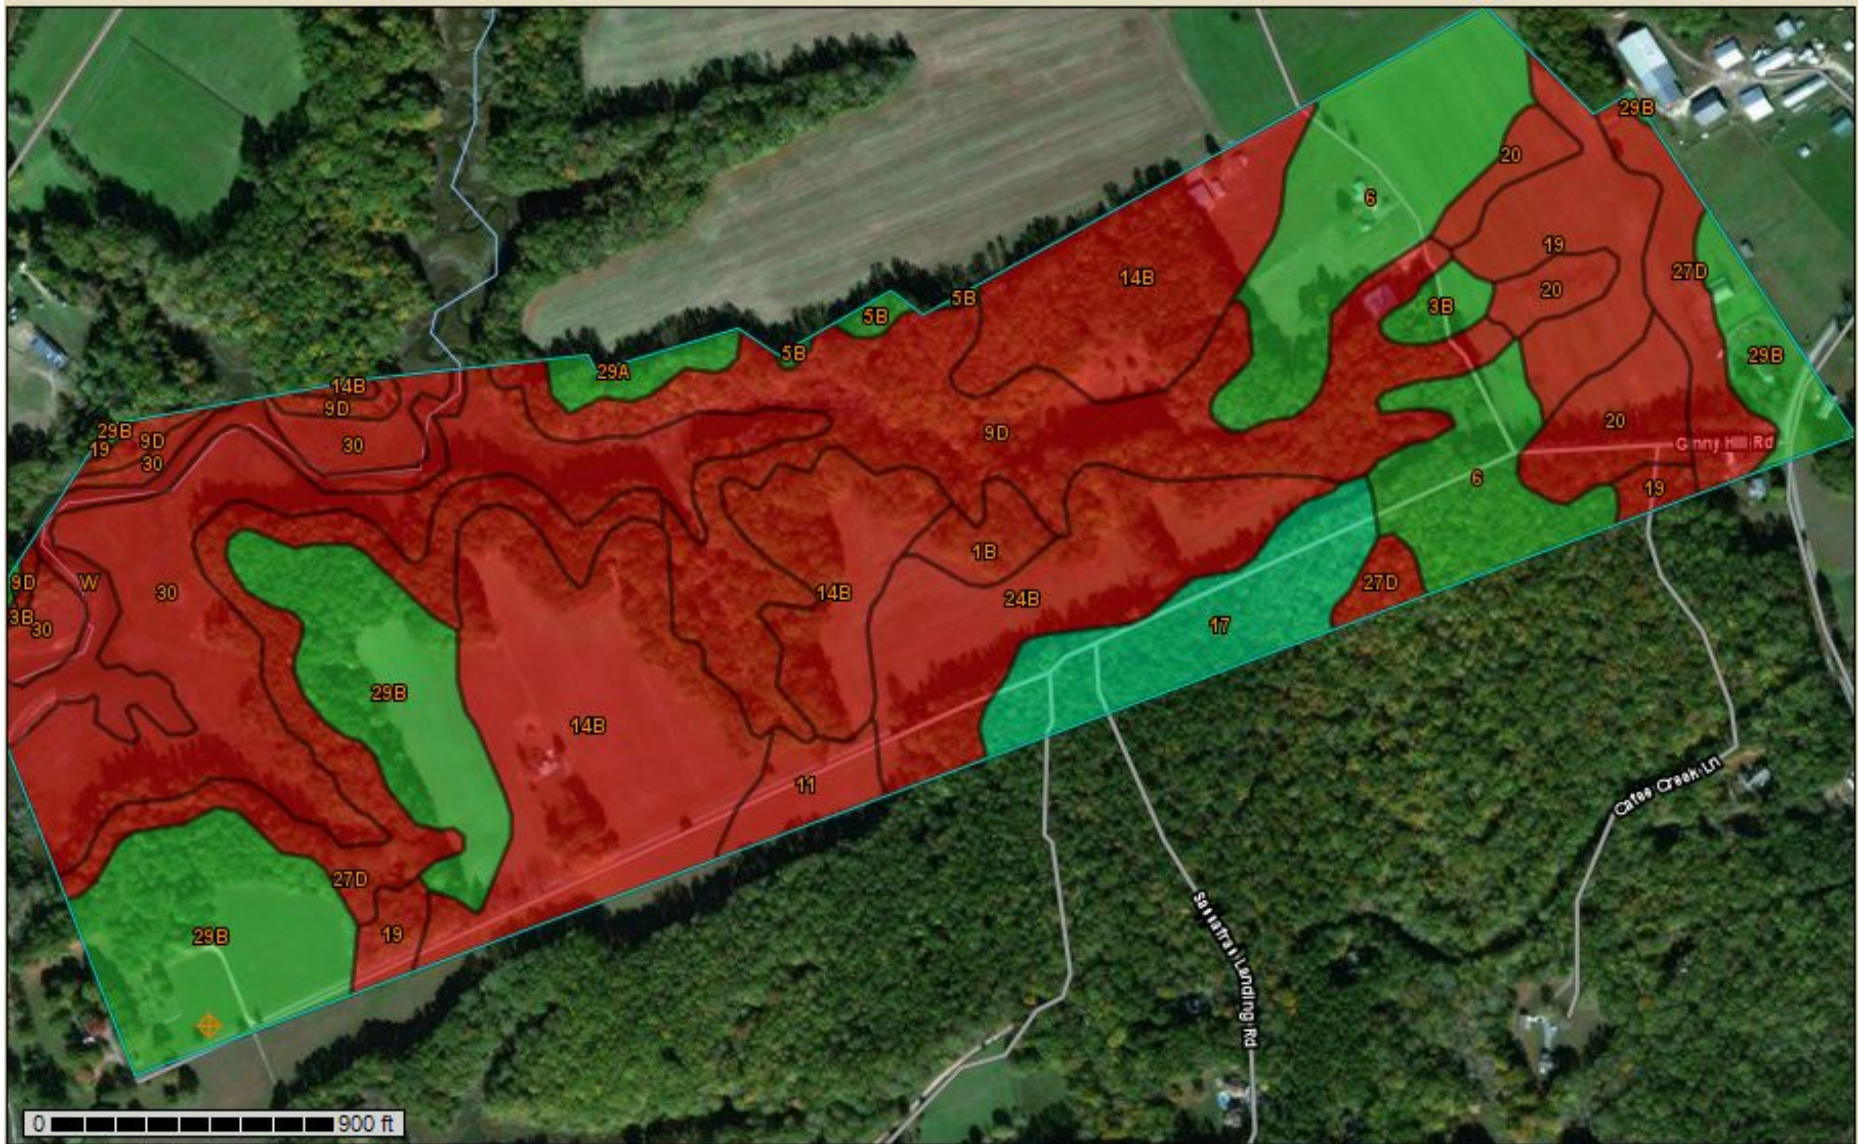
Figure 28: NRCS WebSoils Farmland Classification for WERO Leigh Creek watershed. Areas in red are not recommended for agriculture, areas in green are prime farmland, area in blue is prime farmland if drained. Soil classes W, 30, 27D, 9D, and 14B correspond to Leigh Creek in WERO, and 20 corresponds to the headwaters on the neighbors' property. All are not prime farmland.

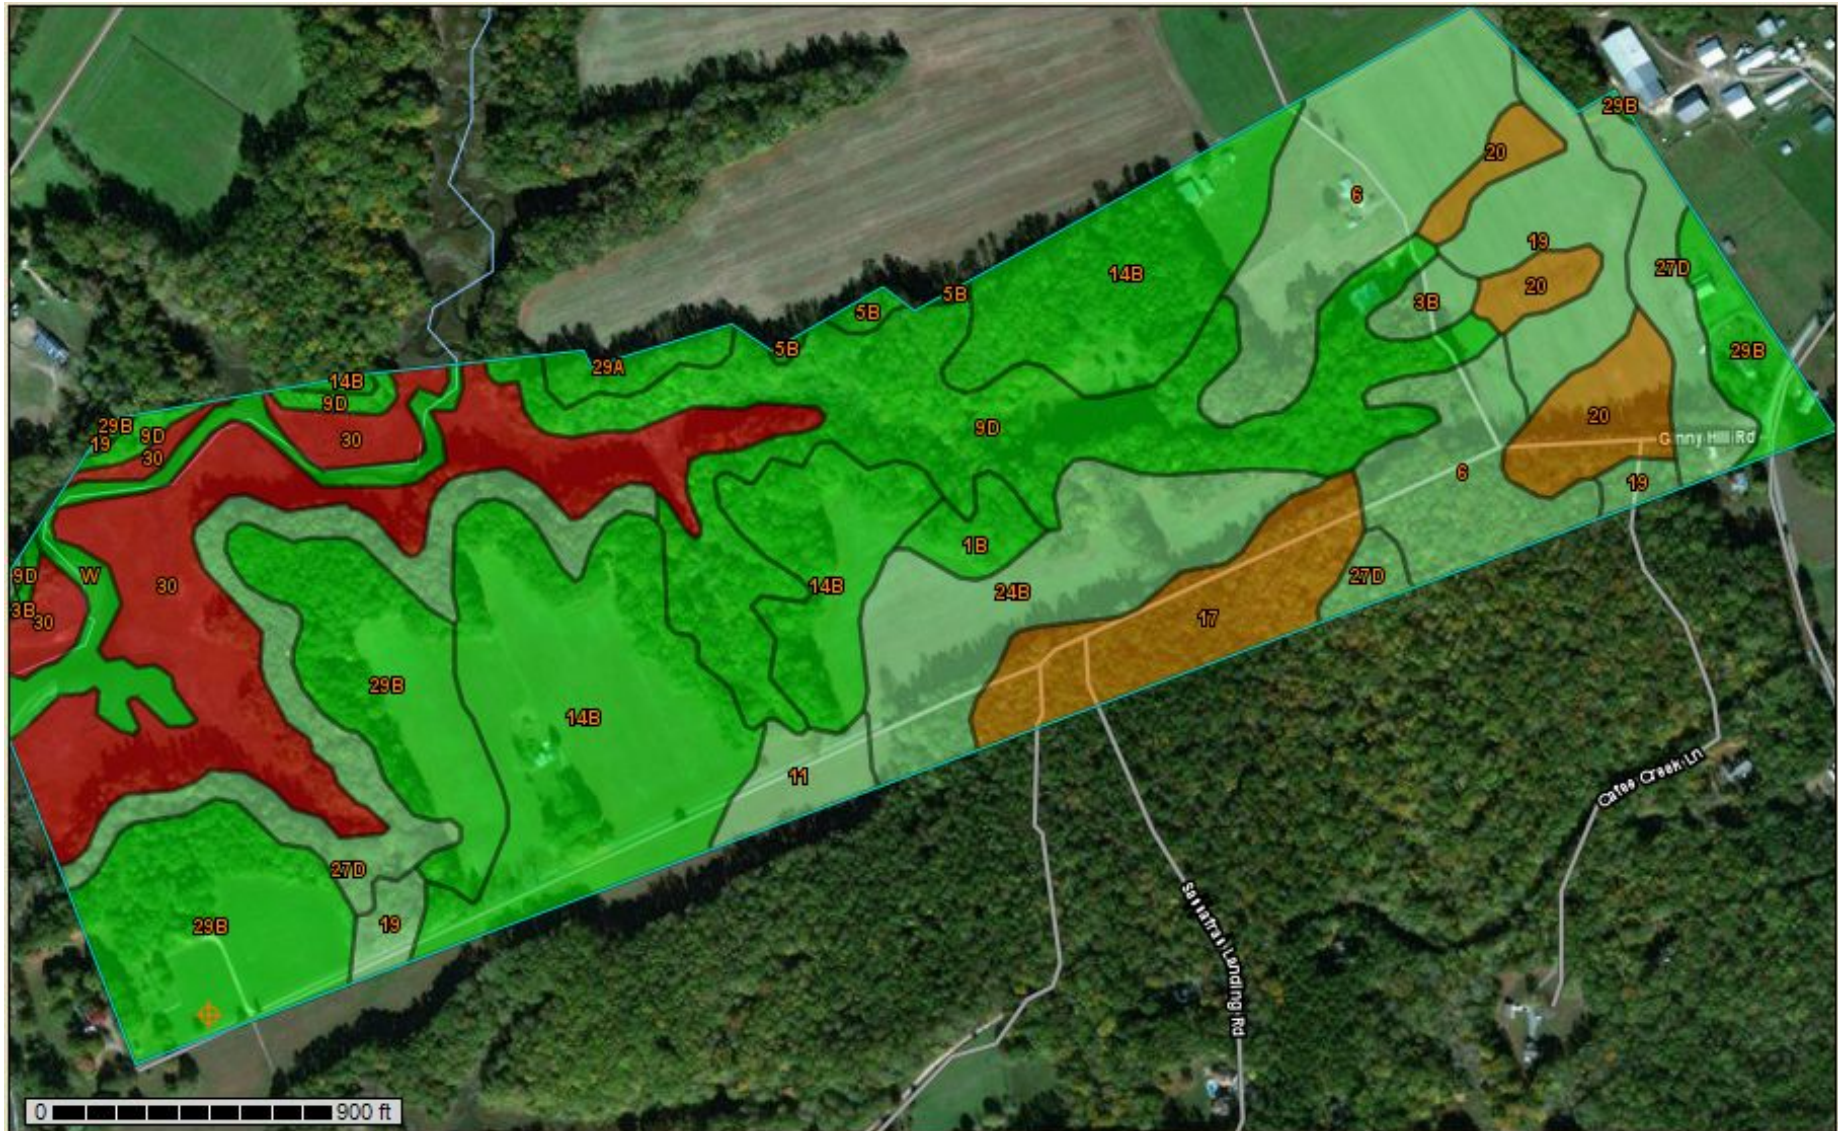
Figure 29: NRCS WebSoils Hydric Soils Classification for WERO Leigh Creek watershed. Areas in red are hydric soils, areas in green are not considered hydric soils, though the upstream wetland is included in these polygons which is why field soils data needs to be collected, areas in blue contain hydric soils in the mix. Soil classes W, 30, 27D, 9D, and 14B correspond to Leigh Creek in WERO, and 20 corresponds to the headwaters on the neighbors' property. Of these, only 30 is listed as Hydric Soil, 20 and 27D contain percentages of hydric soils. 9D and 14B are considered to not be hydric.

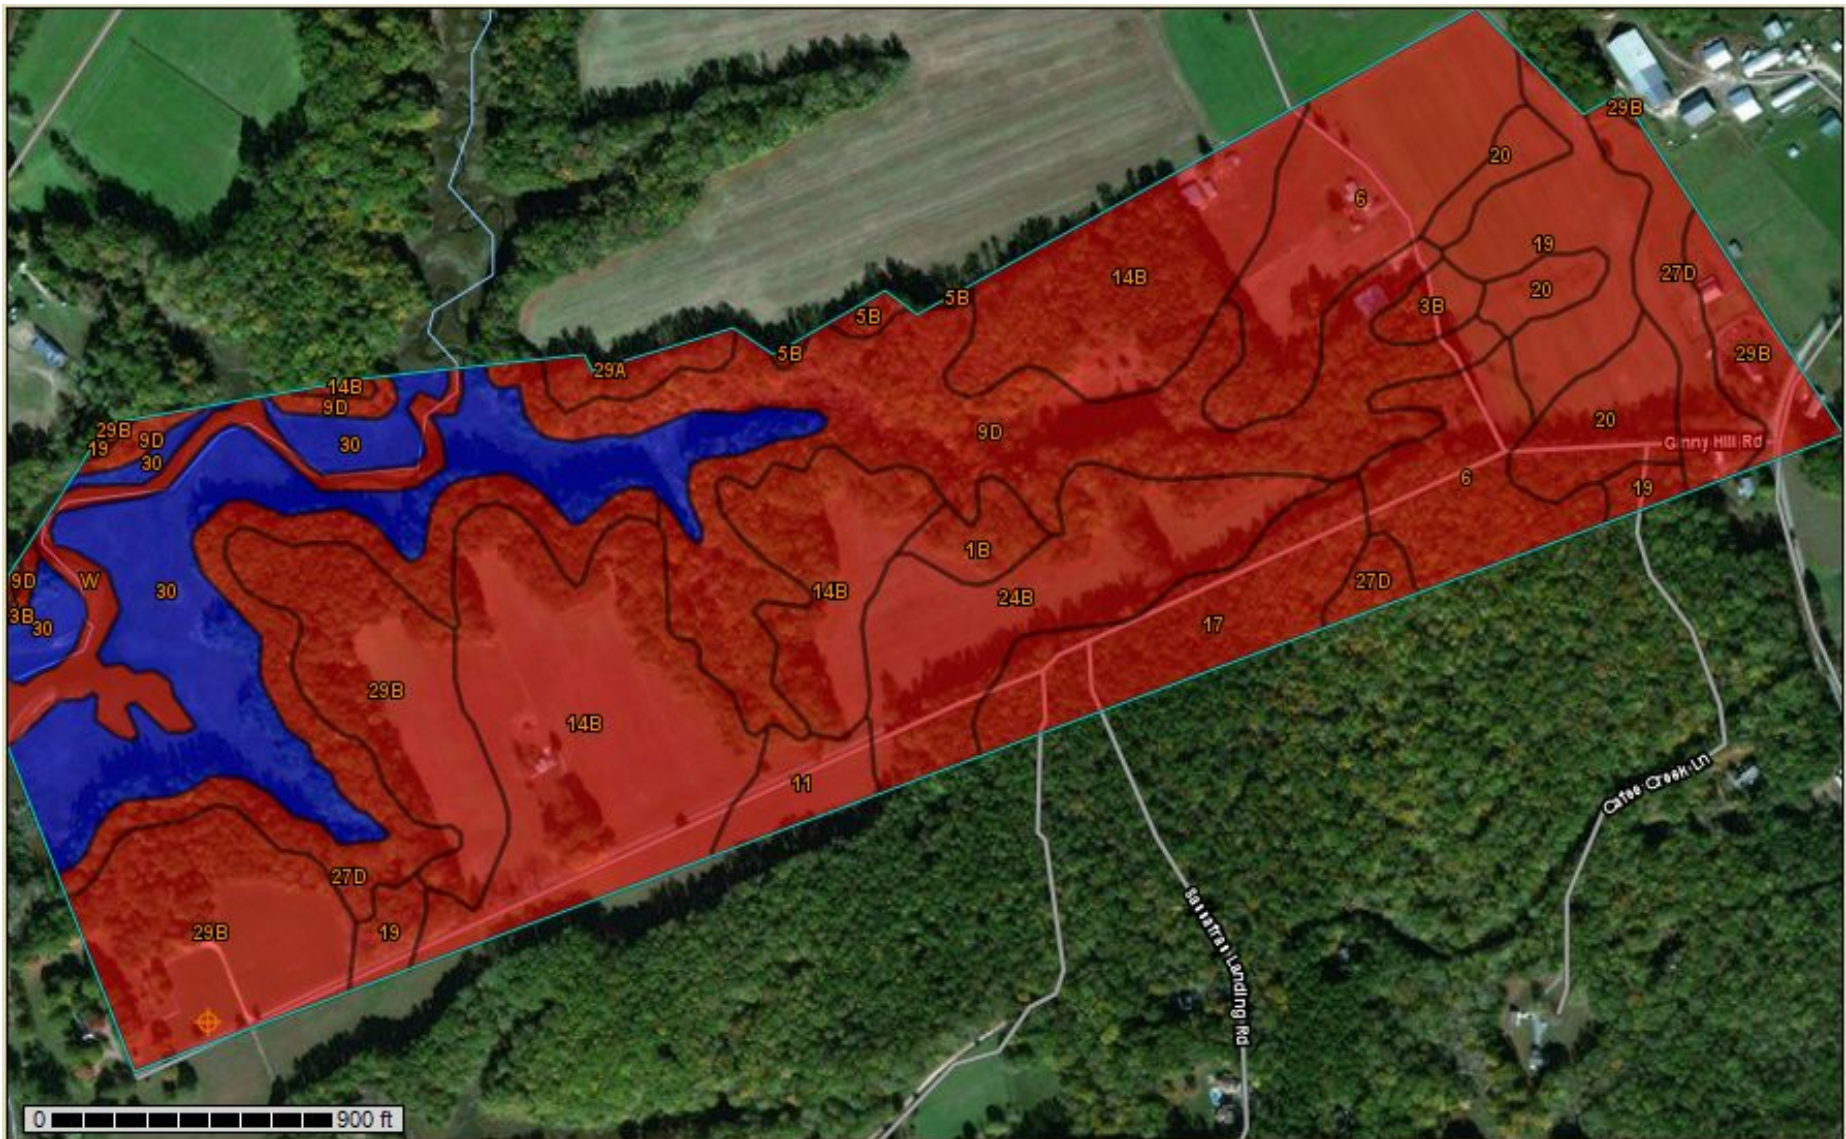
Figure 30: Flood Frequency Class. Soil classes W, 30, 27D, 9D, and 14B correspond to Leigh Creek in WERO, and 20 corresponds to the headwaters on the neighbors' property. 30 is frequently flooded, and corresponds to the SETuarine classes on the Wetlands Mapper (NWI 2.0)

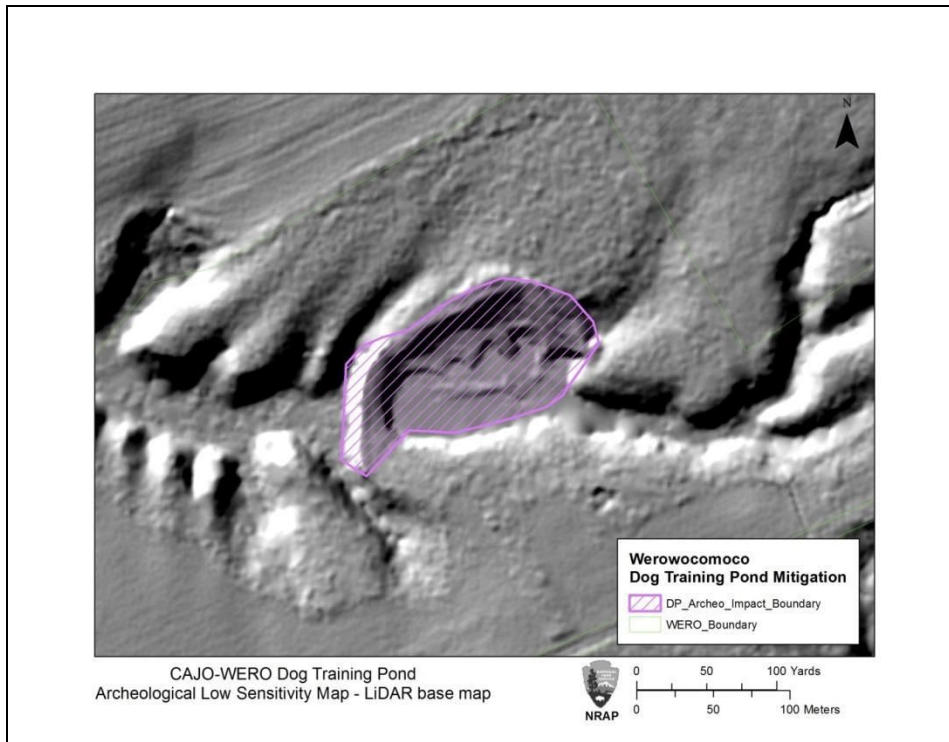
Figure 18 Area of low archaeological sensitivity that does not require archaeological monitoring overlain on bare earth LiDAR base map.

Removal of the culvert at the head of the pond (on the eastern end) can be conducted by removing the culvert pipes and the soil around them. It is likely that there is some sedimentation in the areas on either side of the culvert pipes, some of this can also be removed if necessary. The edges (sides of the drainage) of this area however should not be excavated without further inquiry to archaeological impact.
