## WERO Dam Removal and Habitat Restoration:

*Initial Wetland Delineation Trip Report and Planning Status Summary 9/22/2017*

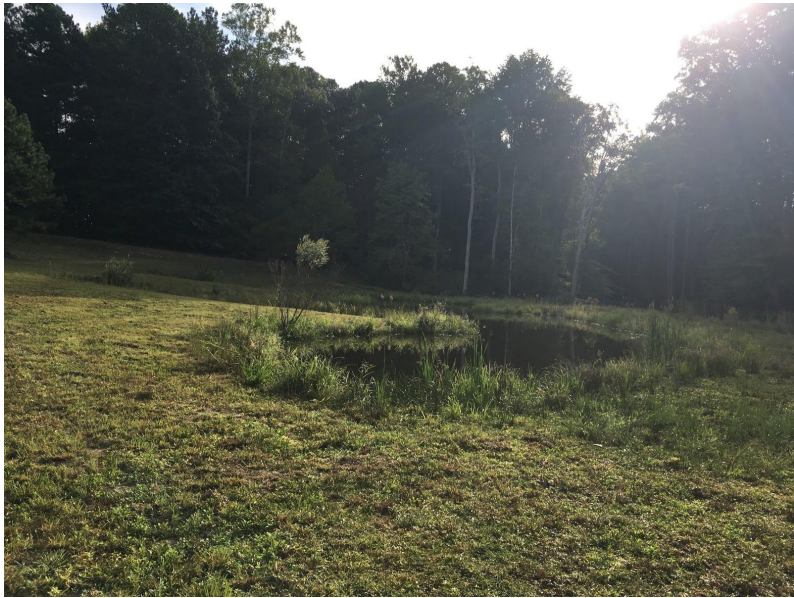
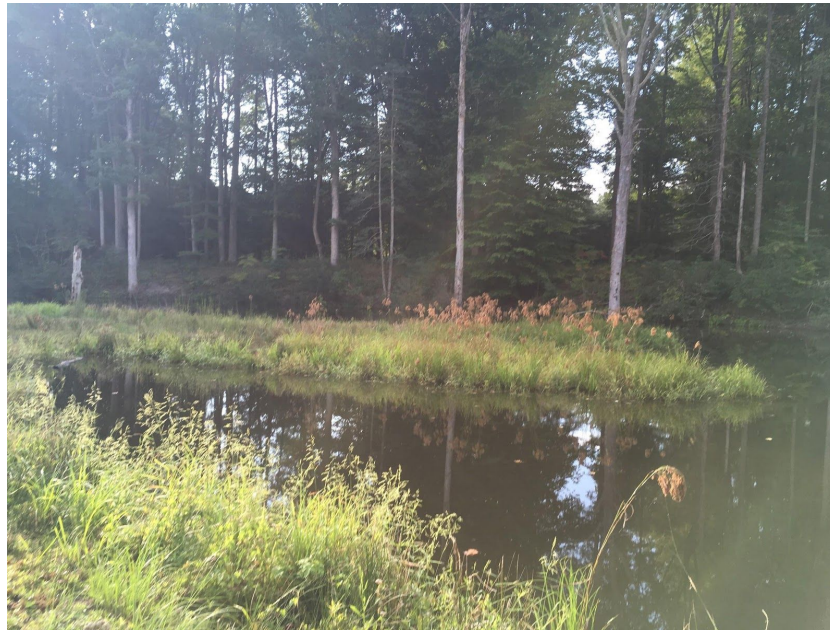
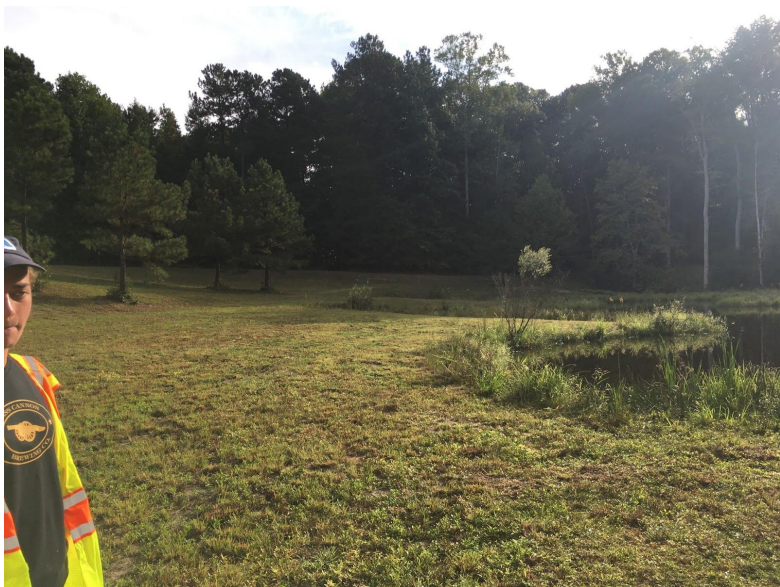
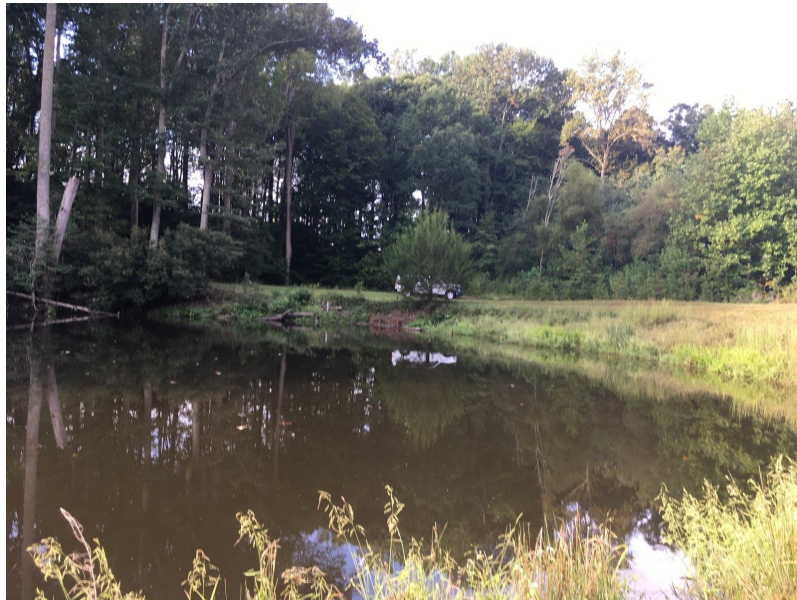
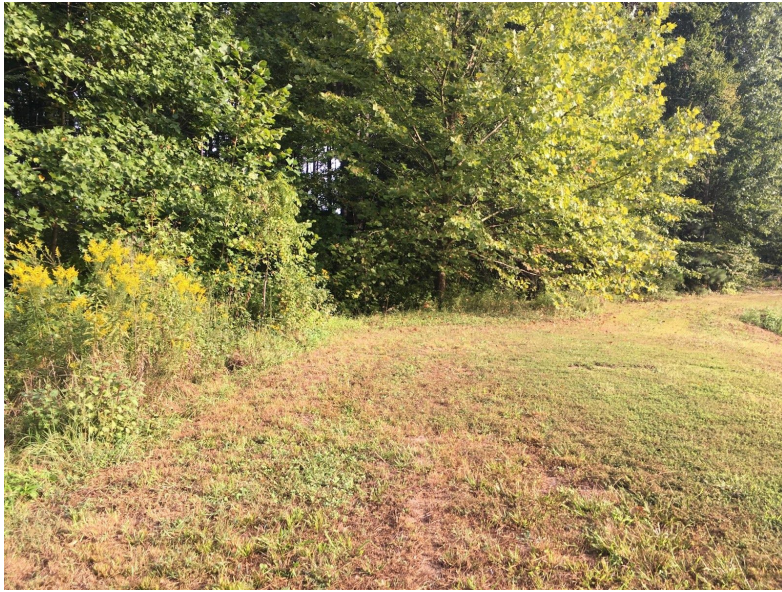
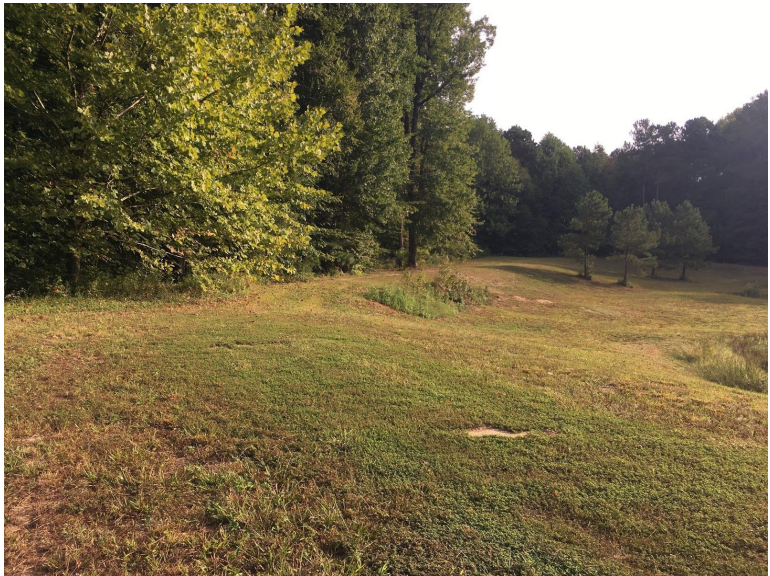
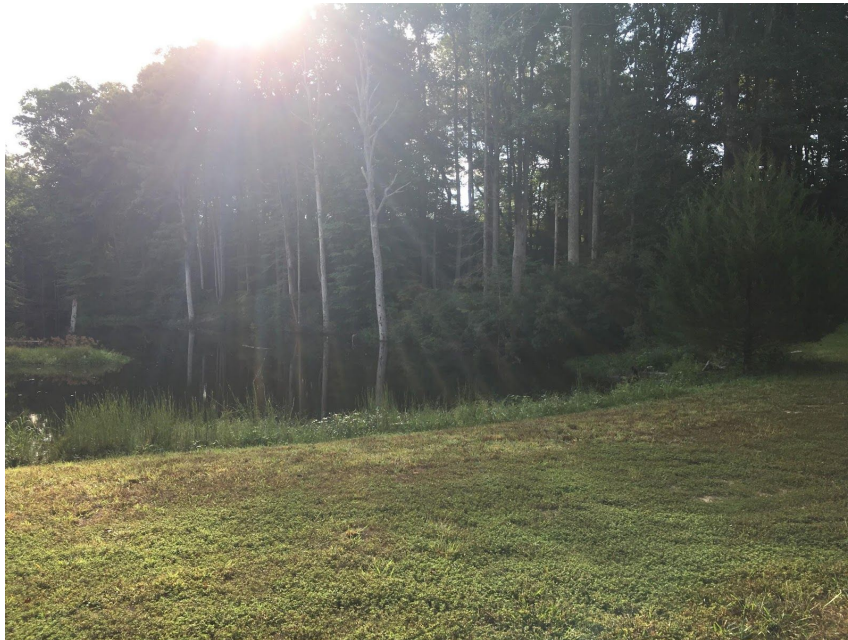
These areas are in place and protected under easement; subject to Chesapeake Watershed setbacks. Some along shore, but limited 3-10 meters, these should be widened as much as possible. Some of the area has been replanted in marsh grass. There is often a steep bank or areas where it has been undercut. The bank edge is forested and has shrubs, many of them may collapse with additional erosion. There are areas where buffer is missing.
