# Fort Barry Balloon Hangar and Motor Vehicle Sheds

## *Abbreviated Historic Structures Report*

Golden Gate National Recreation Area  
San Francisco, California

Produced by the Cultural Resources and Museum Management Division  
National Park Service

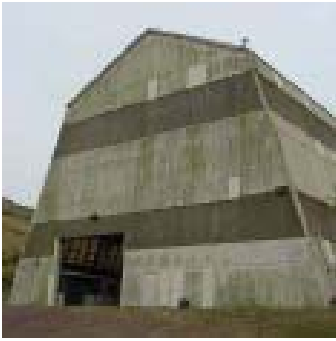
The north elevation of the Balloon Hangar showing the existing 15' x 20' opening and the two tiers of corrugated glass fiber sheets. (Jane Lehman, 2002)

Two rows of translucent, colored corrugated glass fiber sheets exist in place of the original windows. When the sheathing on the first tier was replaced, the window heights were doubled to approximately 9' tall. These sheets are in fair condition.

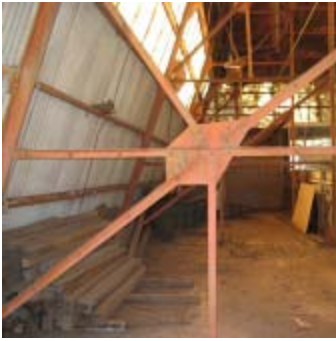
**Current Building** - The lowest tier of the Balloon Hangar siding is corrugated cement asbestos siding in approximately 3' x 6' sheets. They are 3/8" thick with a 4.2" profile in the corrugations. This siding is cracked and broken in many places and has a great deal of green algae on the exterior. Where sheets of siding have broken, an attempt to patch the surface with corrugated metal siding has been undertaken. The upper tiers of siding are the original corrugated asbestos coated iron sheets. These are generally in very poor condition.

An attempt is made to patch the asbestos board siding with corrugated metal siding of the incorrect profile. (John Martini, 2004)

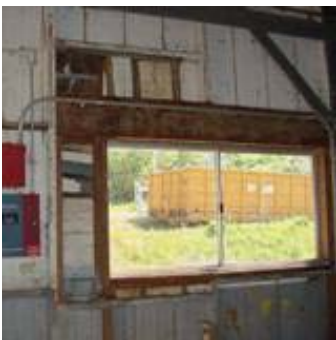
There was at least one wood frame, double-hung window in each end of the Vehicle Sheds. Several of them have been replaced with aluminum sliders of a different proportion than the original.

Aluminum sliding window installed in the area of former wood double-hung window. Note former rough opening. (Jane Lehman, 2004)

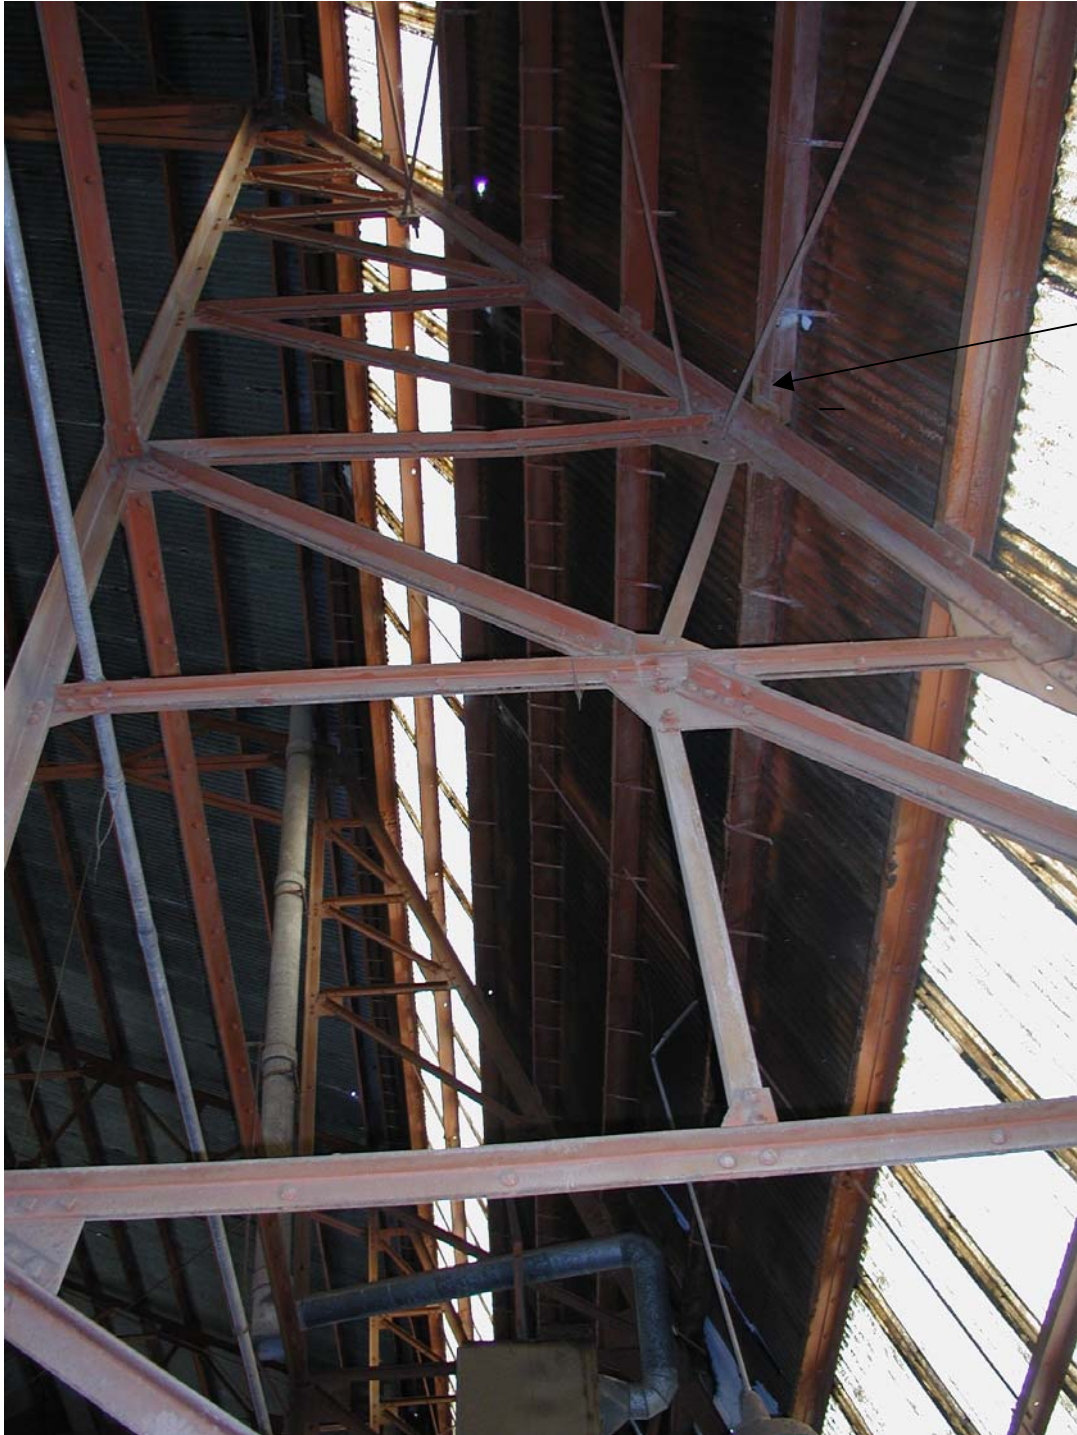
Typical Vertical Truss

1. Many rods in the braces resisting forces in the north-south direction are missing, greatly weakening the building.
2. Large eccentricities exist between the horizontal elements and the diagonal rod braces in the north-south resisting lateral braces. These can lead to severe damage.

Note:  
Eccentricity  
between rods  
and horizontal  
member

1. All missing rod bracings should be replaced. In addition, the eccentricity between the diagonals and horizontal elements in the north-south direction can be remedied by the addition of added horizontal pipe elements and new connectors for the rod bracing.
2. Added sag rods can be replaced on the south wall and members can be added to support these sag rods.
3. All damaged or missing cladding should be replaced. Refer to following report on architectural elements.
4. All sheet metal brackets should be replaced with welded stud bolts.
5. Heater supports should be strapped.
6. Cladding should be cut away from ground slab at corners.

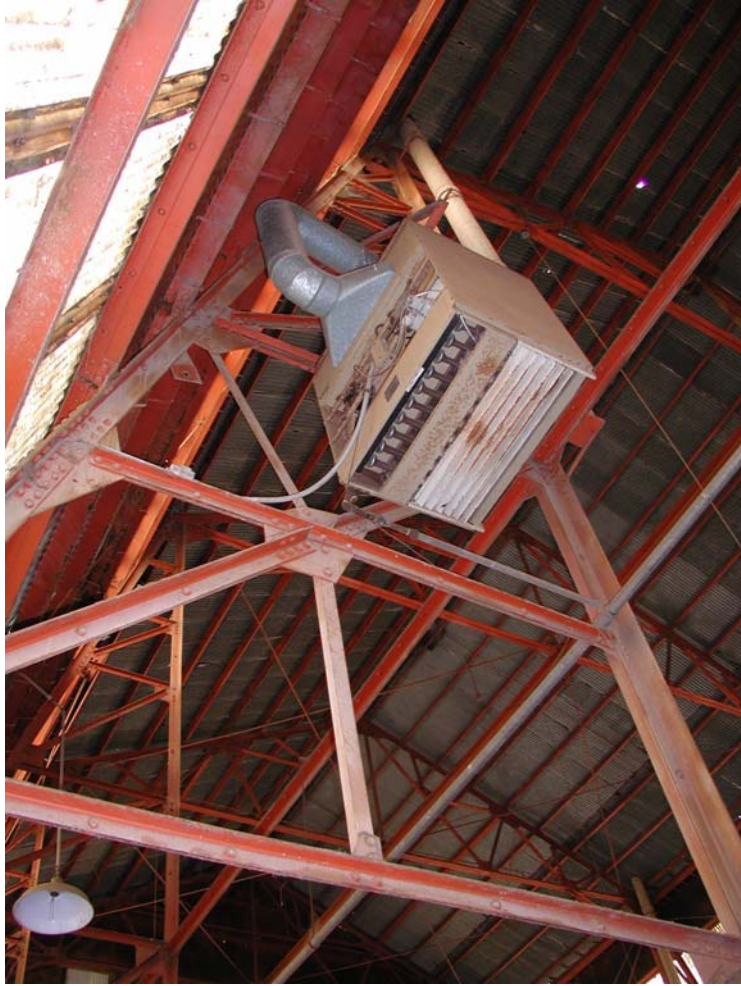
Suspended Heater

6. Attachment of suspended heaters is inadequate and is a falling hazard in the event of an earthquake.
7. Cladding bears on slab on grade, which causes damage if the building moves in wind or earthquake. This can be seen from the damage at the north-east corner.

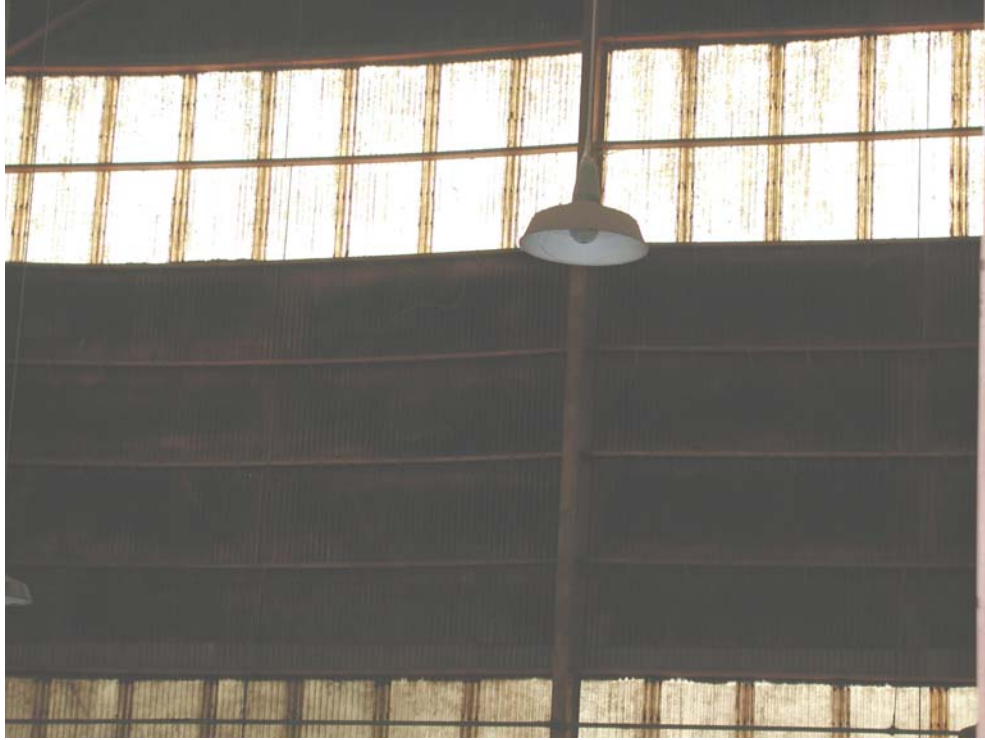
Sagging Wind Girts at South Wall

3. Sag rods and sag rod supports at the south wall are overstressed. This can lead to excessive damage to the south wall cladding, although the south face is the most sheltered.

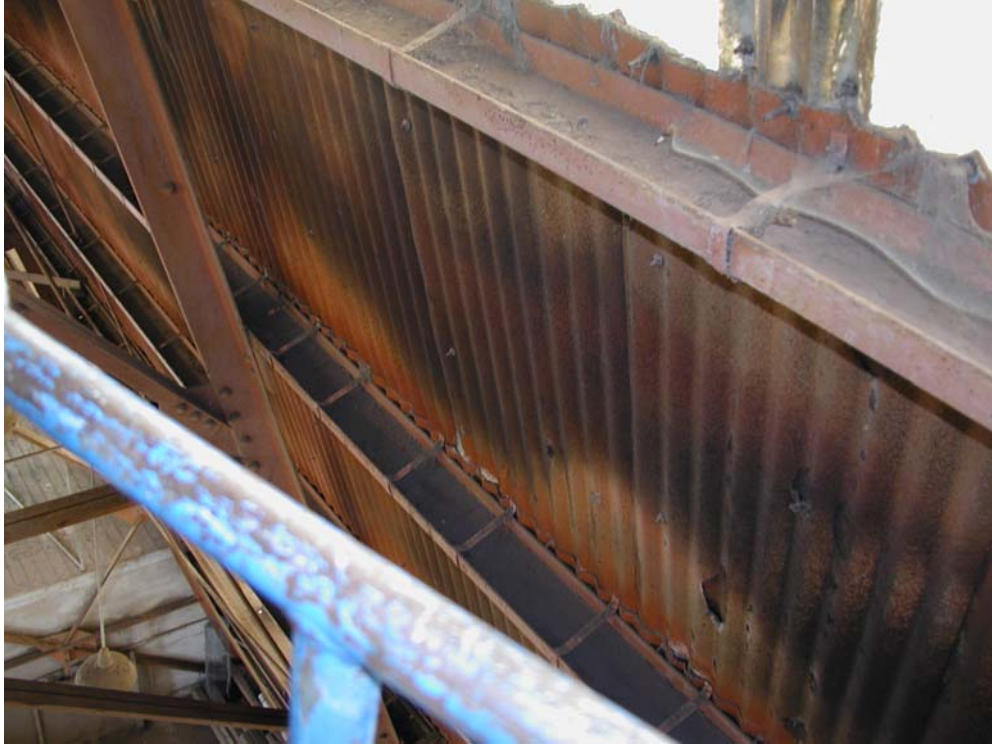
Wall Cladding Bracket Supports

4. Large areas of missing cladding can greatly increase wind loading leading to more damage.
5. The sheet metal bracket cladding attachment is too flexible and leads to damage.

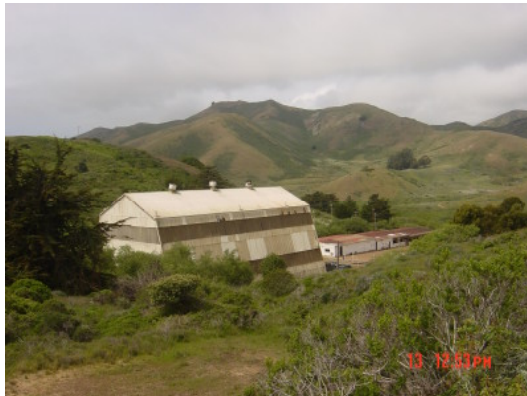
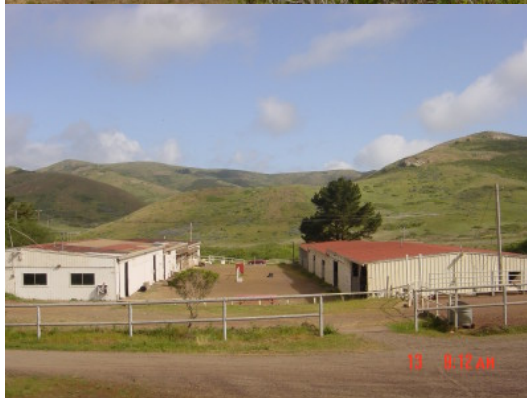
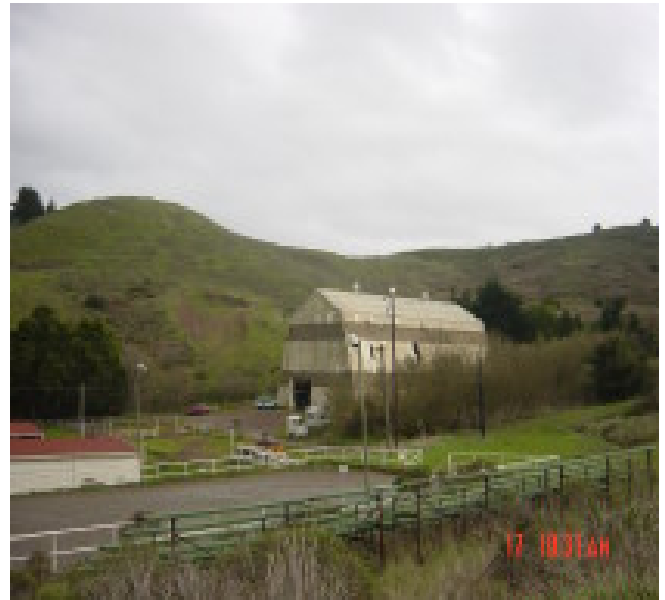
The vegetation has overgrown around three sides of the hangar and is right up against its back side, making it impossible to access for full visual observation.

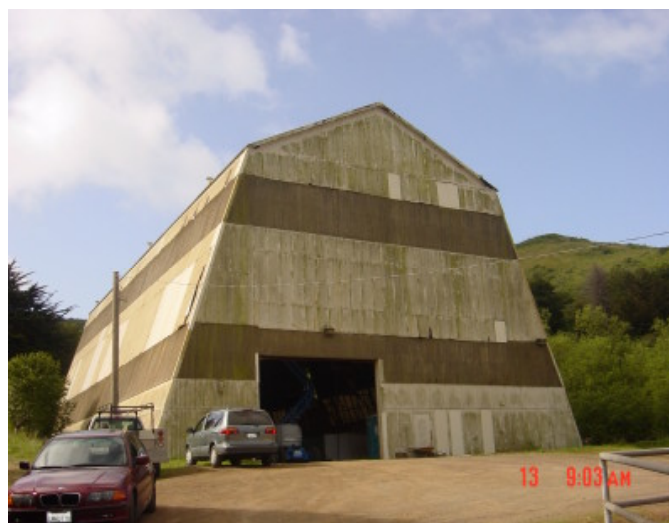
After 1953 to Present

There is a high degree of integrity associated with the Balloon Hangar original appearance and materials, with the notable exception of the large sliding doors that were modified in 1943. The only other major alteration of the exterior was done in 1953, when the original windows, sash and frames were removed and replaced with larger openings covered with fixed corrugated glass fiber sheets on all four elevations. The two 10'x12' warehouse-type hanging doors installed in 1943 are now missing.

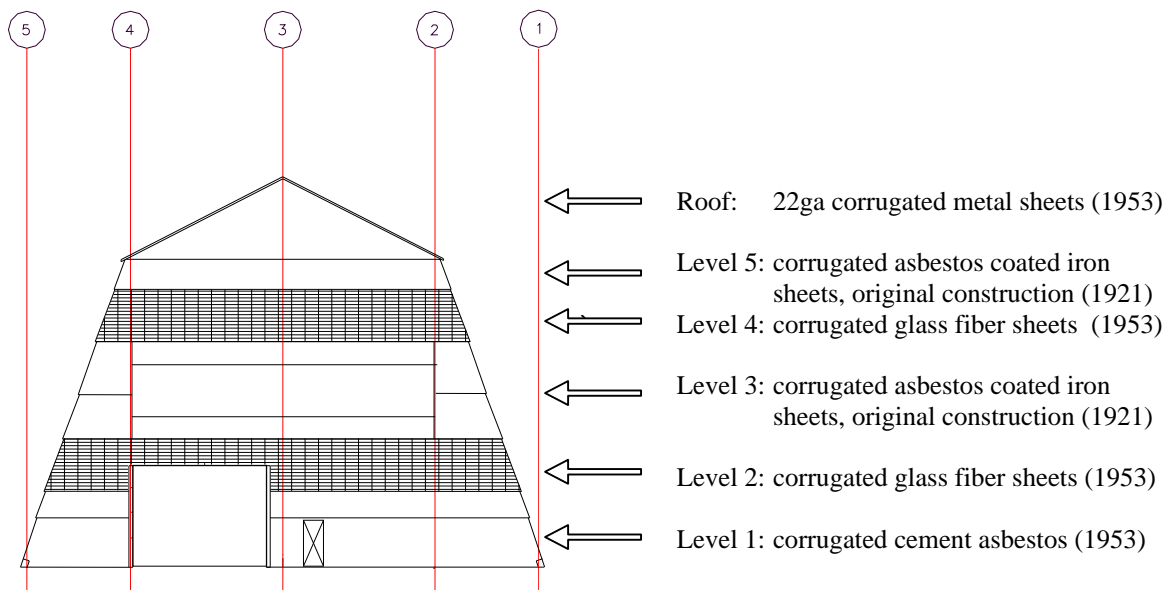
The corrugation radius of the asbestos/iron sheets at the upper levels is similar with that of the glass fiber sheets, but different than the base cement asbestos panels.

A thorough cleaning of the siding throughout is needed, as it appeared covered in rust and moss. (See NPS Hazardous Material Consultants for cleaning of asbestos containing materials).

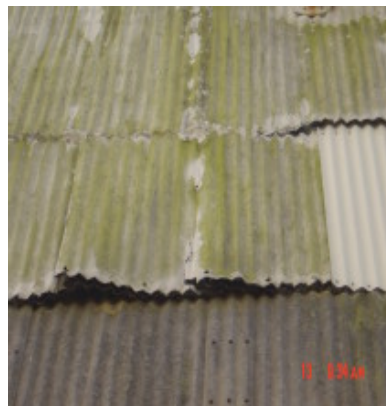
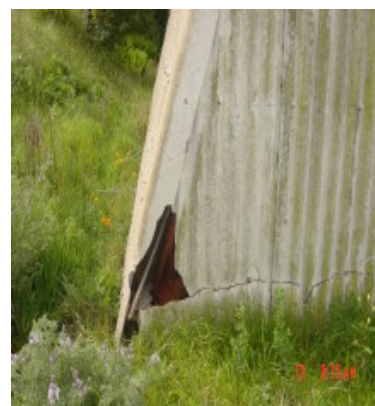
A few sheets at Level 3 became detached from structural brackets and buckled. The most extensive damage occurs at the bottom corners.

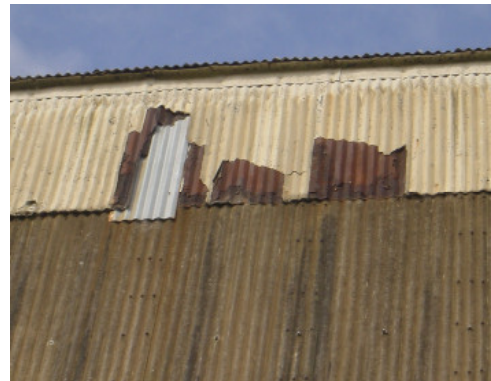
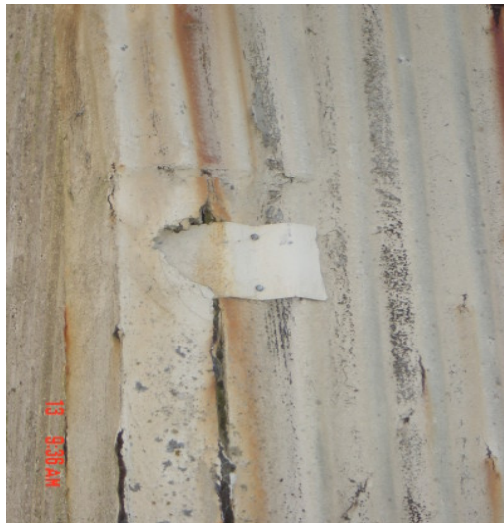
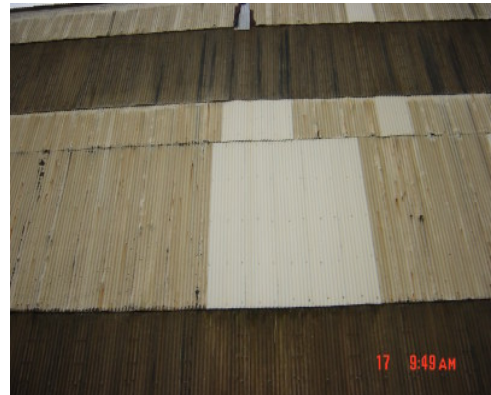
A few sheets at Level 3 became detached from structural brackets and buckled. The most extensive damage occurs at the bottom corners.

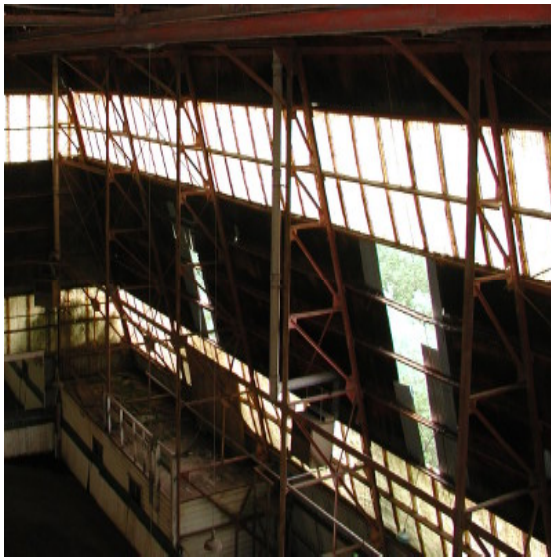
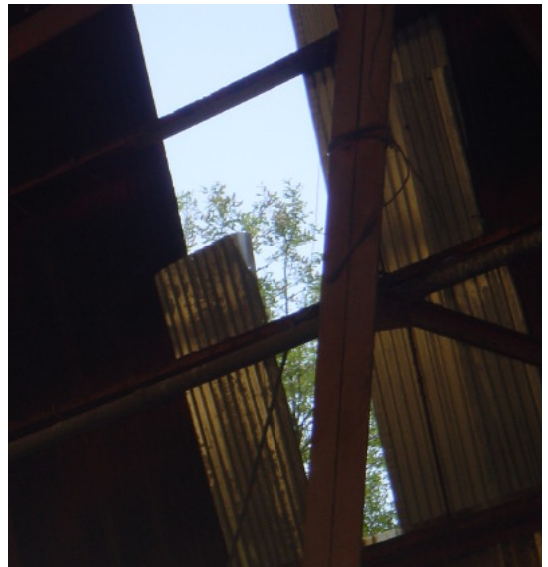
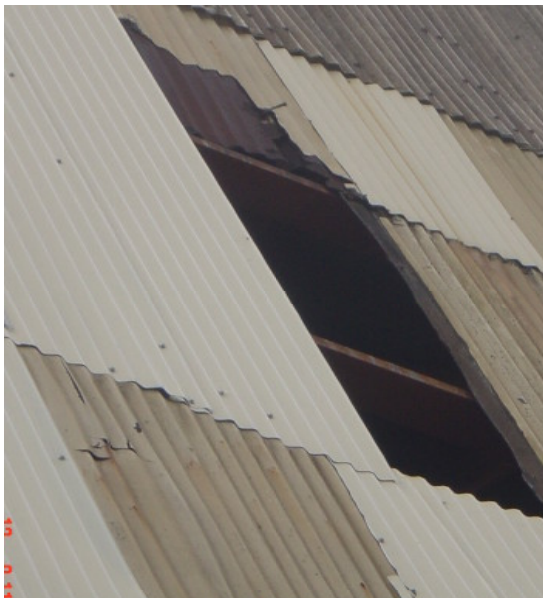
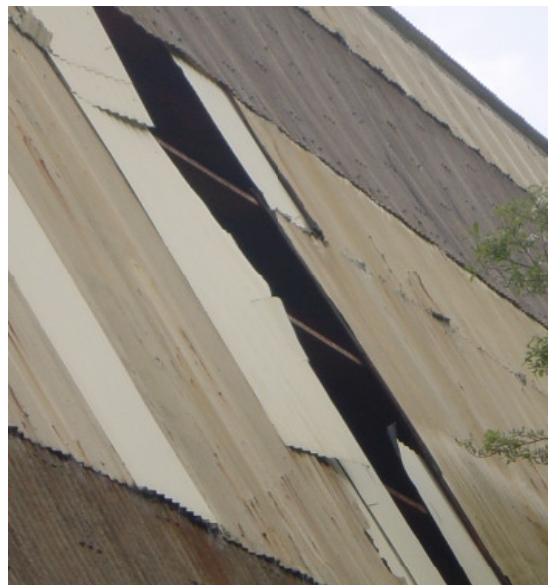
Presently, some remaining replacement panels are unstable and only partially attached to structure, thus constituting a hazardous condition, as they may fall down at any moment.

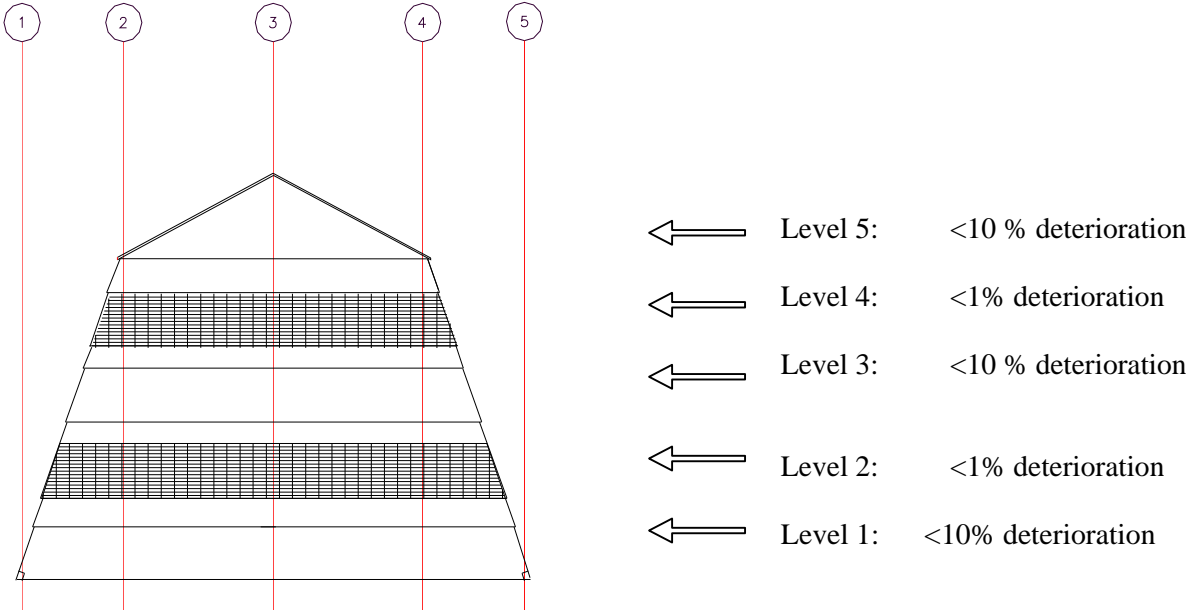
As illustrated by the photos above and insofar as the outgrown vegetation permitted full visual observation, the South Elevation presents the least damage.

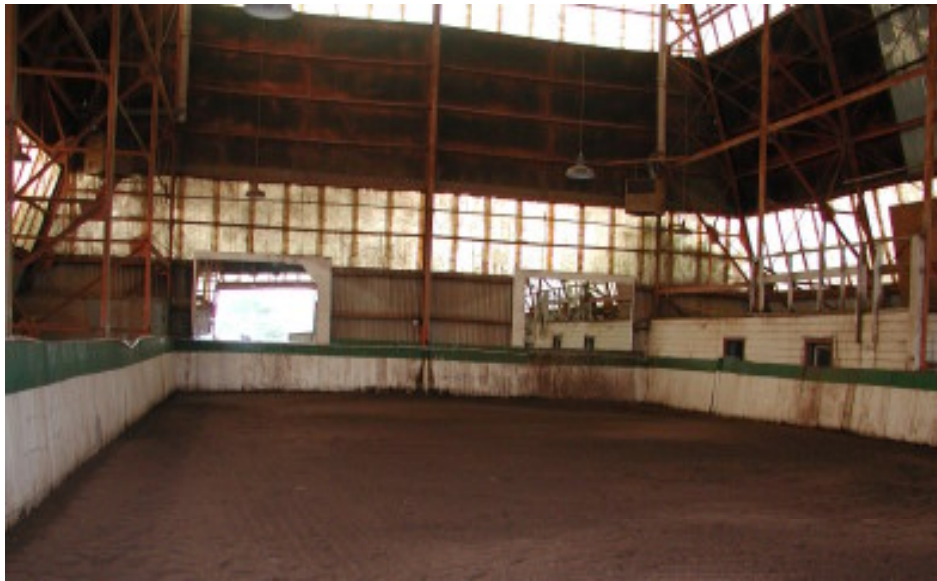
Visual observation from inside out was instrumental in assessing the limited degree of deterioration on this elevation:

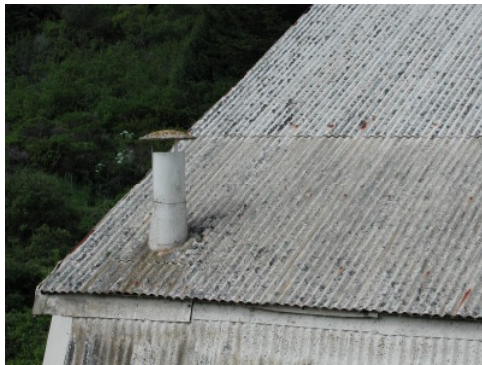
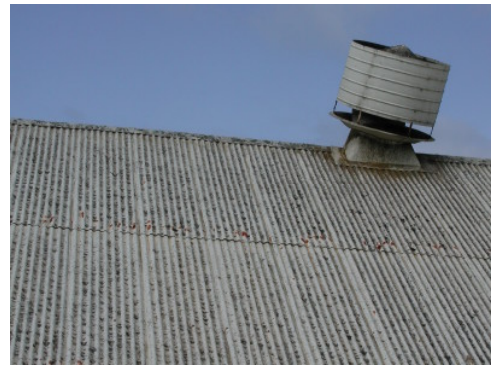
There are three large vents installed at the ridge and six smaller ones located at ridges, three on each side. There is no visible damage around them.

Visual observation from inside out was instrumental in assessing the roof's extent of deterioration: when looked at from inside, various size openings are visible, occurring mostly at seams, allowing water inside the structure. A larger amount of rust is present on the underside, primarily at seams. Past roof repairs are also noticeable.
