Aleutian World War II National Historic Area
Unalaska, Alaska

Fort Schwatka
Self-Guided Tour

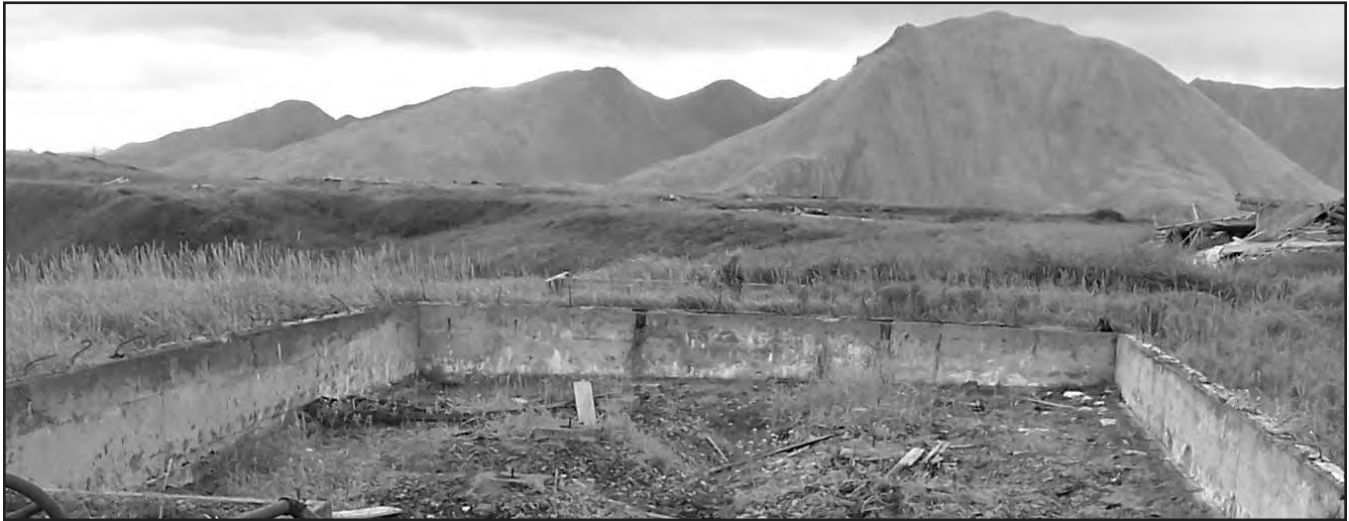
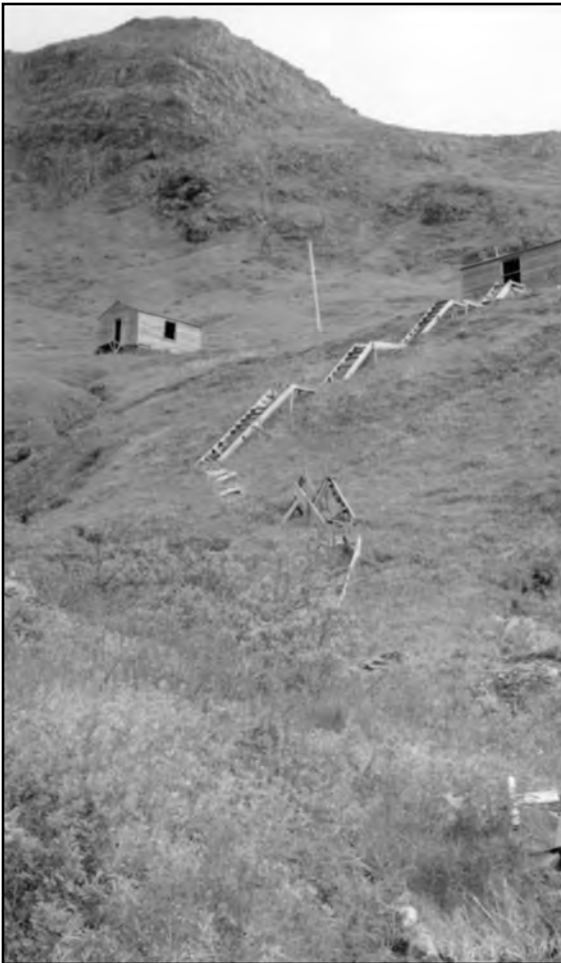
Stop 1

This is the remnants of one of four large barracks of Fort Schwatka (above). Of the four barracks, three housed sixty-three men each and one forty-five men. The opposite page shows one of Fort Schwatka’s wood framed barracks. The building design, typical for this era, is the Army’s standard 700-series architecture.

Across the valley, on a clear day, you’ll see the shadowy imprints of foundations on the steep hillside, tunnels used to access command posts, and rotting remains of the wooden staircases (left) that men used on wet and windy nights to reach their bunks.

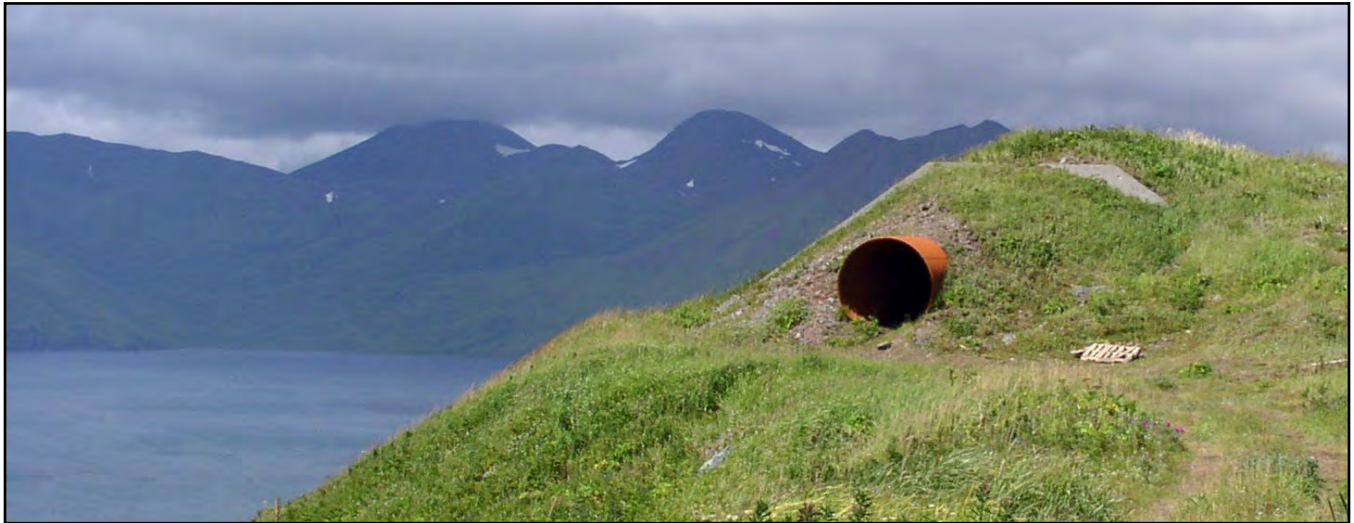
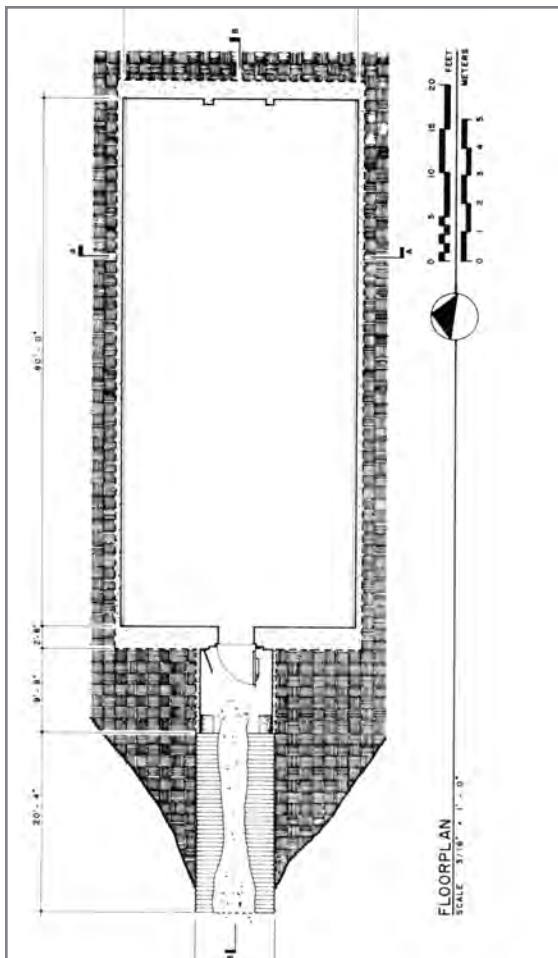
Stop 6

This munitions magazine is known as an “elephant steel” shelter or Armco hut. The shelter design is shown in the left diagram. These structures were built on a cement foundation with panels of heavy-gage corrugated steel bolted together and covered with soil. A turf covered bunker embedded in the hillside made it nearly invisible from the air. If a Japanese plane flew over, the pilot would see another contour on the mountainside. Other magazines are located at Stop 6a and 6b.

The magazine across the road from this stop is shown in the above photo. The historic photograph on the opposite page shows the same shelter prior to being covered with turf. In this photo it is easy to see the concrete walls and heavy metal doors designed to protect it from a nearby bomb blast.

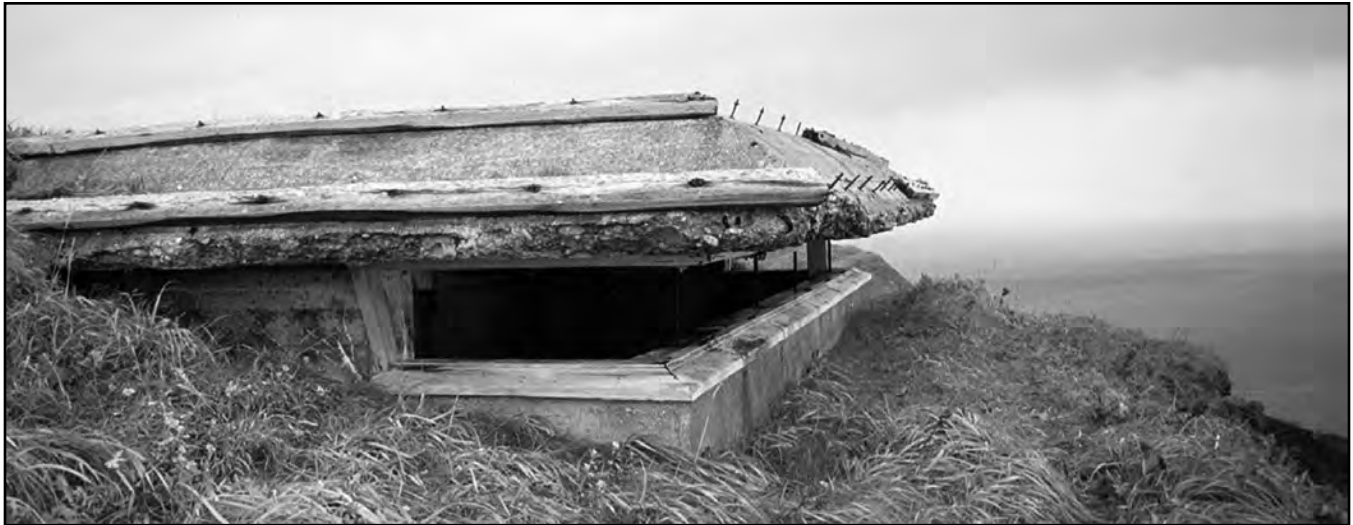
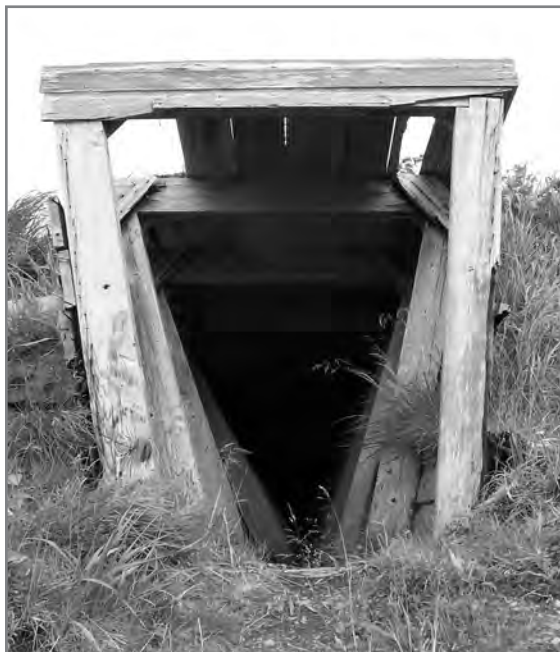
Stop 7

This is the Harbor Entrance Command Post that was constructed in 1943. Soldiers used the tunnel (below) to access the underground operational center and the embedded observation post (above). *Please use the trail to the left of the tunnel to travel to the observation post.* Traveling through the tunnel and into the underground facility is unsafe.

The underground command post was entirely self sufficient with its own power, ventilation, and plumbing. Protecting it were heavy wooden blast doors (opposite). Contained within were a radar, plotting and intelligence rooms, and chemical warfare service equipment. A steep stairway connects the below ground center to the observation post. An airlock manhole door separated the two areas and would have provided some measure of protection from chemical agents.

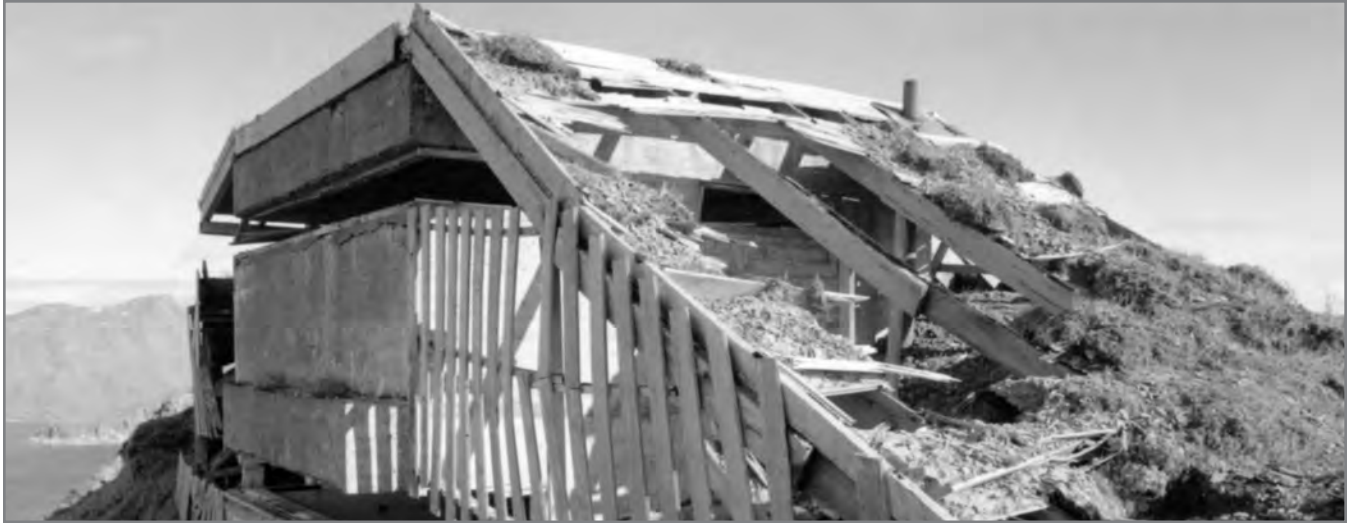
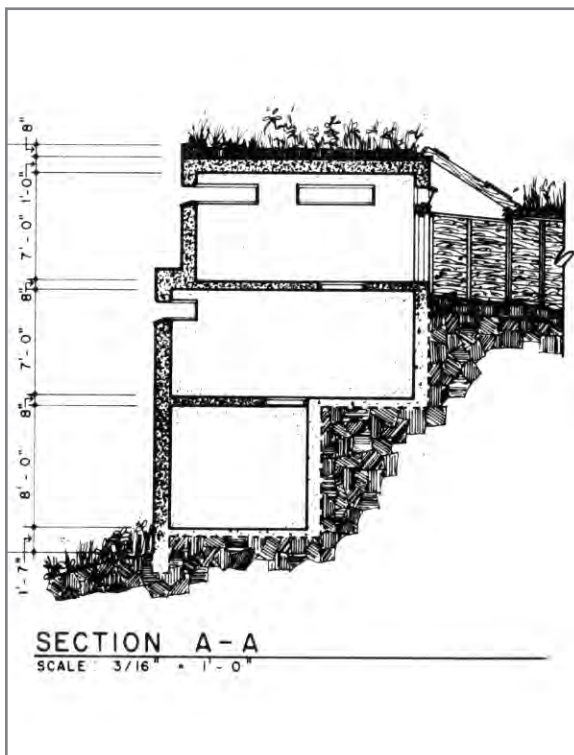
Stop 8

Battery 402 complex was completed in January 1944 and was assigned its sequential construction number which was “402.” This is the Battery Command Station and one of the base end stations of the battery (above, left, and opposite). On the upper level the Battery Commander would coordinate all operations of the battery including target acquisition, targeting priority, ammunition type, and firing orders. Directly behind the base end station is what remains of the state-of-art SRC 592 radar room and the once earth covered tunnel that leads to the concealed below ground plotting room.

On the lower levels of this base end station spotters using an M1910 Azimuth instrument would scope and train on the target and feed information to the engineers in the plotting room located down the hill and across the road (Stop 8a). The engineers in the plotting room would use this data to triangulate on the target, obtain its range and then telephone these coordinates to the 8-inch gun battery station.

Radar provided the battery with target tracking information when visibility was poor due to weather or darkness. This was one of two radar stations at Fort Schwatka; the other one was at Stop 7.

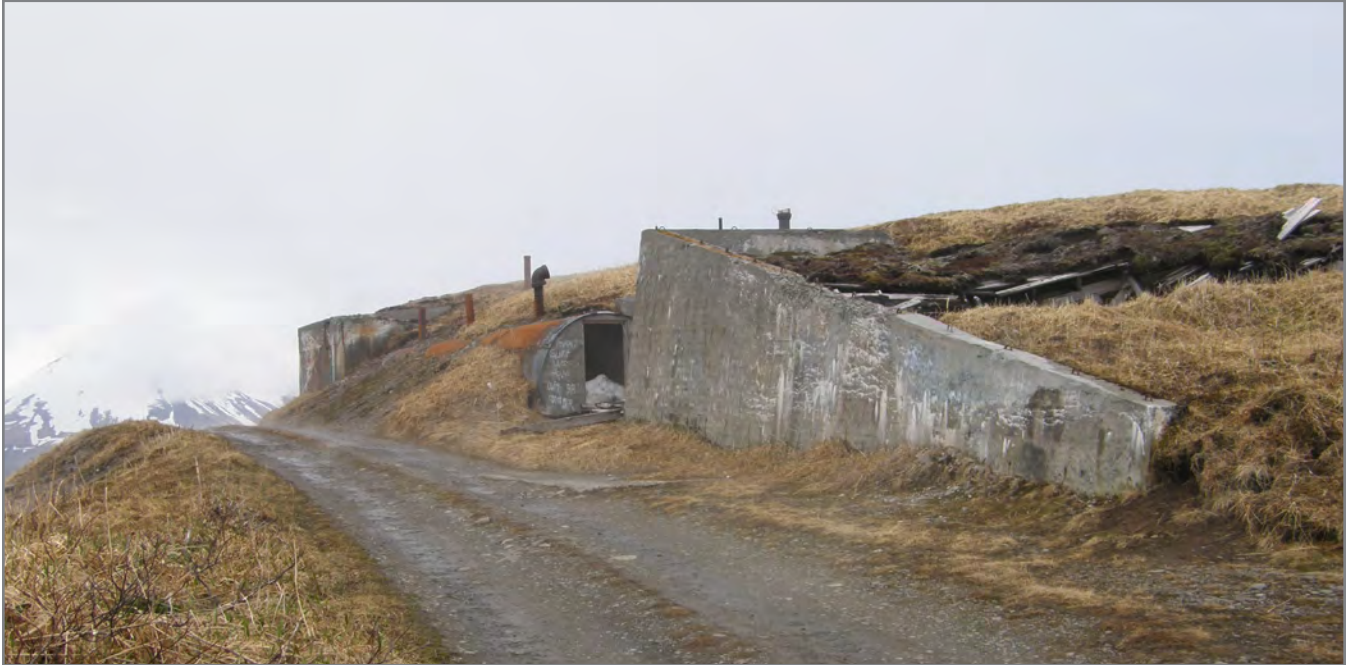
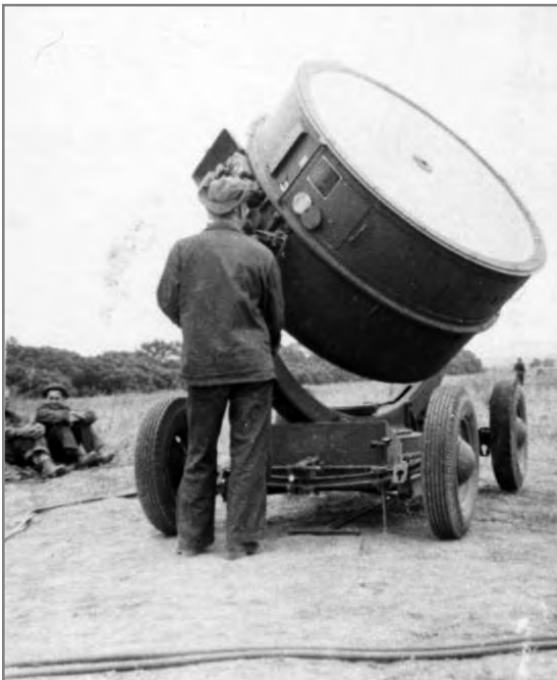
Stop 9

This is the magazine complex of Battery 402 with its two 8-inch gun platforms. The horseshoe design with the connected sod-covered roadways (opposite lower) supplied both guns. The ammunition needed for immediate response was stored on the cement shelf of the ready ammunition room, located in the middle of the corridor (opposite upper). Using carts, shells were wheeled through the thick wooden blast doors to the gun positions at the end of each roadway. Powder sacks were stored in the central room and fuses in another.

The semi-circular quonset room (left of the right side entrance to the battery) was the quarters for the ready crew who manned the guns. Entirely self sufficient, an interior latrine was provided for the ready crew. Two diesel generators housed in a separate room supplied backup electricity to the entire battery including the guns and searchlights (left).

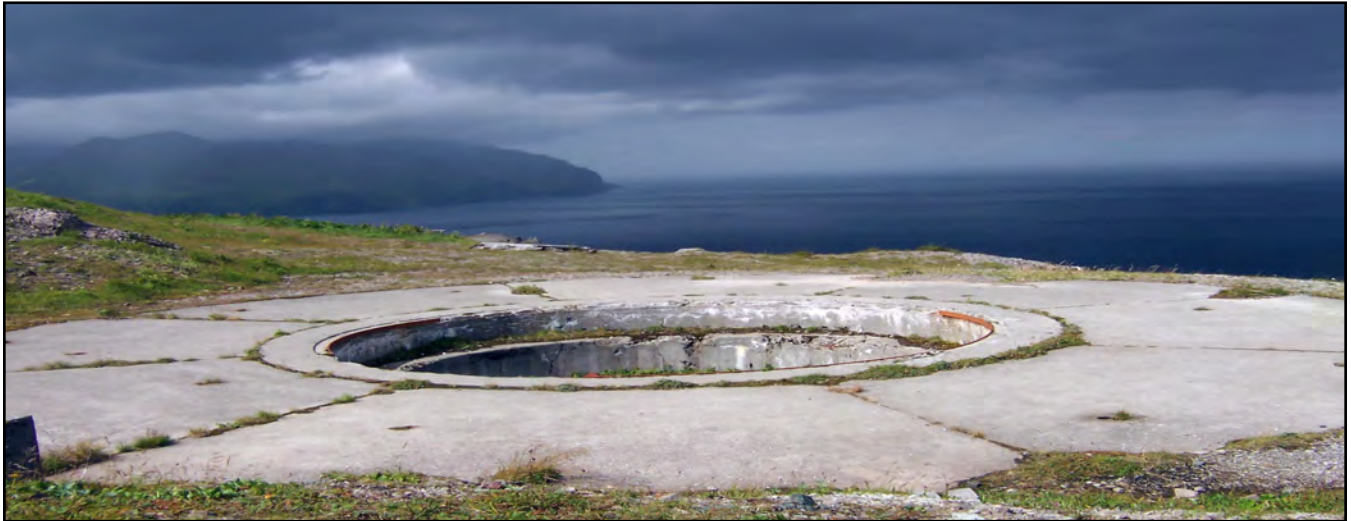
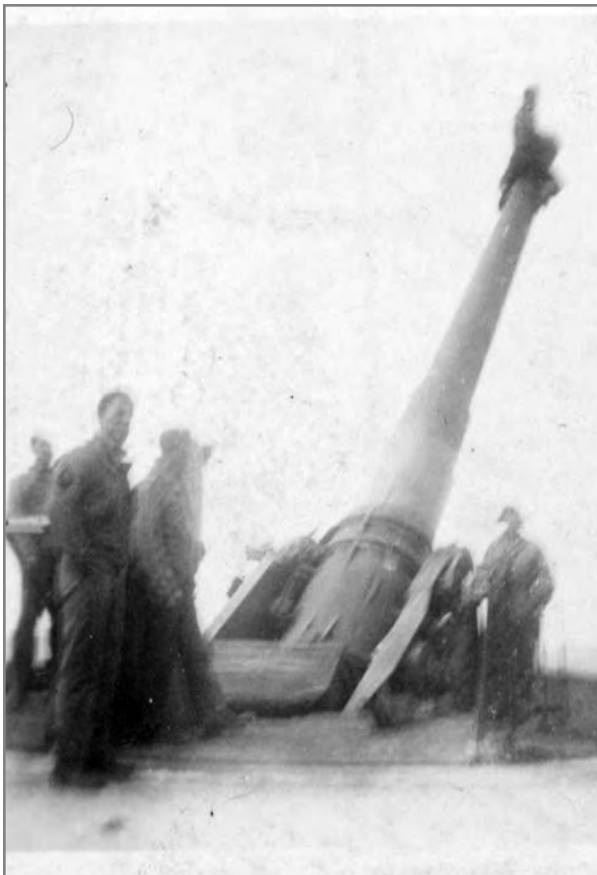
Stop 10

The circular concrete platform directly in front of you is a barbette carriage. This mount is for one of the two 8-inch guns of Battery 402; the other shown in the above photo is on the opposite side of the battery. These 8-inch guns were the largest caliber weapon in the “iron ring” defense. The huge MkVI, Mod 3A2 gun was 30-foot long and weighed 51.5 tons. These guns could fire a 240-pound shell up to 22 miles, dwarfing the range and power of the older 155mm guns that it replaced.

The gun was mounted in the center of the platform (opposite). The nearly 10-foot deep bowl provided space for ballast necessary to balance the cannons heavy barrel. The circular shape gave it a full 360 degree rotation. Notice the narrow table directly behind the gun barrel; this is the ammunition loader (these loaders are now in the semi-circular quonset hut of Battery 402). The shells were carried from inside the battery on wheeled carts, then placed on the trough and rammed into the gun barrel. Manned by the Battery “A” of the 264th Coastal Artillery each gun had a 25 man crew (left).

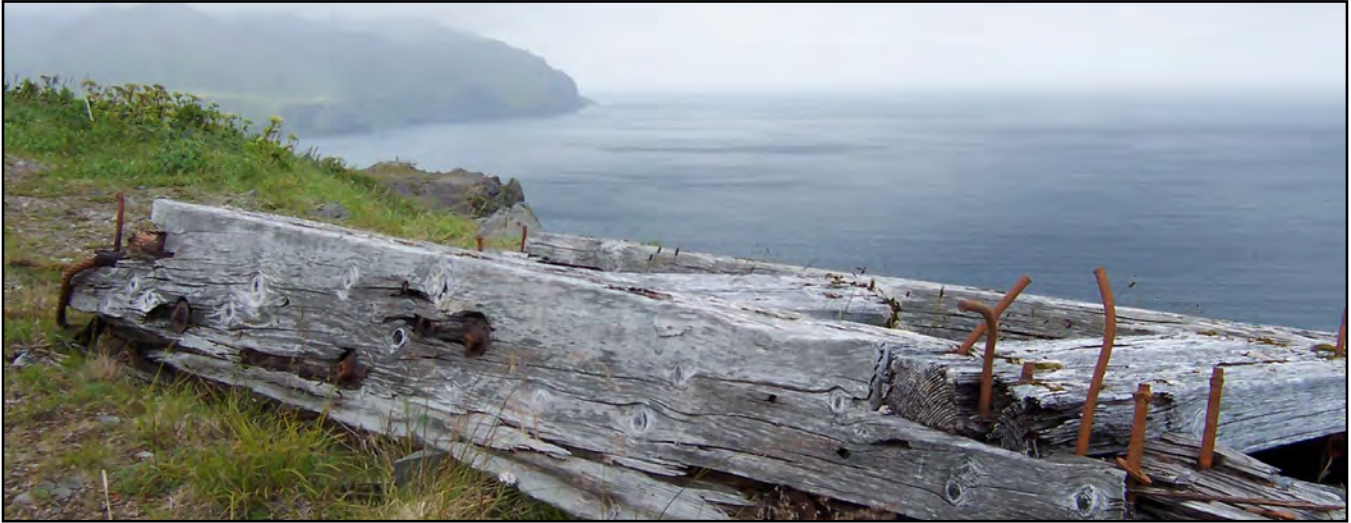
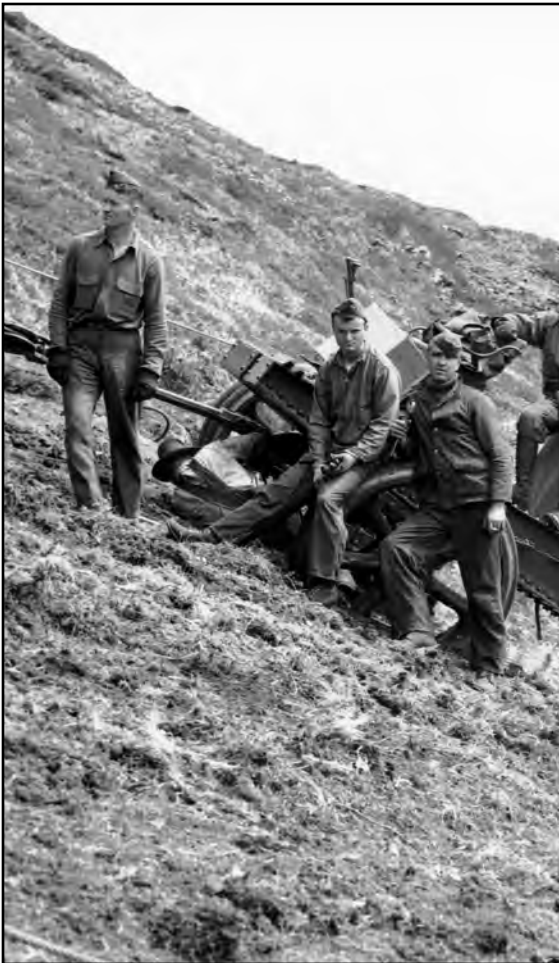
Stop 11

In summer 1941, for the initial defense of Dutch Harbor, this sled (above) was used to haul materials up the slope of Ulakta Head. The photos (opposite and left) show a heavy 13-ton 155mm gun moved up the steep slope. On the beach of Dutch Harbor, by the park entrance, a large engine mounted to a frame would winch the guns and sleds up the slope by using cable running from top to bottom. At the top of the slope a firmly anchored sled called a “donkey” held the cable (below). When the winch rolled the cable in, the sled moved up the steep slope. Later that summer, as Fort Schwatka developed, construction of the road eased the burden of transporting materials to Ulakta Head.

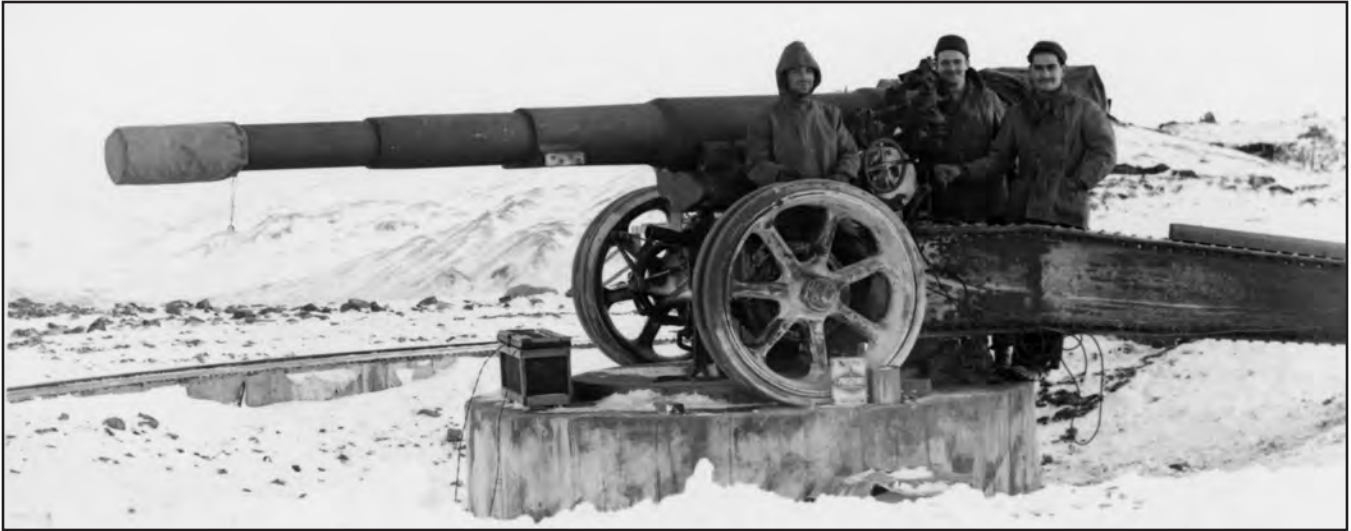
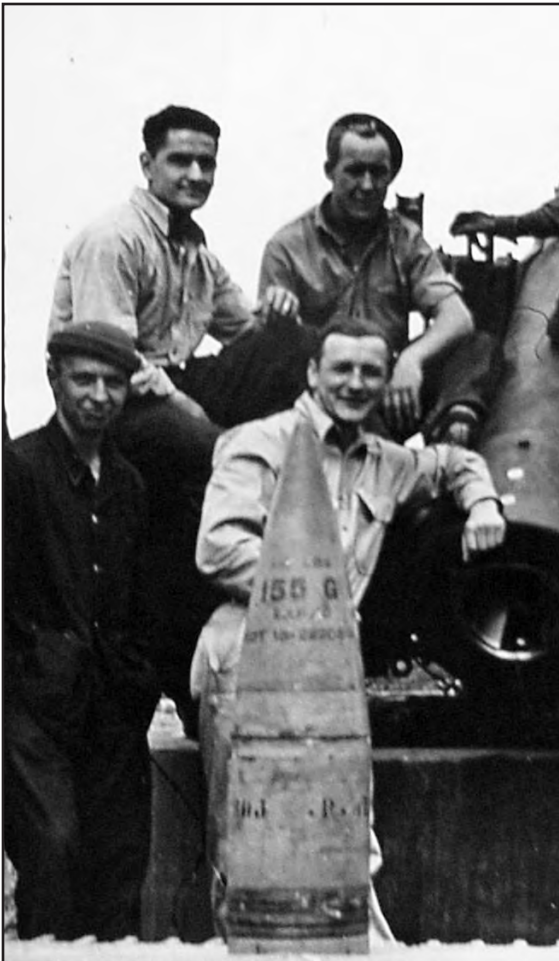
Stop 12

This circular concrete structure is the one of the four Panama mounts on Ulakta Head. Constructed in the summer of 1941, these were the original gun emplacements. It is named a Panama mount because the initial design was first used for defense of the Panama Canal. The 155mm guns placed on these mounts had solid rubber tires that would rest on the “pintle” or concrete cylinder in the center of the mount. The guns’ split-trail carriage rode on the outer rail giving them a full 360 degree rotation. The 155mm gun, a hold over from World War I, is known as American M1917A1 cannon. The barrel of the cannon was 18 feet long and the gun weighted nearly 13-tons. From Ulakta Head the cannons could fire a 95-pound projectile 12.5 miles. Each gun had an 18 man crew.

The photo (opposite page) shows men of “B” Battery of the National Guard Unit 250th Coastal Artillery preparing to fire a gun. The crew is posing with a shell (left) and gun (above). The 250th served here until May 1943.

Battery 402 was constructed over the top of the Panama mount #2. The Panama mount #1 (by Stop 8) is nearly covered with dirt from Battery 402 construction.

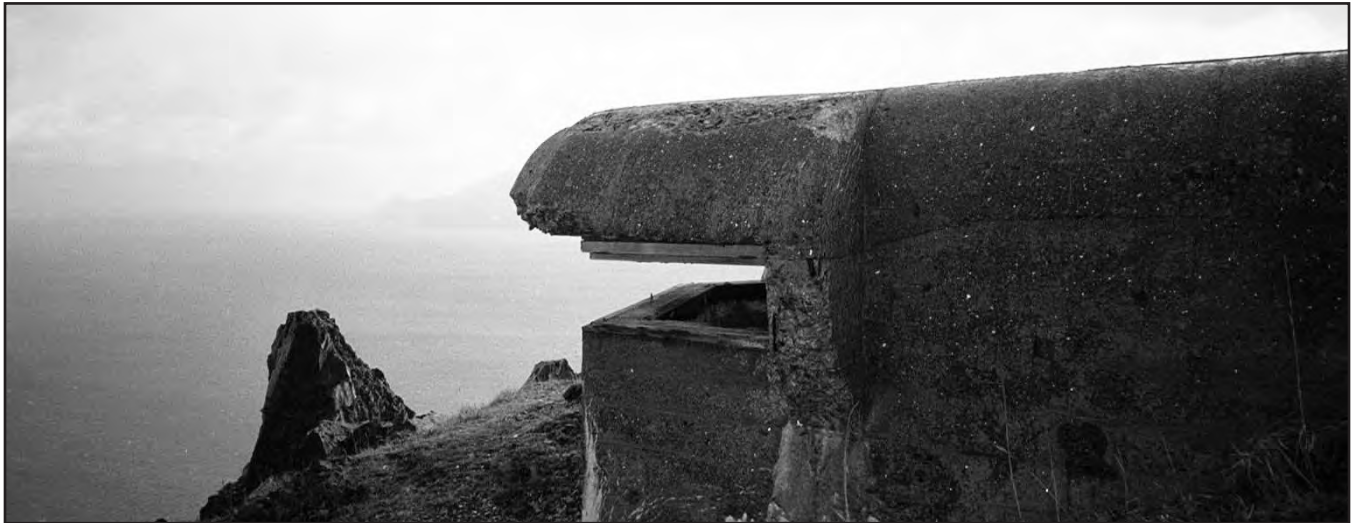
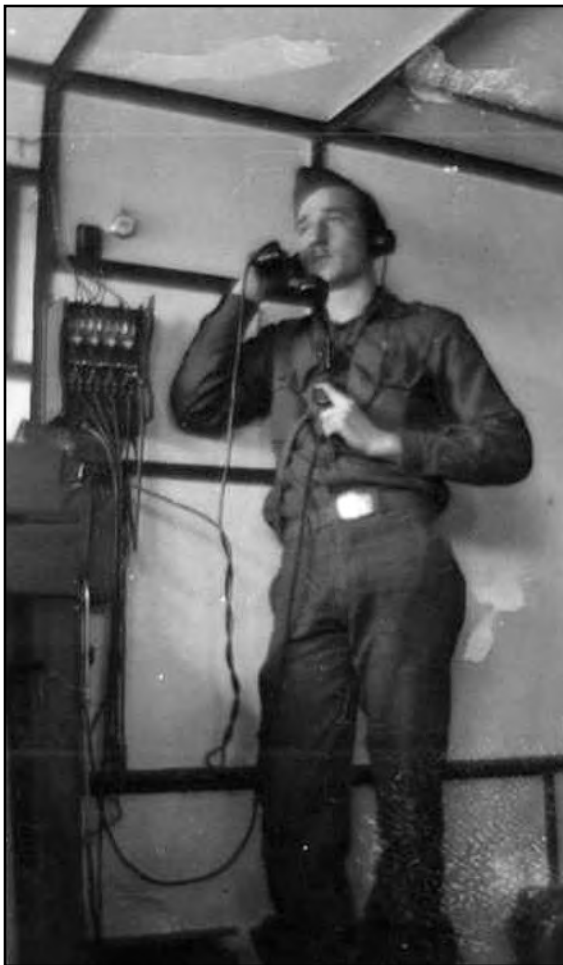
Stop 13

Once inside the base end station (above and opposite), you will notice an iron mount bolted to the floor. The mount held a M1910 Azimuth scope that was used to find the location and distance of the target. Telephoned to engineers (left), this data would allow them to triangulate on the target and obtain its range. Data from at least two base end stations were needed in order to triangulate and calculate the speed of a target.
